# Roar Ege: The Lifecycle of a Reconstructed Viking Ship

EXARC Journal Issue 2020/2 | Publication Date: 2020-05-25

Author(s): Triona Sørensen <sup>1</sup> ✉, Martin Rodevad Dael <sup>1</sup>

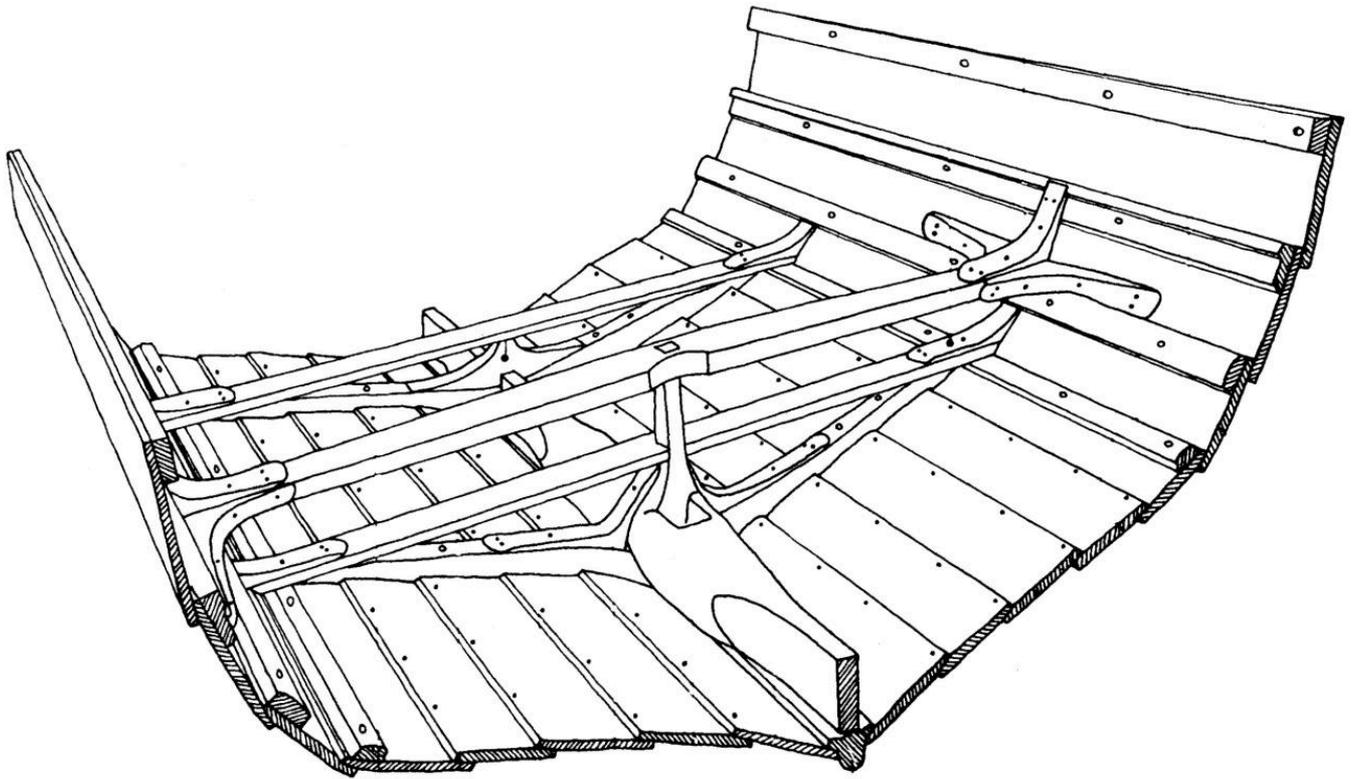
This repair encapsulates one of the major challenges associated with maintaining clinker-built boats. Clinker-built boats are constructed using a technique where boards and other components overlap each other (See Figure 8). Even with regular care, maintenance and cleaning, these overlaps can create ideal conditions for rot. Of particular note here are the longitudinal reinforcing timbers – the stringers. Clinker-built ships are designed to have a degree of flexibility – this is one of the advantages of the method as it allows for light constructions which can take a considerable beating when at sea. The downside of this flexibility is that components – such as the stringers – which are only fastened using treenails, can work themselves loose over time. This creates gaps between components, trapping moisture and organic matter between the contact surfaces of the stringers and the boards they are fastened to, facilitating the growth and spread of rot. The outer shell of the hull, which is comprised of overlapping boards is not affected by rot in the same way. The land, or overlap, between the boards is caulked using tar and wool, and this helps to exclude moisture from the joint. Where planking material has become subject to damage from rot, it has generally been because it started in the internal stringers and then spread to the surrounding planking material.

FIG 8. RECONSTRUCTED CROSS-SECTION OF SKULDELEV 3, SHOWING THE MANNER IN WHICH THE VARIOUS COMPONENTS OVERLAP EACH OTHER (AFTER CRUMLIN-PEDERSEN AND OLSEN 2002, 198, FIG. 3).

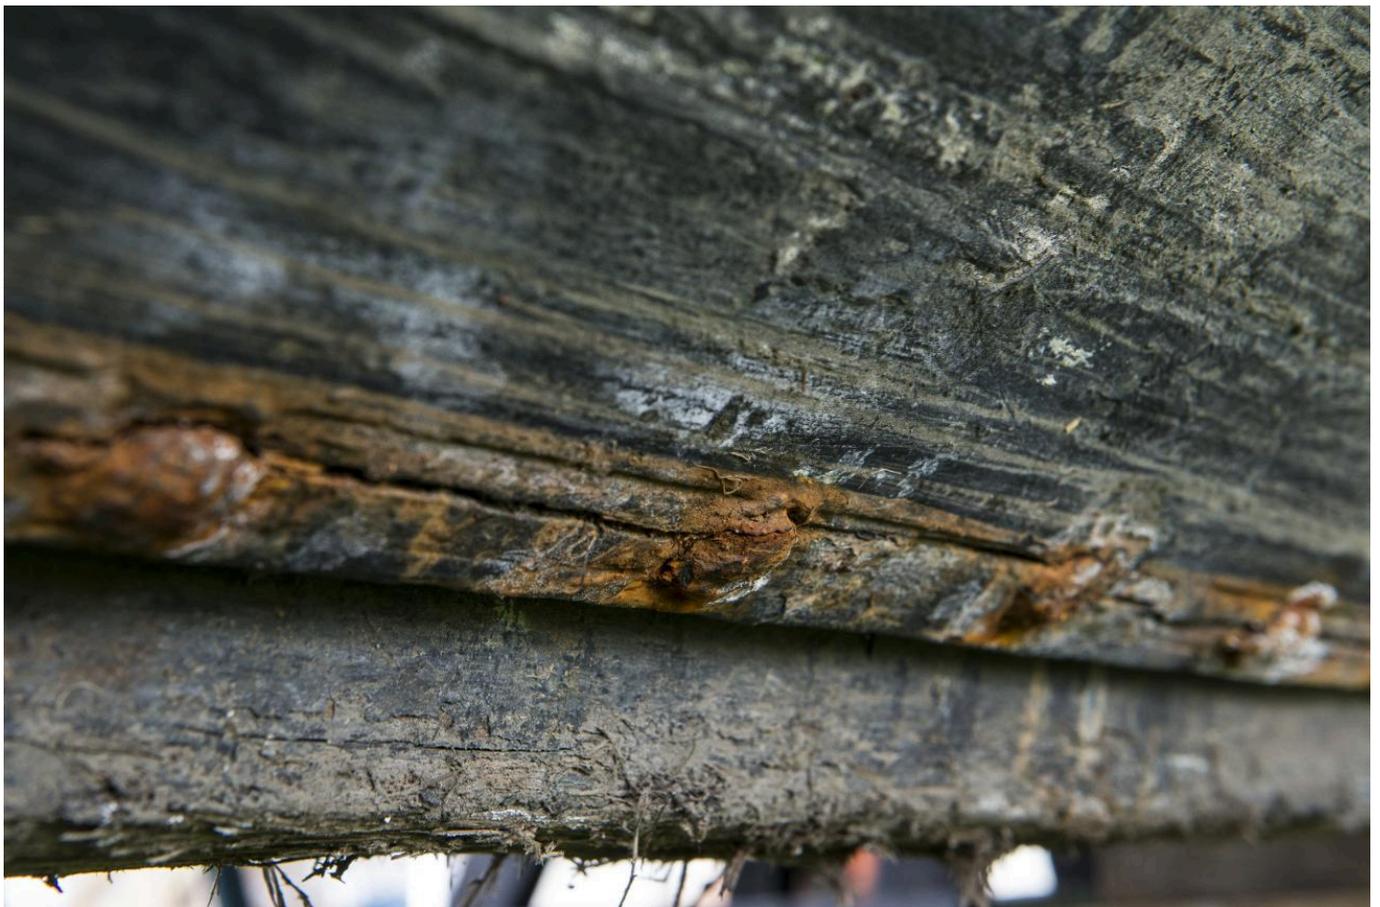
The other significant problem our reconstructions face is the rate at which the iron rivets corrode. They expand as they rust and this leads to cracks occurring in the planking material around the rivets (See Figure 9). The iron fastenings used in the construction of *Roar Ege* are perhaps the main element that deviates from the project's ambitions about using the same materials as would have been used in the Viking Age. In the early 1980's, very little archaeometallurgical analysis of ship's fastenings had been carried out. The project team therefore relied on the limited information that was available, drawing heavily on the work of Olfert Voss and Vagn Fabricius Buchwald<sup>1</sup> (Voss, 1962; Andersen, *et al.*, 1997, p.42).

FIG 9. DAMAGE CAUSED TO SURROUNDING PLANKING BY RUSTING RIVETS (PHOTO: WERNER KARRASCH. COPYRIGHT: VIKING SHIP MUSEUM IN ROSKILDE).

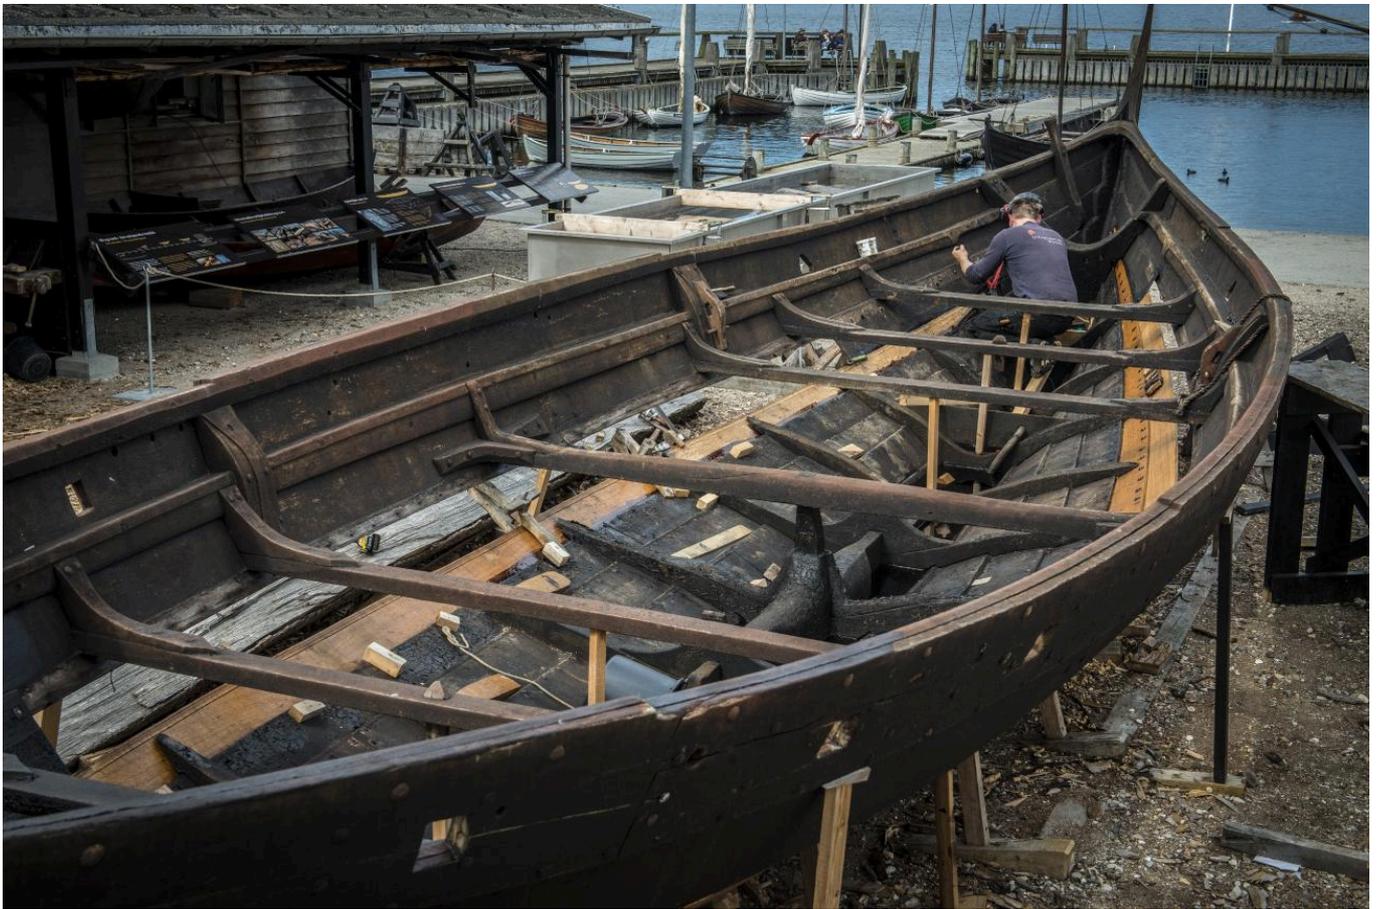
The last major repair to *Roar Ege* was carried out in 2014 and saw the replacement of the fifth and sixth strakes as well as several major internal components (See Figure 10). It had been hoped that this repair would keep *Roar Ege* on the water for another five to ten years but unfortunately, this was not to be the case. By 2015, the state of the hull had deteriorated significantly below the waterline. Considerable leaks appeared where rusting rivets began to

FIG 10. EXTENSIVE REPAIRS WERE CARRIED OUT ON ROAR EGE IN 2014 WITH A VIEW TO KEEPING THE SHIP AFLOAT FOR SEVERAL MORE YEARS. THIS ENDEAVOUR WAS ULTIMATELY IN VAIN AS ROAR EGE WAS RETIRED ON LAND TWO YEARS LATER (PHOTO: WERNER KARRASCH. COPYRIGHT: VIKING SHIP MUSEUM IN ROSKILDE).

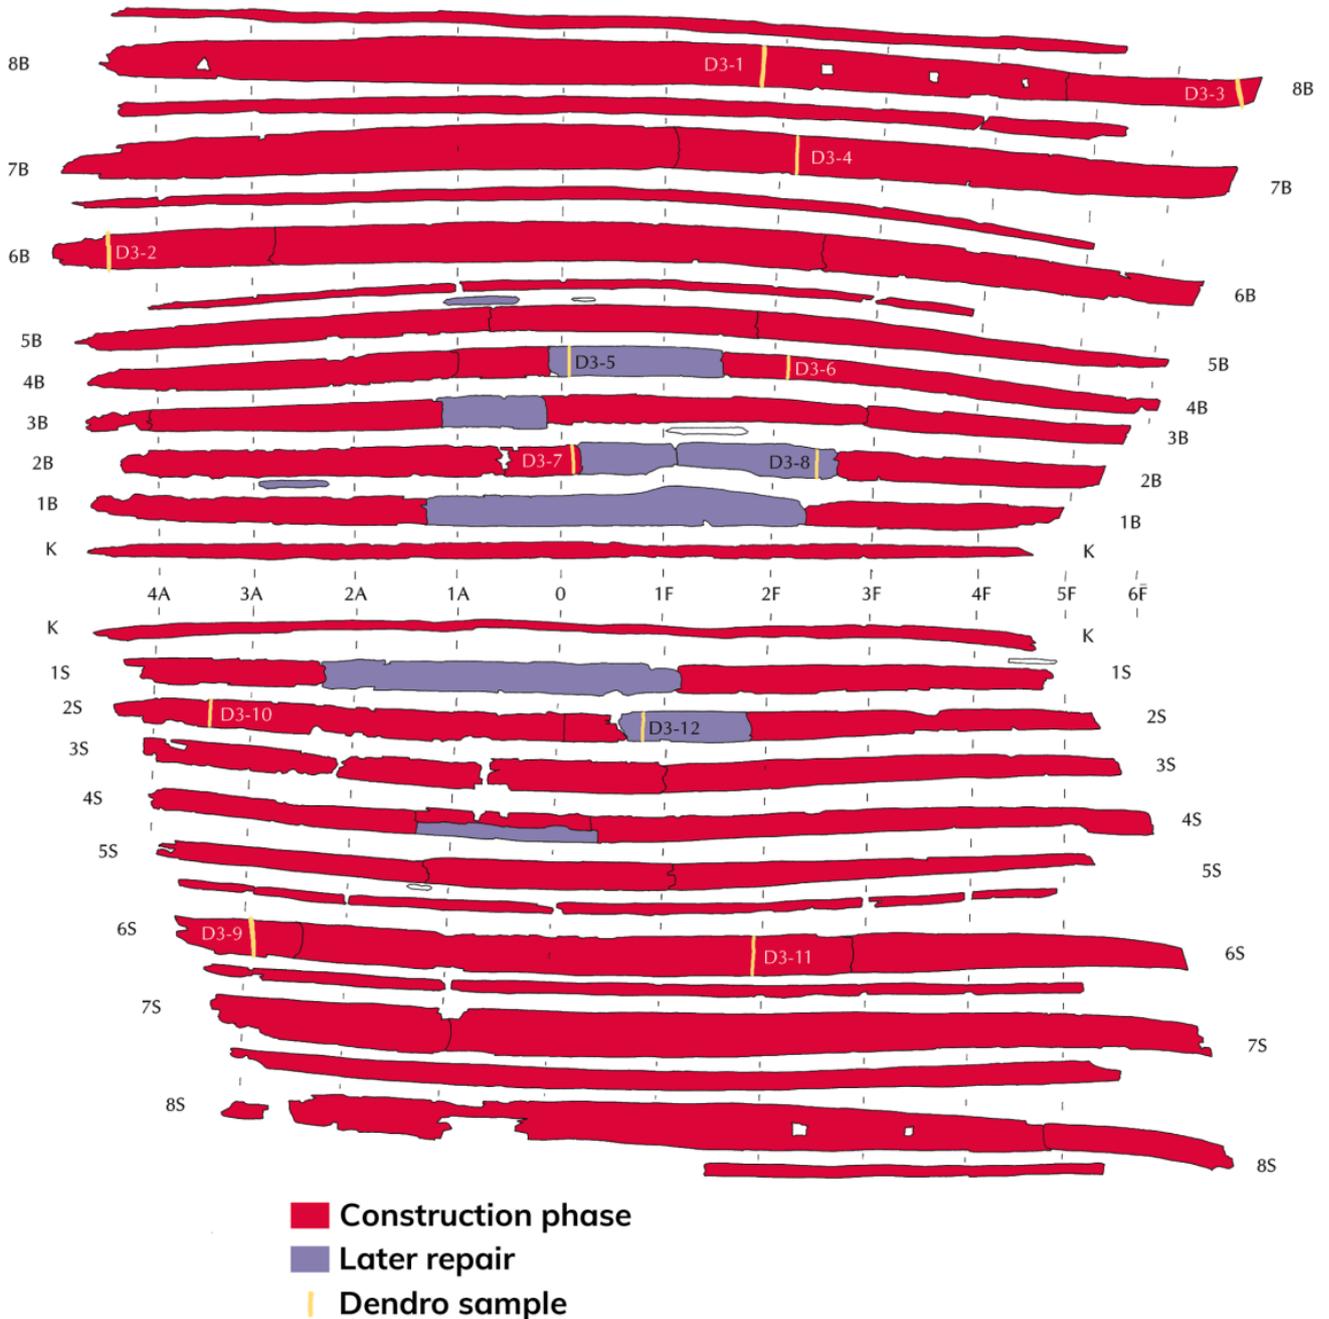
Skuldelev 3 is estimated to have been between twenty to thirty years old when it was scuttled at the barrier at Skuldelev (Crumlin-Pedersen and Olsen, 2002, p.333). This total tallies well with the 31 years *Roar Ege* had in active service. Skuldelev 3 had been repaired several times during its lifetime, with short sections of planking being replaced below the waterline (See Figure 13; Crumlin-Pedersen and Olsen, 2002, p.230). Strikingly, the situation with the sequence of repairs on *Roar Ege* can be seen as quite the opposite. Apart from the sheathing added in 2012 and the general deterioration of the lands in 2016, the majority of the repairs have been located above the waterline.

FIG 13. THE PLANKING OF SKULDELEV 3 WITH INDICATION OF REPAIRS MARKED IN PURPLE (AFTER CRUMLIN-PEDERSEN AND OLSEN 2002, 230, FIG. 41).
