Mock-up Presentation of the Gate Tower to the Hill Fort at Liptovská Mara

Oto Makýš Department of Building Technology, Faculty of Civil Engineering, Slovak University of Technology, Bratislava, Slovakia *

• The author discusses the importance of including maintenance costs while planning an experimental construction based on the example of Liptovská Mara.

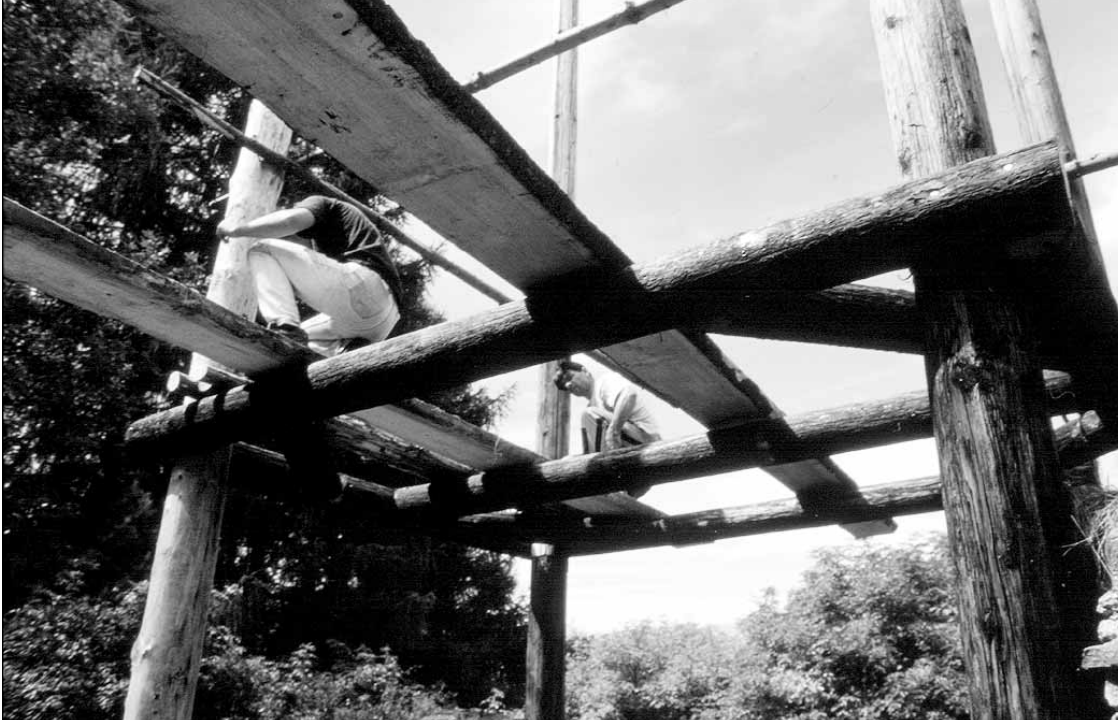
Fig. 2 The tower at the stage of a finished rough construction in the summer of 2003. ■

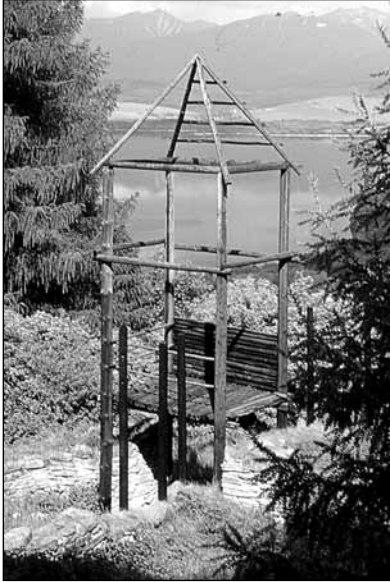
Fig. 1 Condition of the tower in 2000. ■

The lack of maintenance showed on the tower construction with the decay of the pine post in the contact zone of ground-air and its general weakening (during reconstruction it was possible to break it with the pressure of one hand). Part of the rungs was destroyed and rot had developed in most of the joints caused by the collecting of rain water. The centres of the tops of the electric posts were also damaged – to about 0.3-0.5 m depth. The posts were cracked – some of the cracks reached nearly 2/5 of the diameter and were up to 1 m long. Two posts were damaged by woodpeckers – several rounded holes about 5-4 by 10-12 cm in size and about 5-7 cm deep.

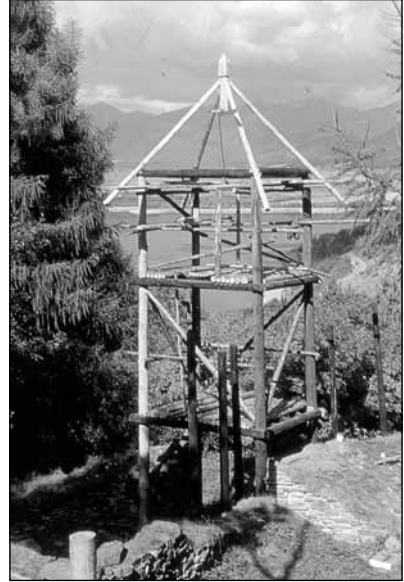
Fig. 3 Condition of the tower in autumn 2003. ■

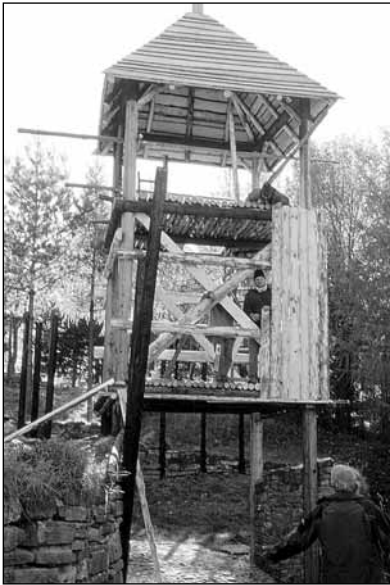
Fig. 8 Horizontal strengthening of the tower at floor level. ■

g) All floors were both in the horizontal and vertical planes made thoroughly draught proof

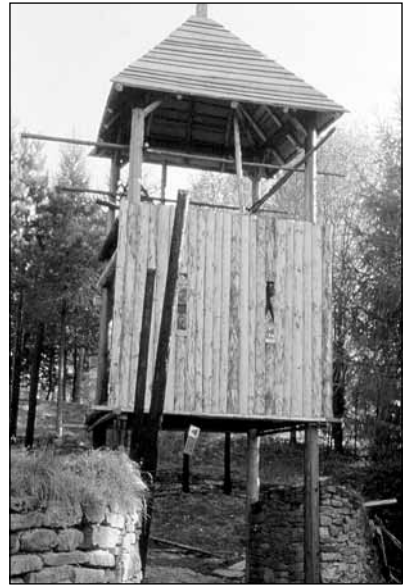
Fig. 10 Putting on the covering under supervision. ■

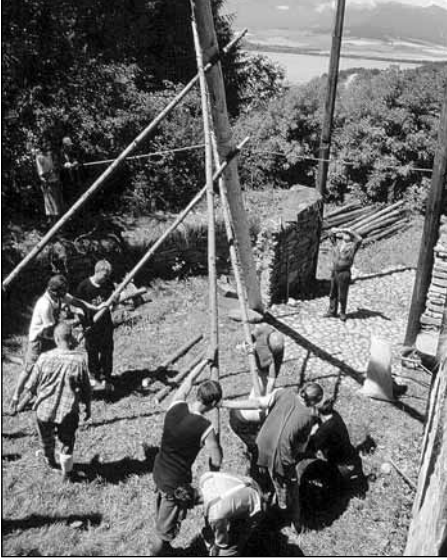
Fig. 7 Erecting a new post. ■

a) Within the given time it was shown to be impossible to obtain and bring to the site of the hill fort a fourth industrially impregnated electric pylon more than 10 m long – therefore we had to use a freshly cut spruce instead

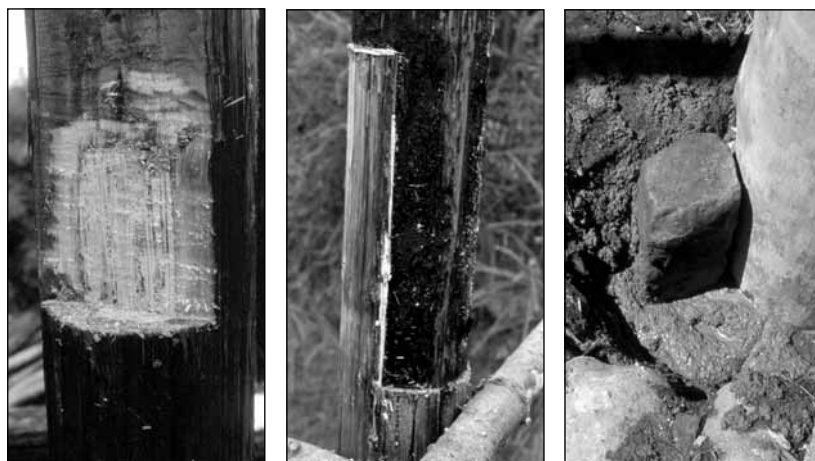
Fig. 4 Cleared and filled in area of rot at the joint of a post and rung. ■ **Fig. 5** Extension of the damaged ends of posts with overlapping joint. ■ **Fig. 6** Reversible fitting of a post into concrete. ■

c) The setting of the new post into the original hole had to be reversible – therefore blocks of sandstone were embedded into the concrete. If necessary it will be possible to break these and pick the concrete out in pieces.

a) In place of many of the original joints of posts with rungs, decay had started – the damaged wood was therefore completely removed and the resulting recesses again reinforced with lamellas

f) The centres of the tops of the posts started to rot (up to 0.5 m) in the direction of the fibres – we therefore cut off the ends and replaced them with new healthy wood, joined to the old posts by overlapping
