Rediscovering and Rebuilding the Tranent-Cockenzie Waggonway: archaeology and experimental archaeology of Scotland's First Railway

[EXARC Journal Issue 2025/2](#) | Publication Date: 2025-08-06

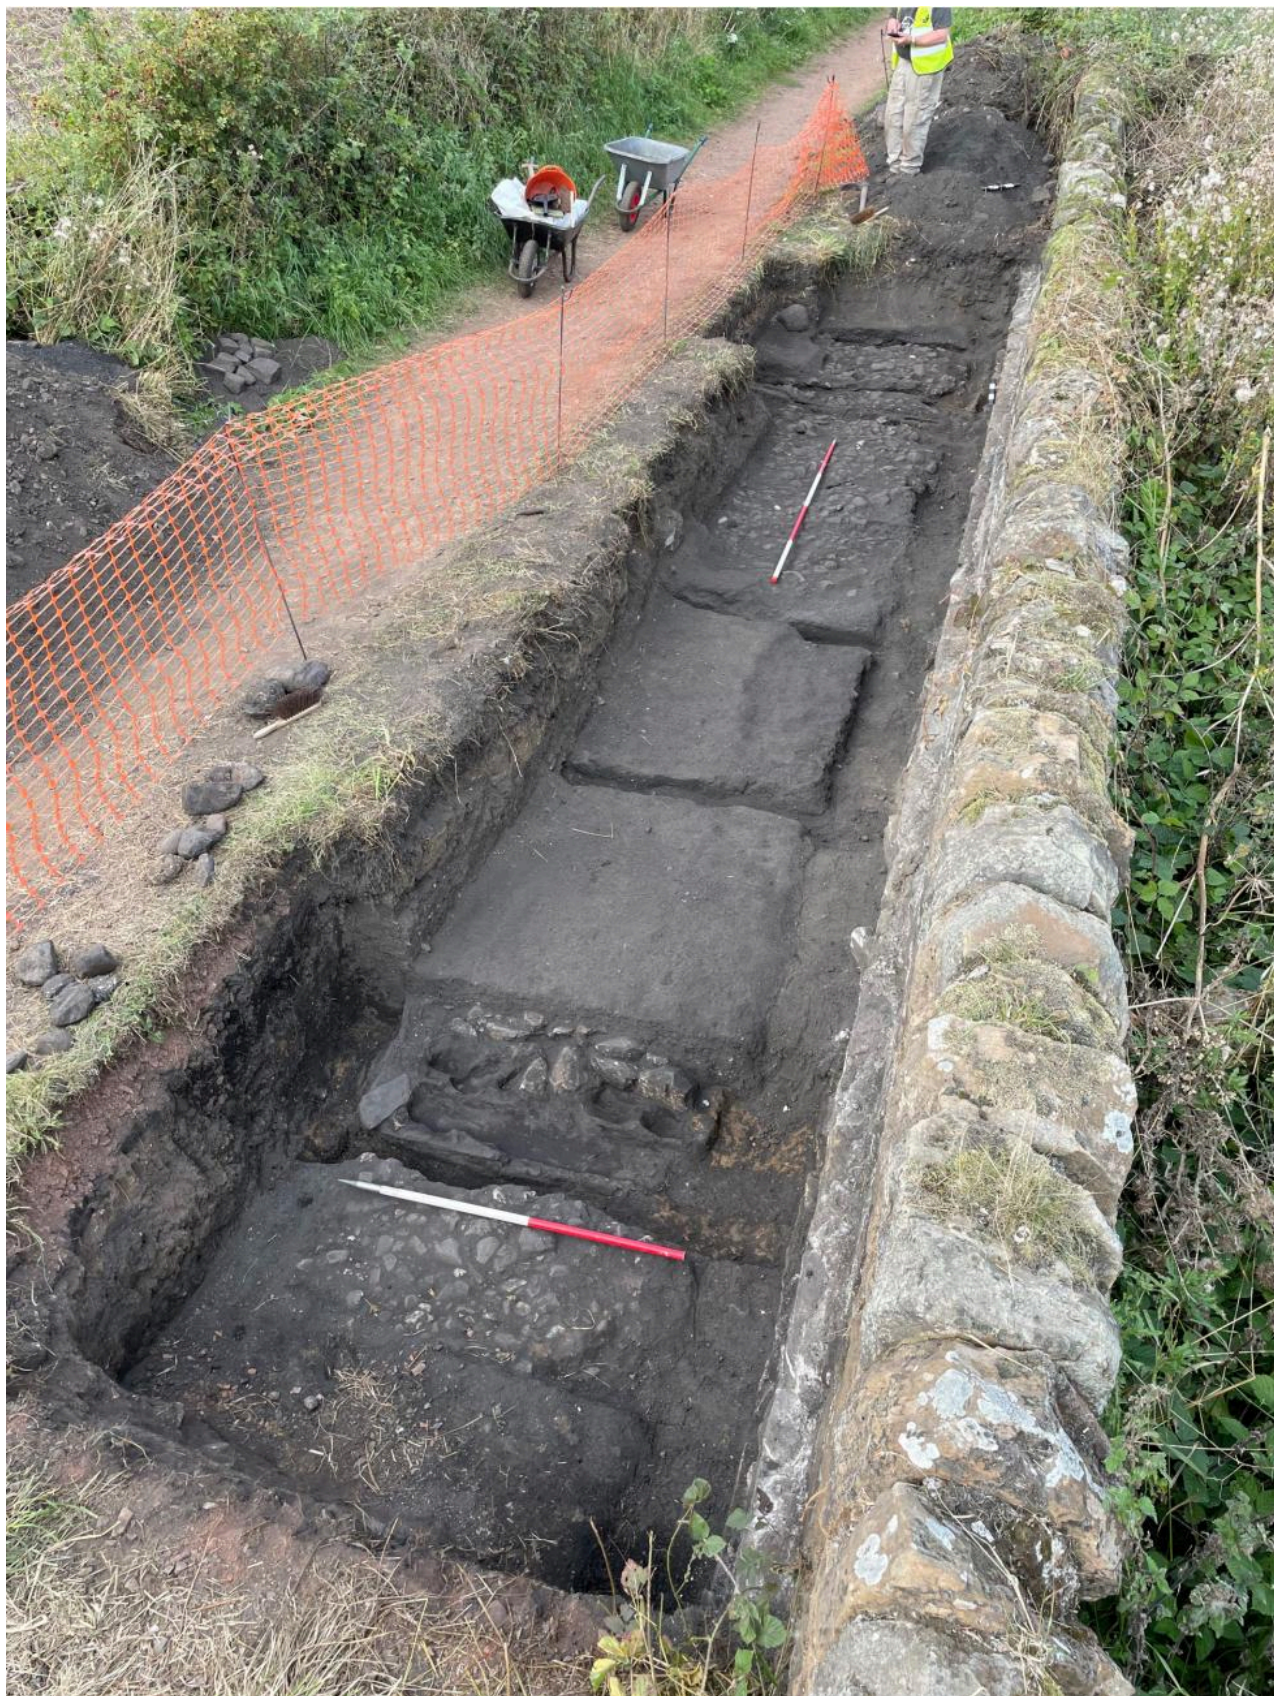
FIG 2. OVERVIEW OF THE 2021 EXCAVATION AT PRESTONPANS BATTLEFIELD, LOOKING NORTH. EVIDENT ARE VOIDS FROM RAILS AND SLEEPERS; THE THICKNESS OF THE SMALL COAL HORSE TRACK AS WELL AS THE LARGE ROUNDED BEACH COBBLES WHICH OVERLAY A TIMBER CORDUROY, WHICH SURVIVED AS WET AND MINERALISED WOOD. PHOTO BY ANTHONY DAWSON.

The first phase of activity on the site was laying a corduroy of round or half-round timbers directly onto the natural, all top and sub soil having been removed. There was no evidence for any redeposited material from ditch digging being used to level the site or create an embankment. This corduroy created a 'raft' on which the waggonway was built, being used to spread its weight as it was 'floated' across an area of soft and boggy ground. These round or half-round timbers show minimal evidence for processing; they were still in the round and with bark left on. Archaeological work on other wooden railways suggest that this was an unusual construction technique as shallow trenches were dug into which sleepers were set on top of a shallow bed of small coal and ashes (Bell, 2018, pp.17-26). The method of construction employed on the Tranent-Cockenzie waggonway was clearly dictated by geographical concerns and crossing an area of wet ground (See Figure 2).

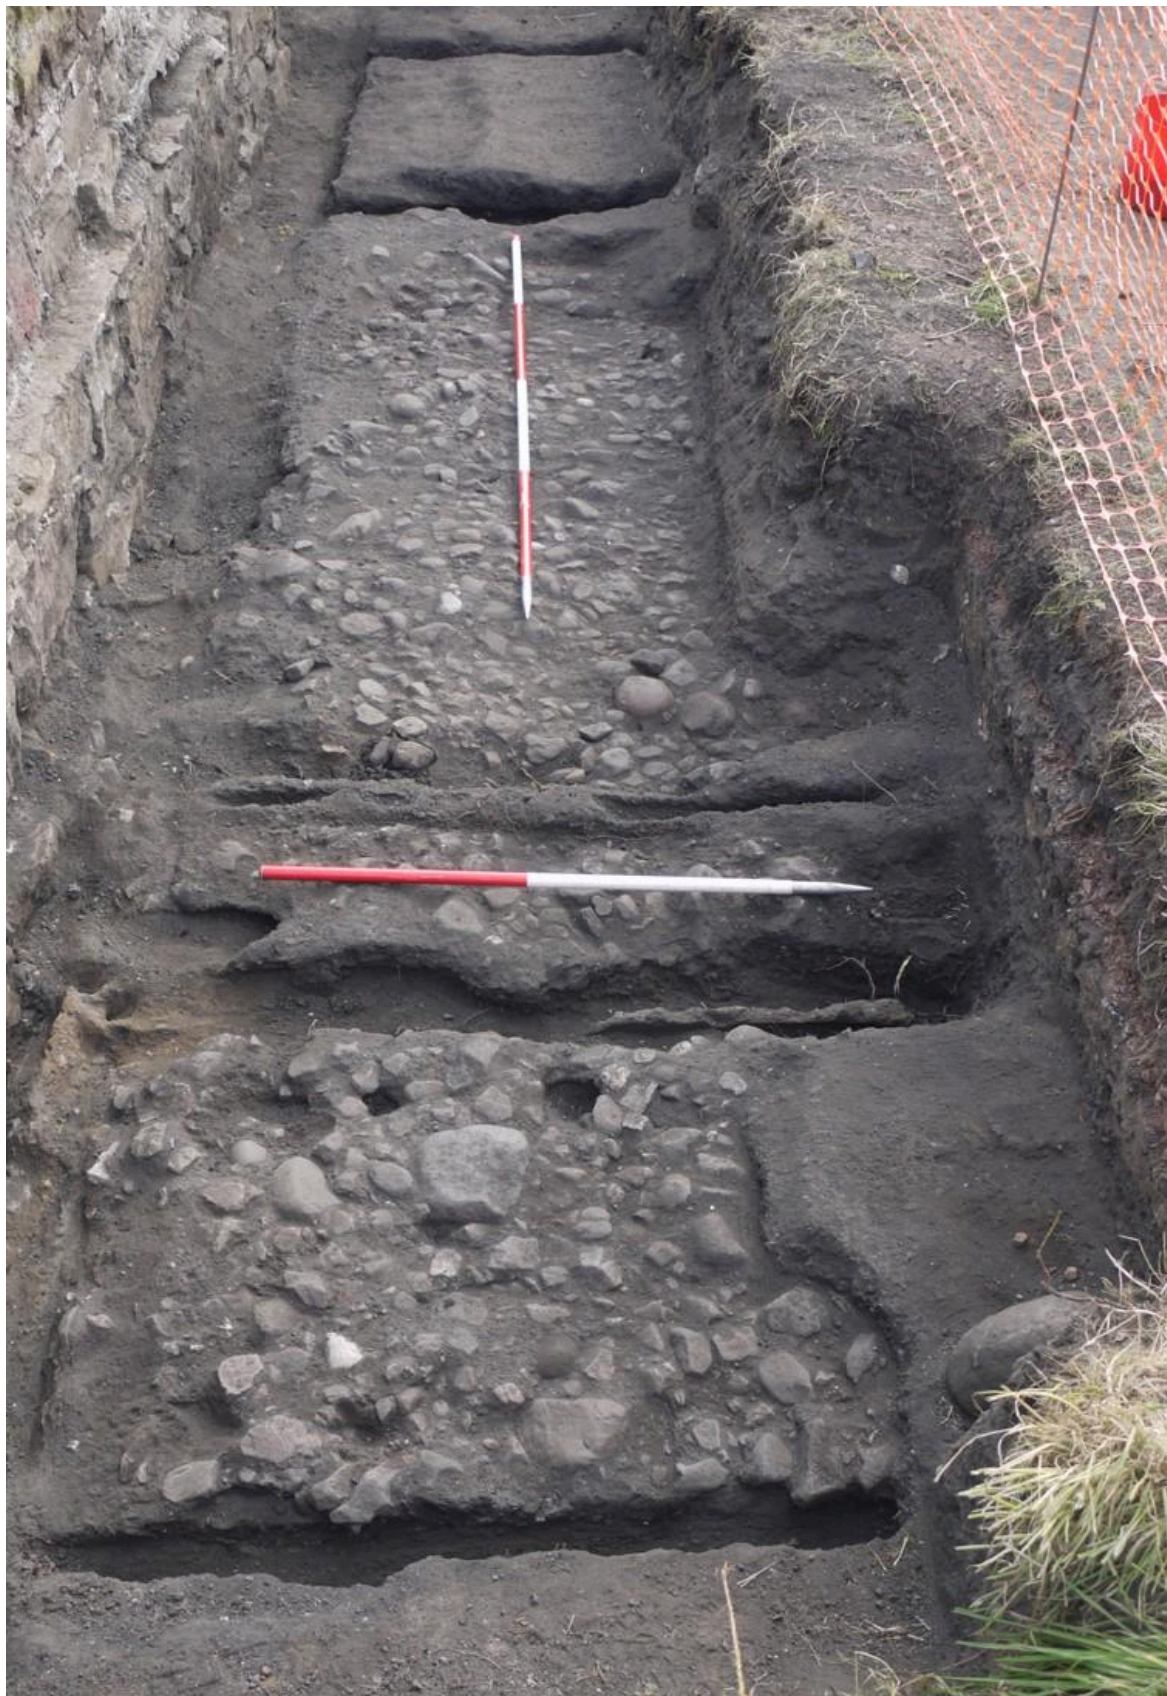
FIG 3. VIEW OF THE 2021 LOOKING SOUTH. VISIBLE AT THE NORTH END OF THE TRENCH ARE MINERALISED WOOD RAILS AND SLEEPERS SET WITHIN THE COBBLE AND BROKEN STONE BALLAST OF THE HORSE TRACK. ON THE E SIDE PRESERVATION INCLUDED A HALF-LAP JOIN BETWEEN SLEEPER AND RAIL. PHOTO BY ANTHONY DAWSON.

This ballast material was contained by the voids of timber rails and sleepers, set at 4 feet 8 inches (1.42m) gauge. The use of 4ft 8in gauge, together with the terminology 'waggonway' would suggest links with waggonway building tradition around Newcastle upon Tyne where a gauge of 4ft to 5ft was preferred, suggesting a cross-border link and transfer of technology (Lewis, 1970, pp.134-136, 164-165). The rails were a maximum 20cm x 20cm in section, equating toward the upper end of rail size quoted by Lewis for Newcastle waggonways; he suggests a general size of 4.5in x 5in (8.8cm x 12.7cm), but never larger than 6in square (15.2cm) (Lewis, 1970, p.165). Rails at Lambton were 12cm - 13cm square and varied in length from 1.25 - 3.3m in length. Those at Willington were generally 12cm x 16cm and ranged in length from 0.5m to 4.92m (Bell, 2018, pp.17,35) (See Figure 3).

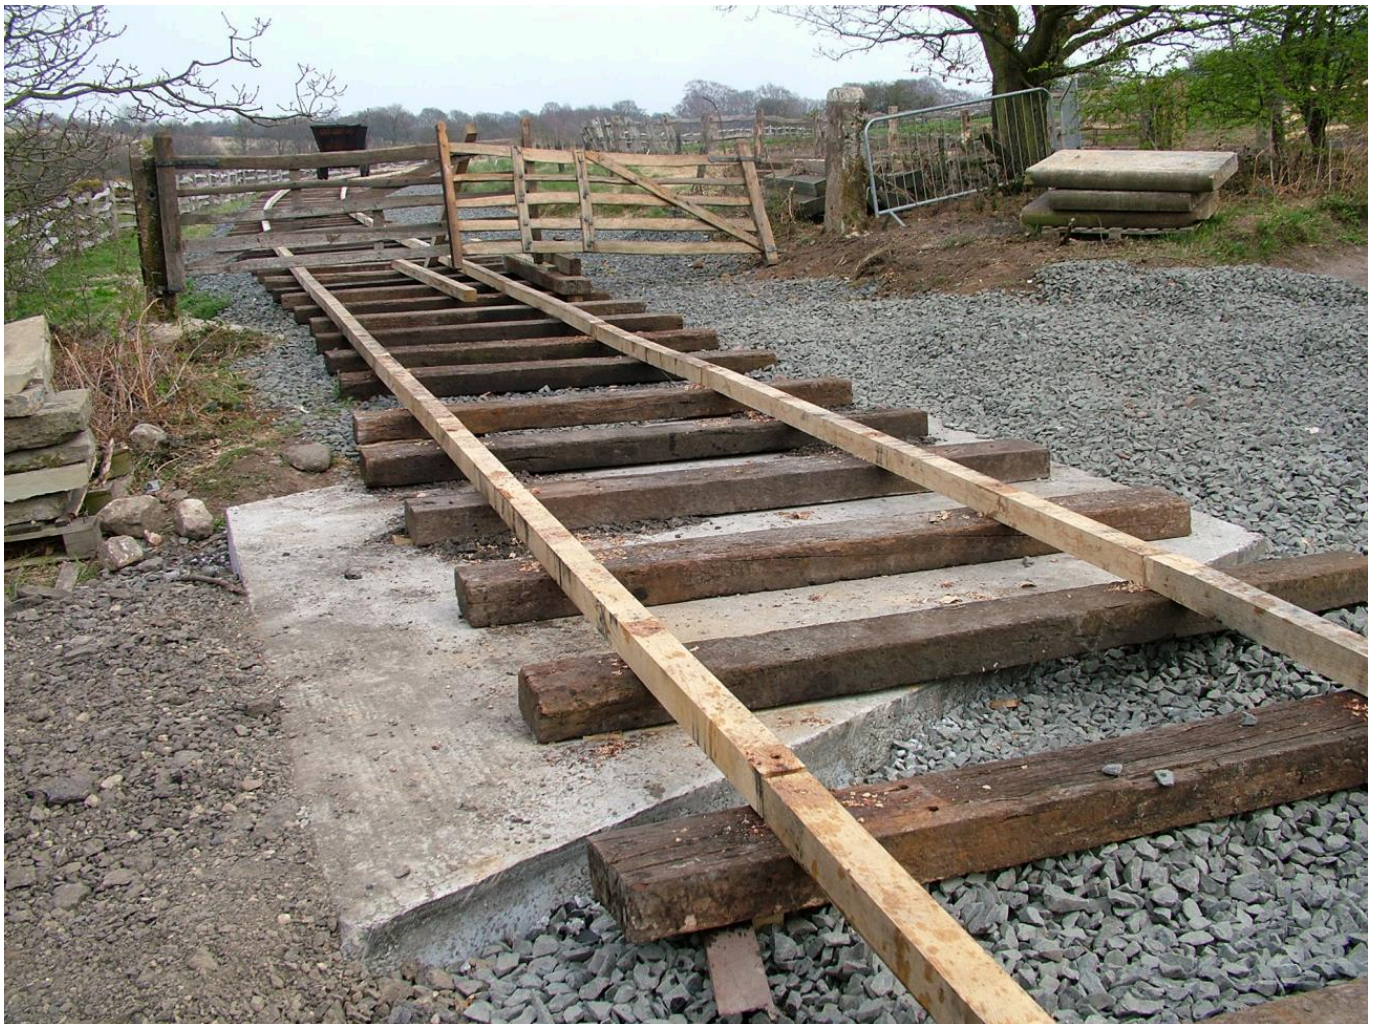
FIG 5. CONSTRUCTION OF THE REPLICA WOODEN WAGGONWAY AT BEAMISH WHICH USED A MIXTURE OF MODERN MATERIALS (SUCH AS SLEEPERS AND PRE-SAWN OAK TIMBER) BUT ALSO TRADITIONAL METHODS SUCH AS DRILLING TRENAIL HOLES BY HAND. PHOTO BY PAUL JARMAN, BEAMISH MUSEUM.

A 200 yard long wooden waggonway, based on the Lambton D pit waggonway was built under the auspices of Paul Jarman at Beamish Museum in the early 2000s. This was built using a combination of techniques and has been described as 'too substantial for a waggonway.' For ballast, a sub-base of broken brick was utilised, which was then ballasted. Reclaimed mainline Jara sleepers were re-purposed, accompanied by oak rails as was therefore probably far more robust than the eighteenth-century originals which were quite rough and ephemeral. It was built by a trained carpenter who made some changes to the construction, such as drilling holes for the trenails at an angle so that the rails would not lift from the sleeper. Ballast was spread by machine using a 'JCB' type excavator. No ditches were dug but it was securely fenced off to respect neighbouring landowners wishes. Experiments with running an iron-wheeled waggon with coned wheel treads were carried out on the replica waggonway. It is likely that wooden wheels had parallel wheel treads rather than tapered or coned like modern wheel treads, but that iron wheels had coned wheels. A wheel with parallel treads would have more 'grip' on the wooden rail but would need a substantial flange to help keep it on the rail which would add to the rolling resistance between wheel and rail. A coned wheel, whilst helping to centre the wheel on the rail, would not distribute the waggon's weight evenly across the rail and tend to crush the gauge or flange side of the rail. Lewis notes that from the 1770s onwards the upper rail was often planed to create a convex shape. This probably came with the introduction of iron wheels, the shape of the rail mirroring that of the coned wheels tread (Lewis, 1970, pp.165-166) (See Figures 5 and 6).

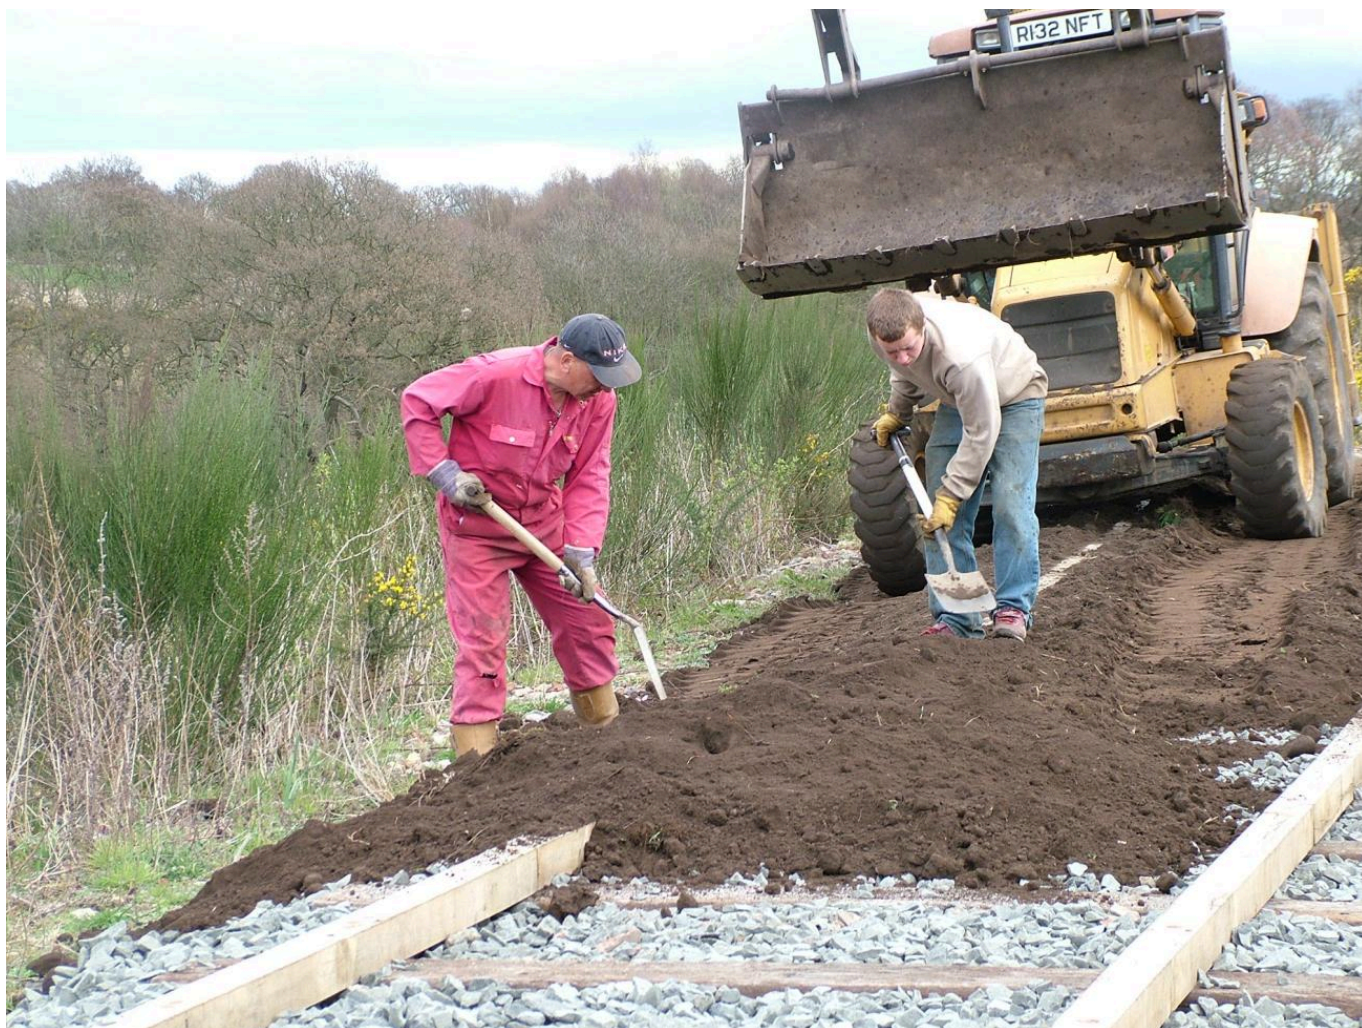
FIG 6. THE BEAMISH REPLICA WAS BALLASTED BY MACHINE. IN ORDER TO RESPECT THE LANDOWNERS WISHES NO DITCHES WERE DUG BUT IT WAS SECURELY FENCED OFF. PHOTO BY PAUL JARMAN, BEAMISH MUSEUM.

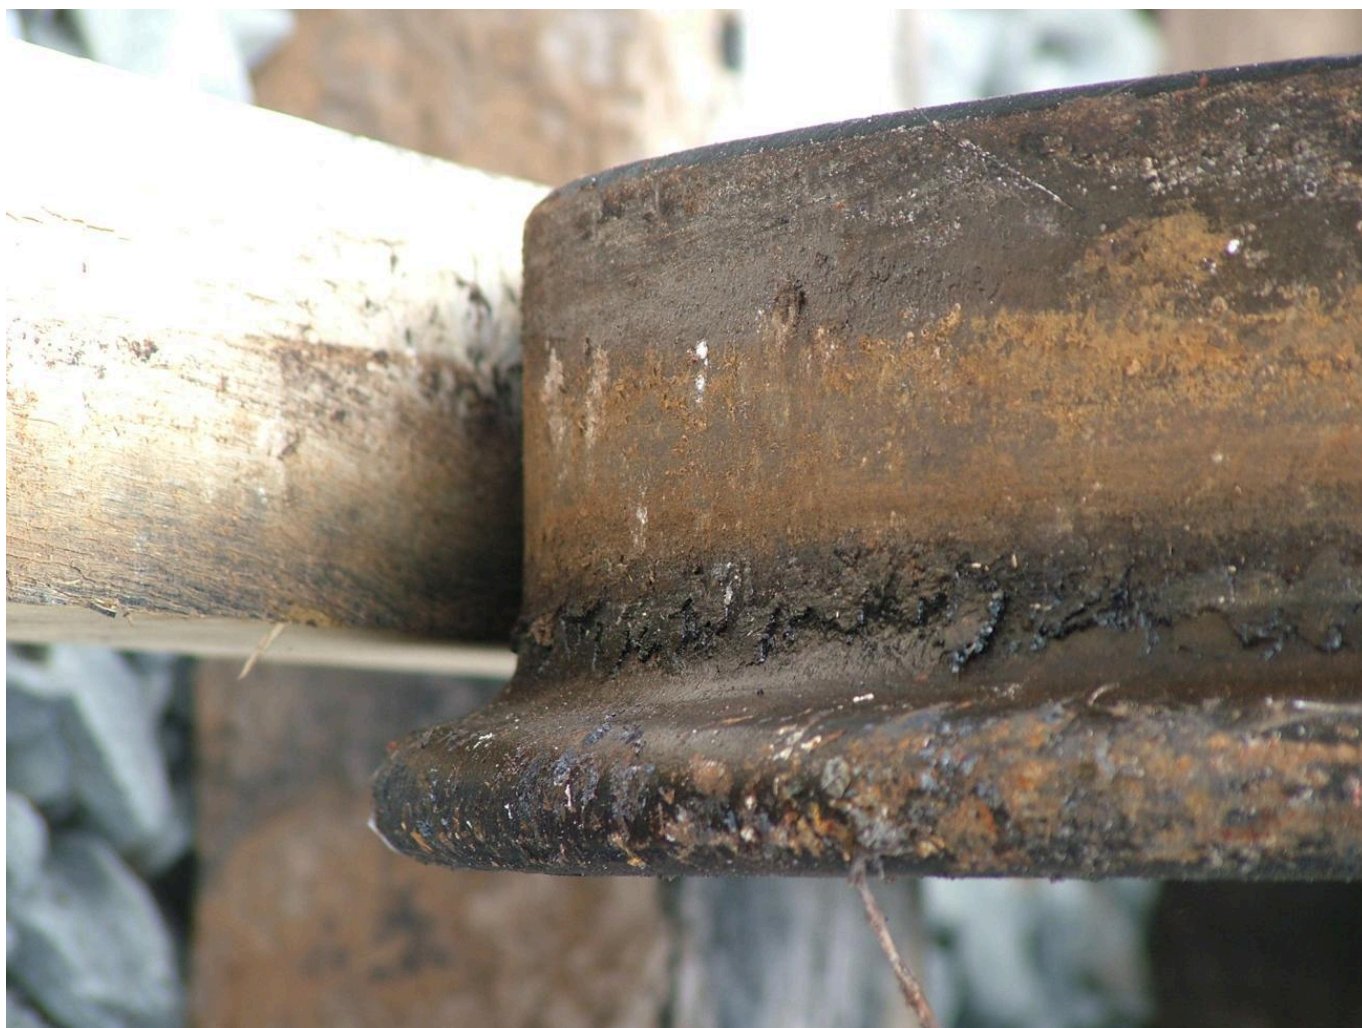
FIG 7. THE RELATIVELY POOR INTERFACE BETWEEN A CONED, CAST-IRON WHEEL ON THE REPLICA 'CHALDRON' TYPE WAGGON AND THE WOODEN RAIL. THE WHEEL IS TRYING TO CRUSH THE WOOD TO MIRROR THE SHAPE OF ITS TREAD. PHOTO BY PAUL JARMAN, BEAMISH MUSEUM.

It was found that due to a poor wheel: rail interface between coned iron wheels and square wooden rails that check rails, to help keep the wheels on the rails, were required. Likewise, 'if the horse took a racing-line, it helped the waggon transition along quite well' (Jarman, 2024, pers. comm.) and kept

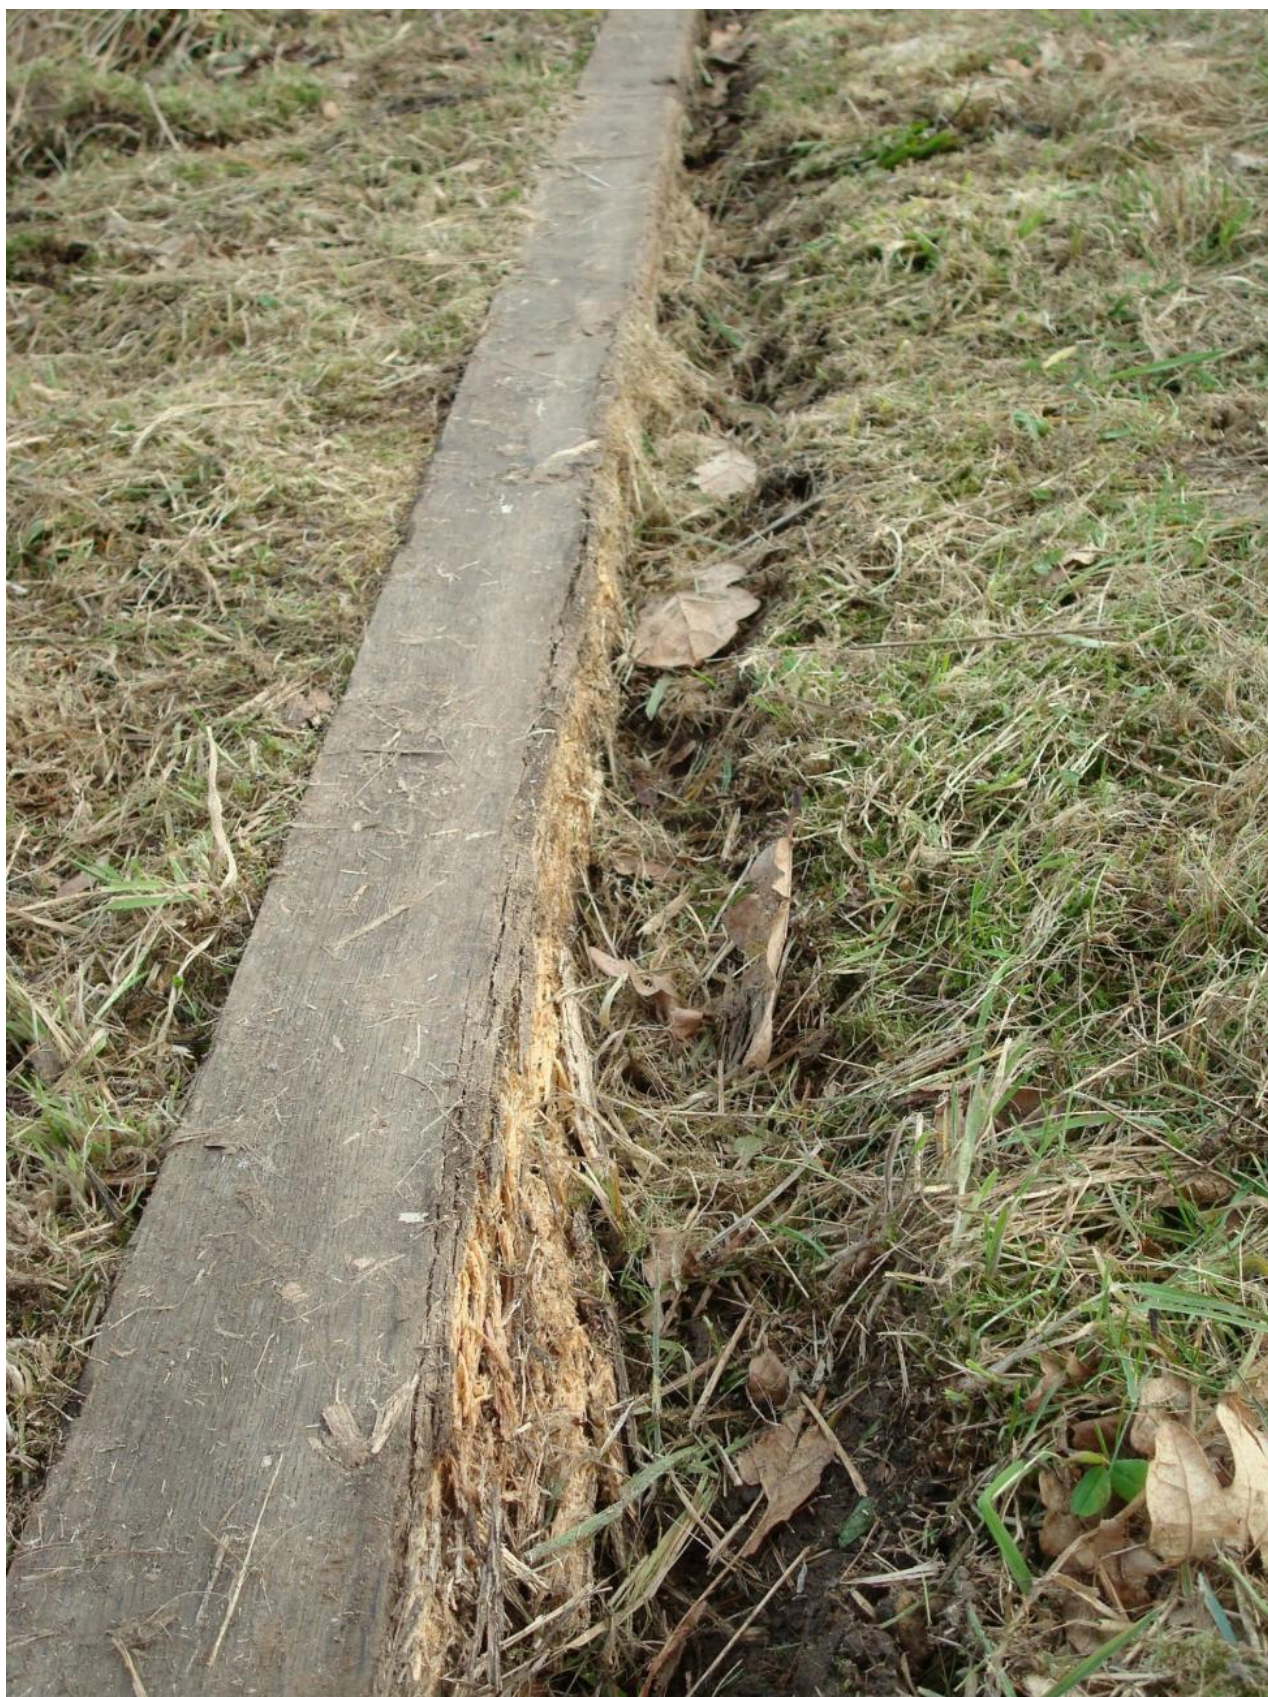
FIG 8. THE WHEEL AND IN PARTICULARLY THE FLANGE OF THE IRON WHEELS DAMAGED THE INSIDE FACE OF THE RAILS. THE RAILS WERE CRUSHED BY THE WEIGHT AND SHAPE OF THE WHEELS, AND THE FLANGE RUBBING AGAINST THE INSIDE FACE OF THE RAIL CAUSE CONSIDERABLE DAMAGE. THIS SUGGESTS LATER 18TH CENTURY WROUGHT-IRON STRIPS ON TOP OF THE RAIL WERE PERHAPS EITHER IN THE WRONG PLACE, OR REINFORCED THE EDGE, RAISING THE WHEEL SUFFICIENTLY SO THAT THE CONED TREAD RAN MORE HAPPILY ON THE STRIP OF IRON AND ALSO RAISED THE FLANGE SO THAT IT DIDN'T DAMAGE THE INSIDE OF THE RAIL. PHOTO BY PAUL JARMAN, BEAMISH MUSEUM.

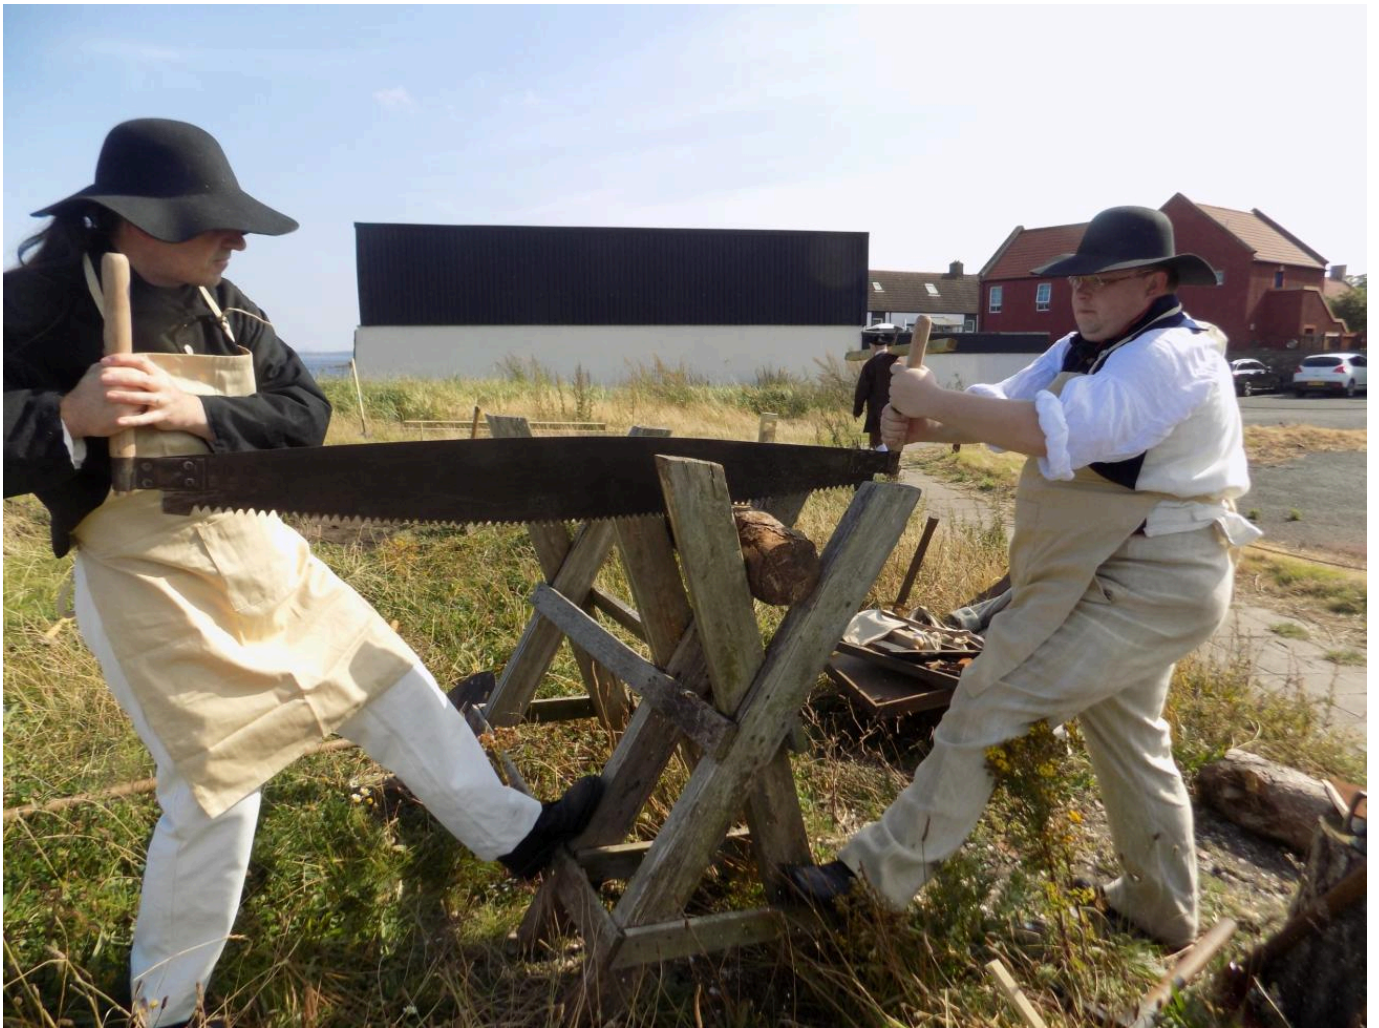
FIG 9. CUTTING ROUND WIND-FALL SLEEPERS TO LENGTH. SLEEPERS WERE CUT TO ONE AND A HALF TIMES THE GAUGE.
PHOTO BY ANTHONY DAWSON.

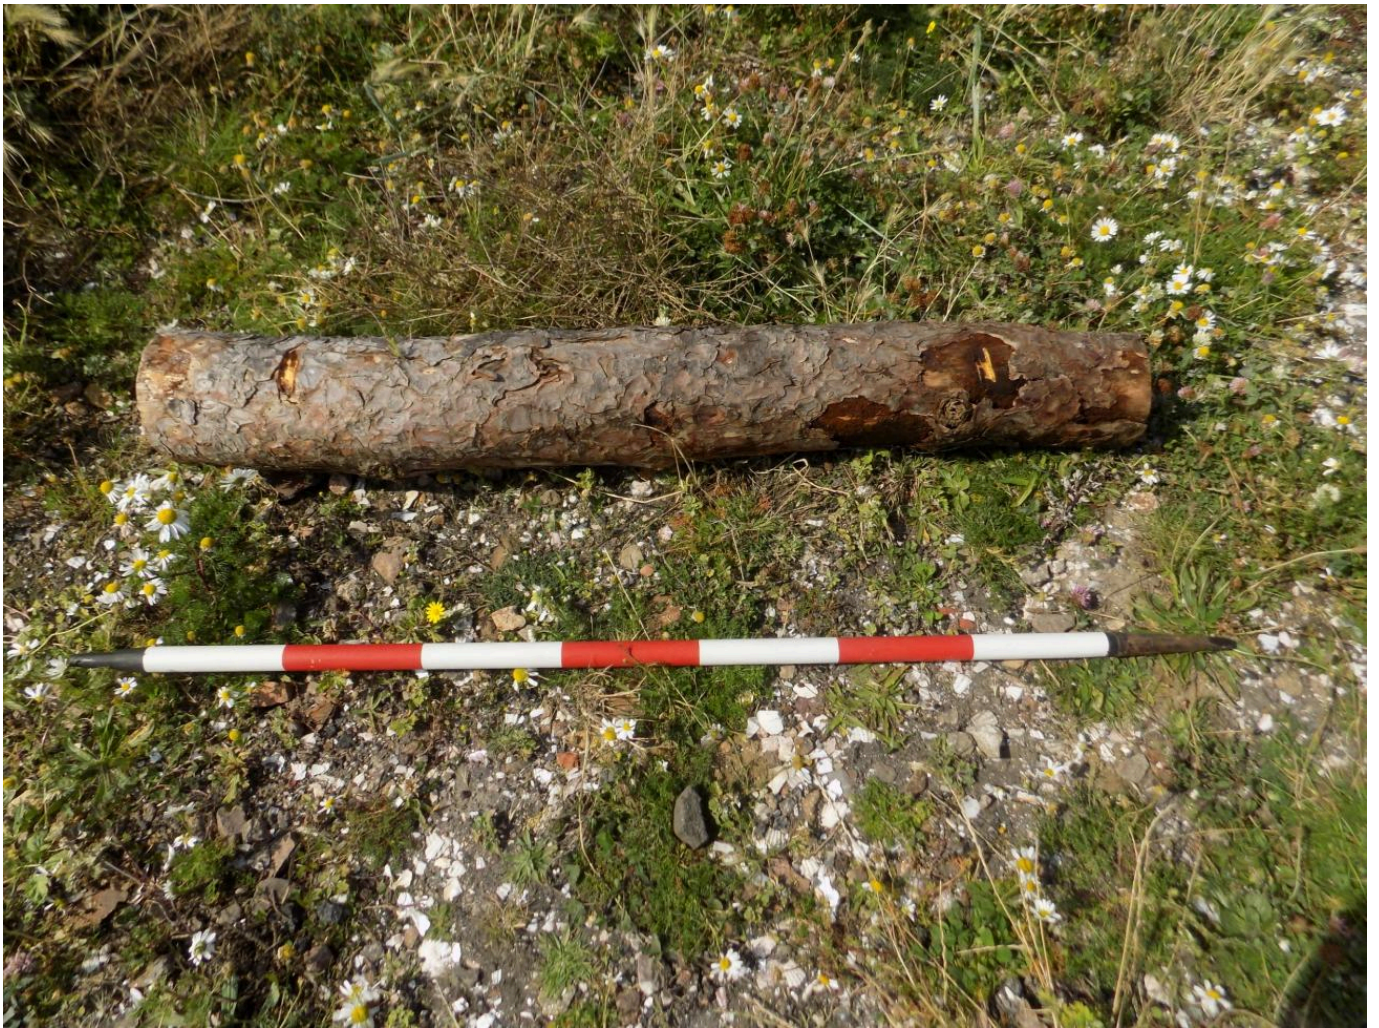
FIG 10. SLEEPER CUT TO LENGTH, BEFORE FURTHER PROCESSING TO CREATE A SHOULDER AND REBATE TO TAKE THE RAIL.
PHOTO BY ANTHONY DAWSON.

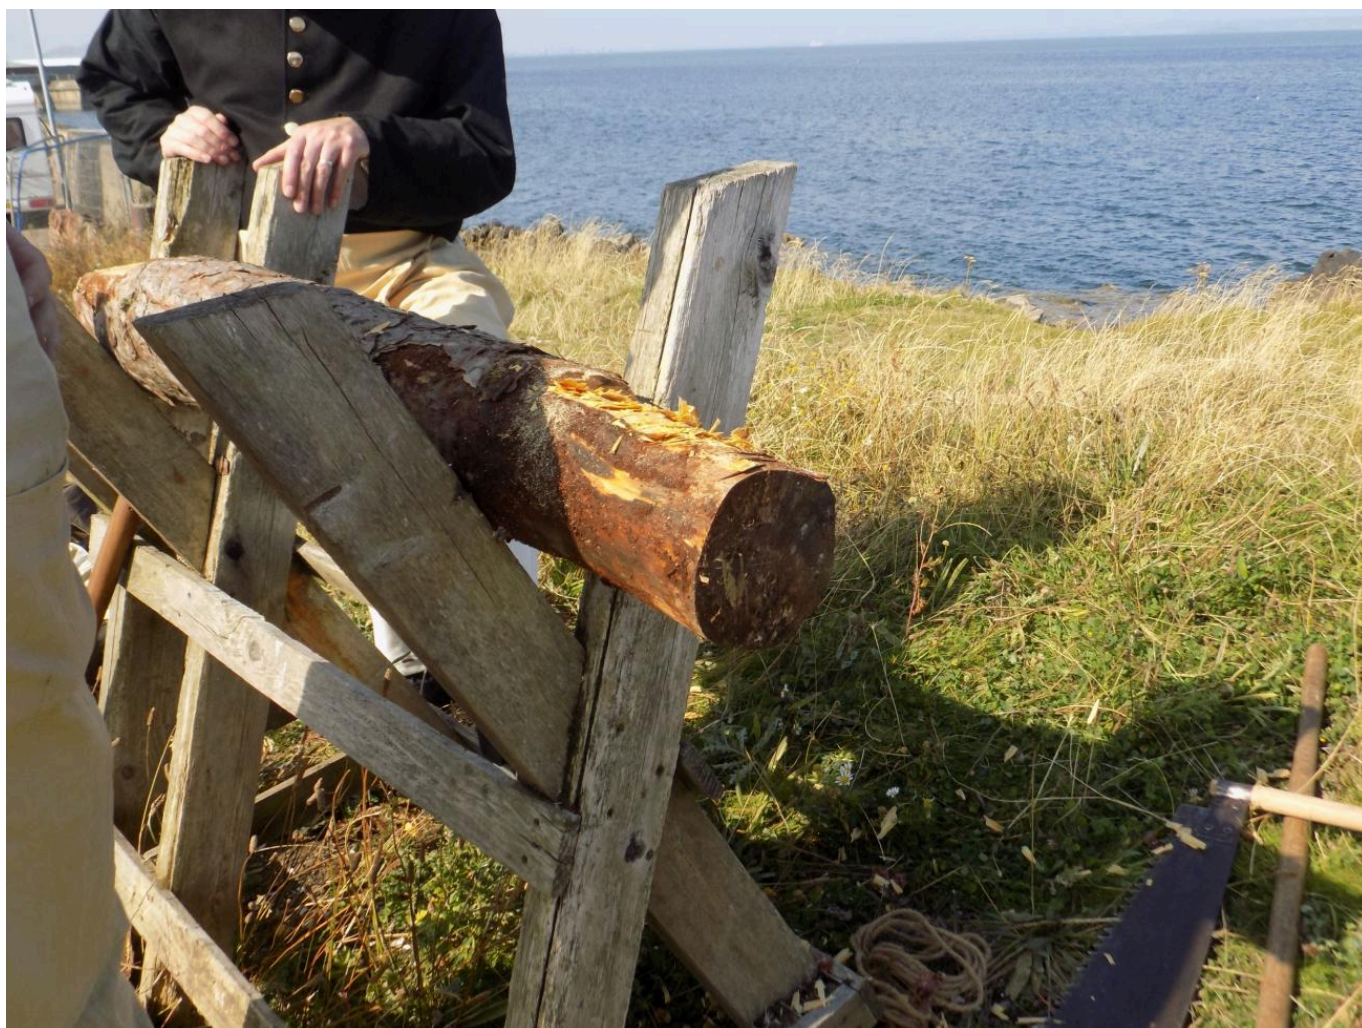
FIG 11. CUTTING SHOULDERS AND REBATES ON THE SLEEPER WAS BY SAW TO MARK OUT THE SHOULDER, AND THEN USING HAND AXES AND A BOX PLAIN TO CREATE A LEVEL SURFACE ONTO WHICH THE RAIL WOULD SIT. PHOTO BY ANTHONY DAWSON.

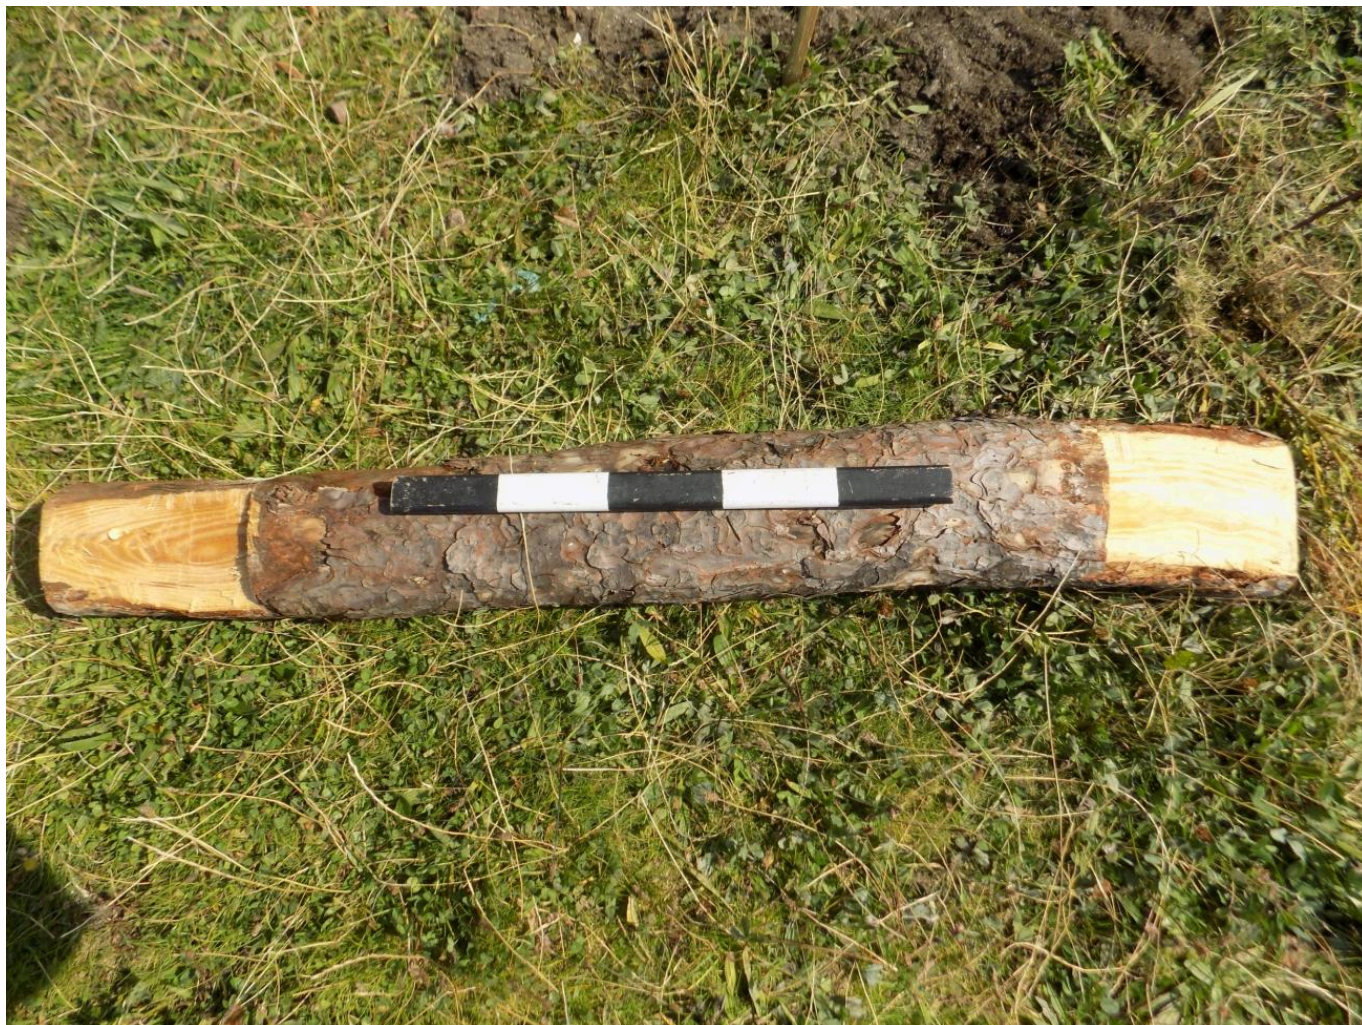
FIG 12. COMPLETED SLEEPER, DEMONSTRATING THE MINIMUM AMOUNT OF PROCESSING REQUIRED TO PREPARE ONE. IN TOTAL ONE INDIVIDUAL TOOK 60 MINUTES TO PRODUCE A SINGLE SLEEPER. PHOTO BY ANTHONY DAWSON.

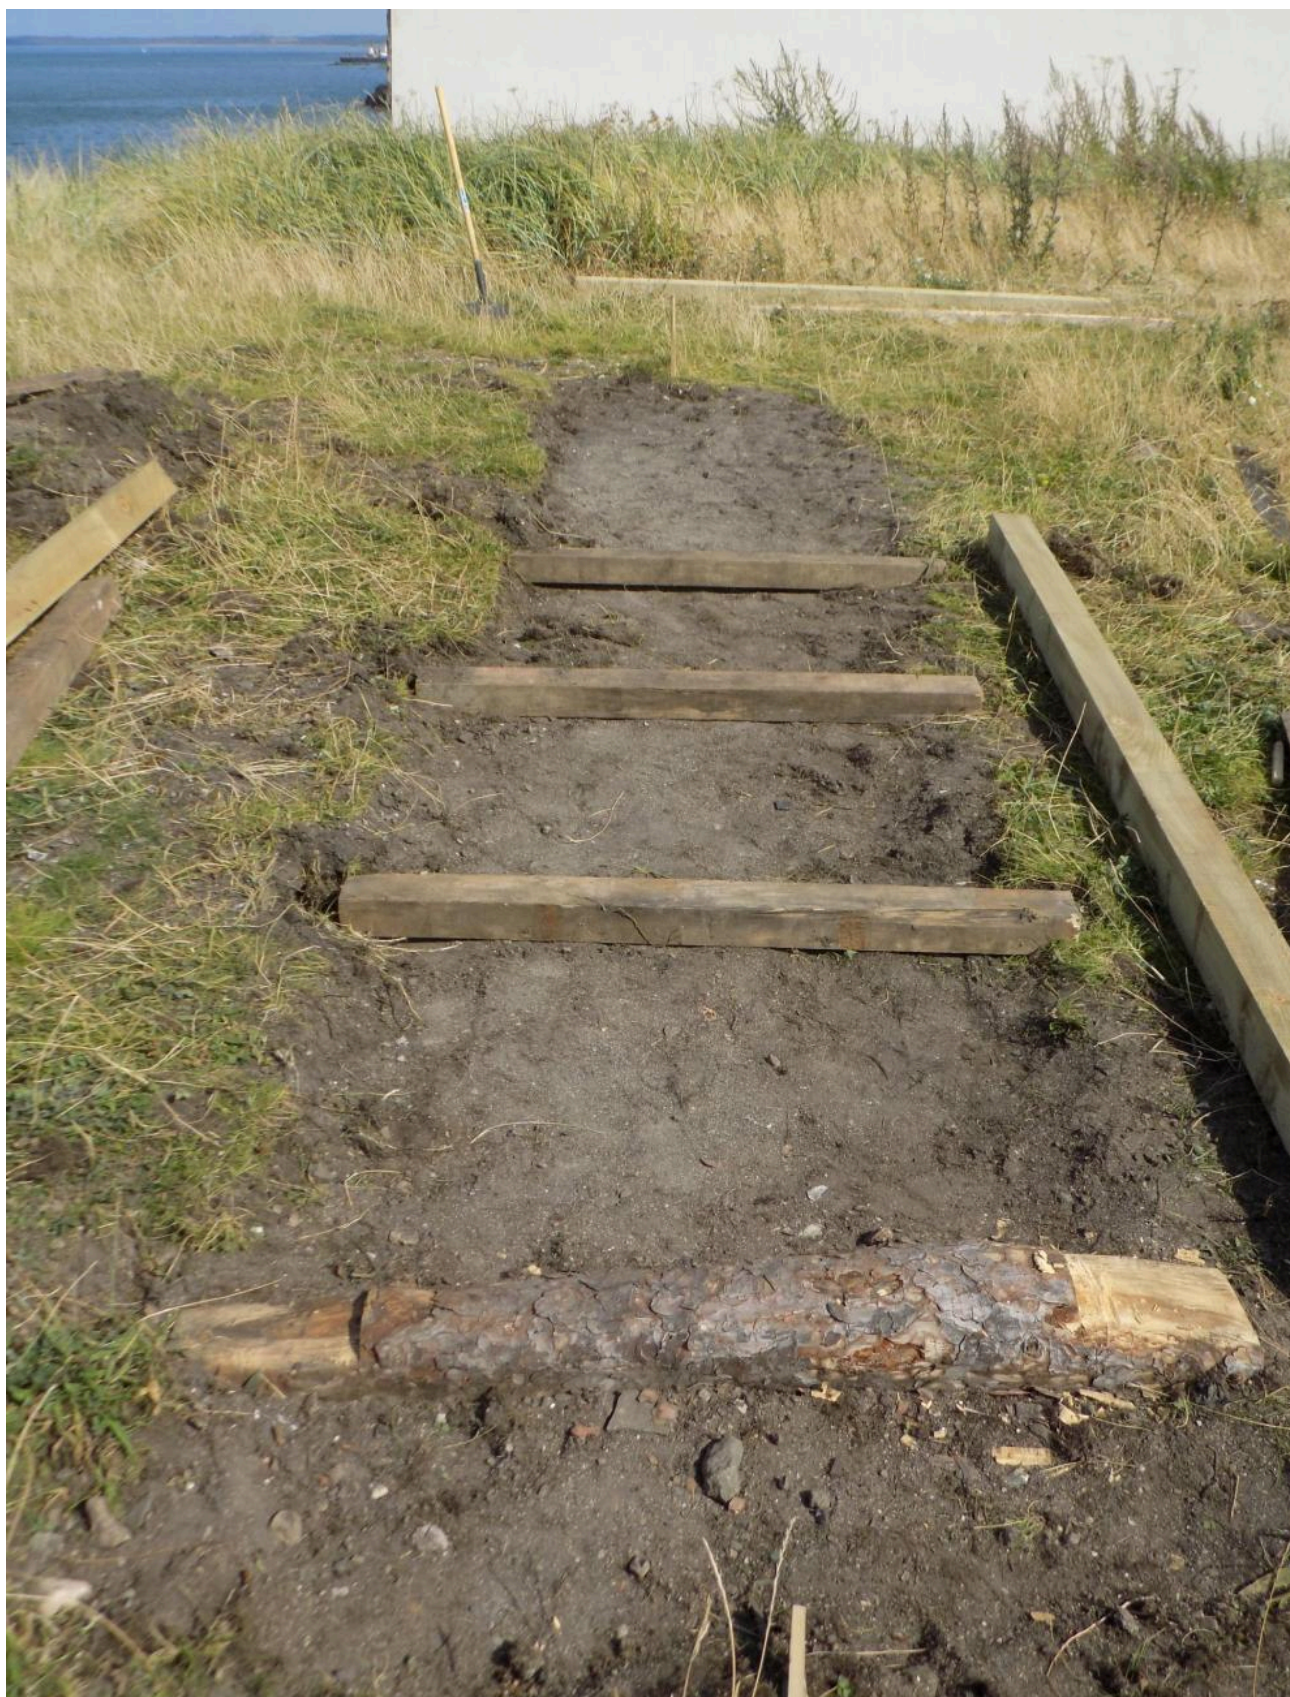
FIG 13. ROUND TIMBER SLEEPER HALF BURIED AND LEVELLED IN THE EARTH WITH FOUR MACHINE-FINISHED SLEEPERS ROUGHLY IN SITU. PHOTO BY ANTHONY DAWSON.

Irrespective of whether rails and sleepers were made at the work site or, as this paper argues, in a timber yard at Cockenzie, it is unlikely that processing of trees took place at the work site. The material would already have been processed into deals and planks by Dickson in Cockenzie. Whole trees would have been too difficult to transport to the work site and materials either as prepared rails and sleepers or as planks would have been transported along the waggonway from their primary processing site in Cockenzie to the work site. Evidence of in-situ woodworking has yet to be found archaeologically, although all the wood working waste and debris was photographed and recorded as indicative of the type of material which might be found archaeologically (See Figures 13 and 14).

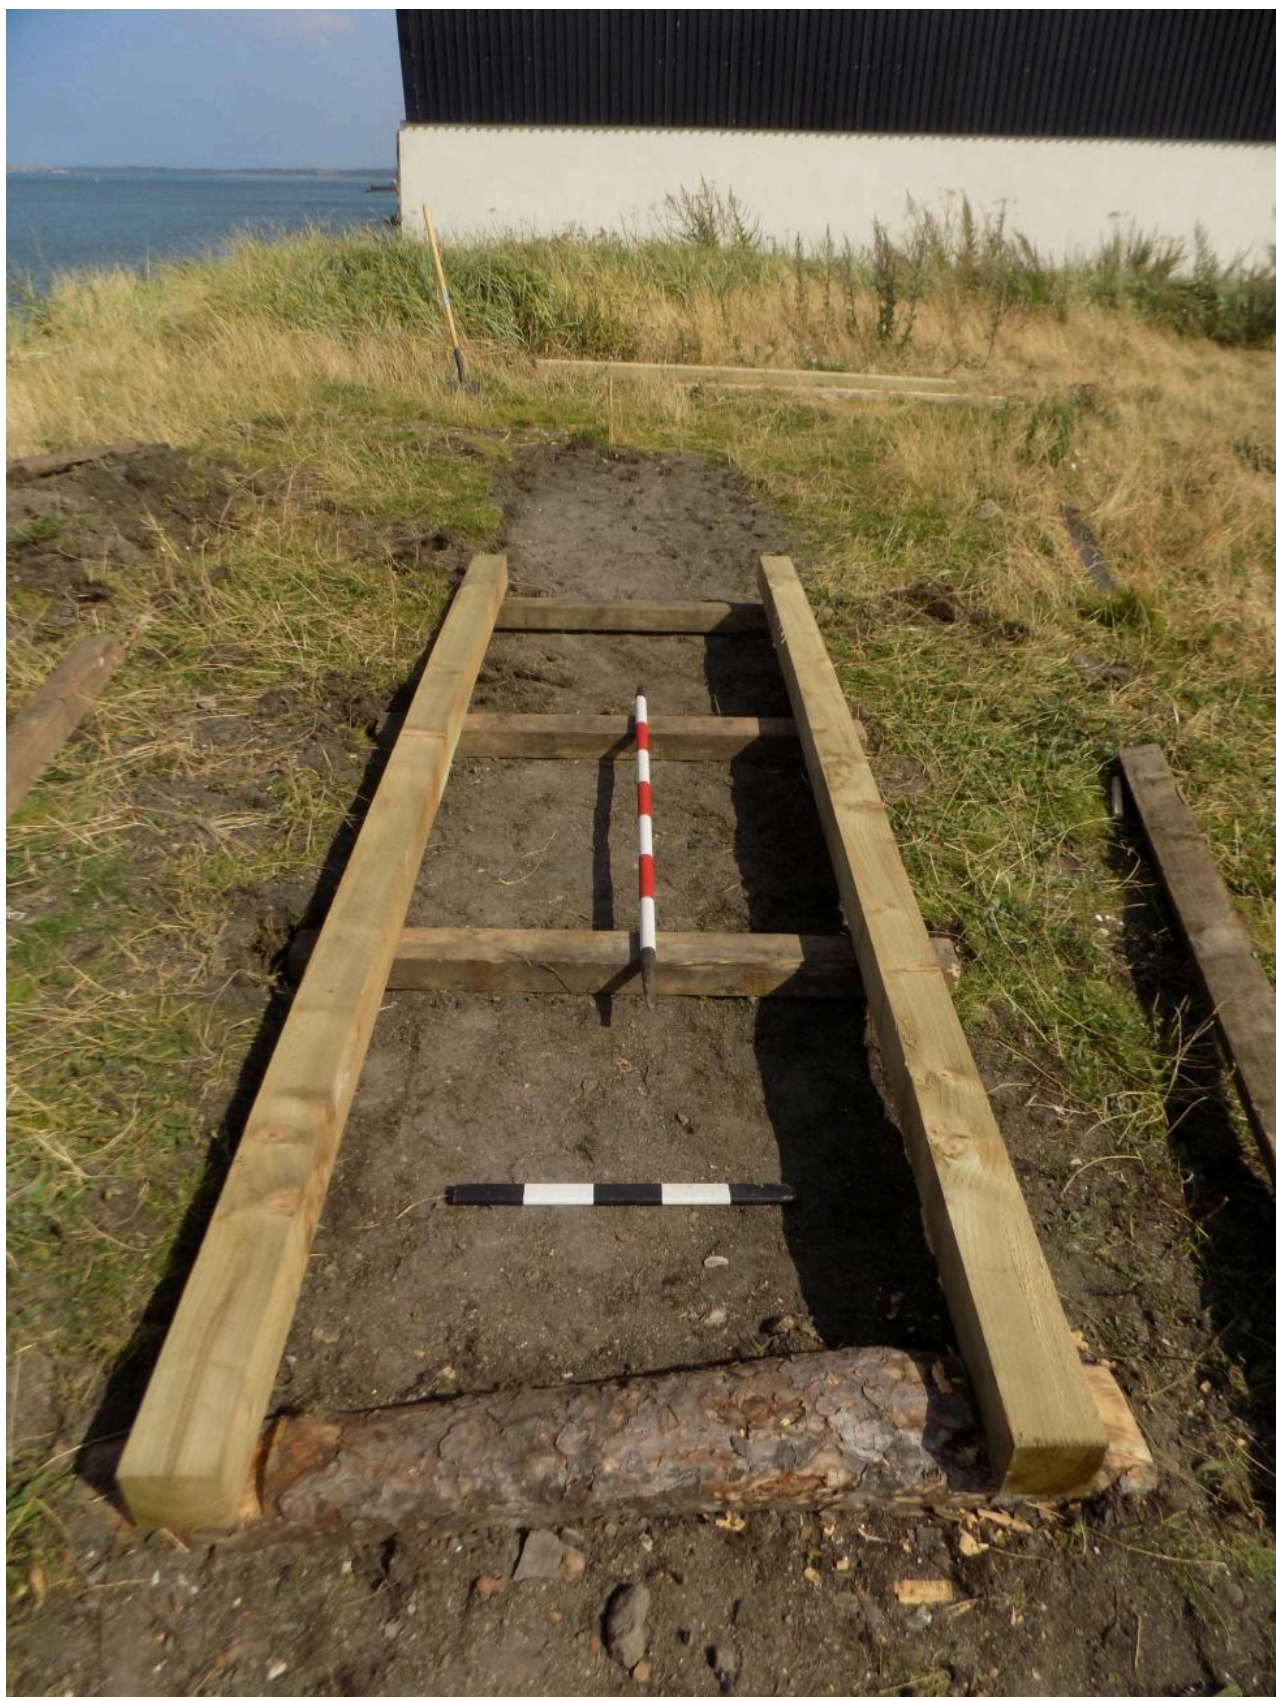
FIG 14. SLEEPERS AND RAILS IN SITU, PRIOR TO DRILLING OF HOLES FOR TRENAILS AND BALLASTING. BUILDING SUCH A RAILWAY REQUIRED THE MINIMAL AMOUNT OF TOOLS OR SKILLS. PHOTO BY ANTHONY DAWSON.
