Rediscovering and Rebuilding the Tranent-Cockenzie Waggonway: archaeology and experimental archaeology of Scotland's First Railway

[EXARC Journal Issue 2025/2](#) | Publication Date: 2025-08-06

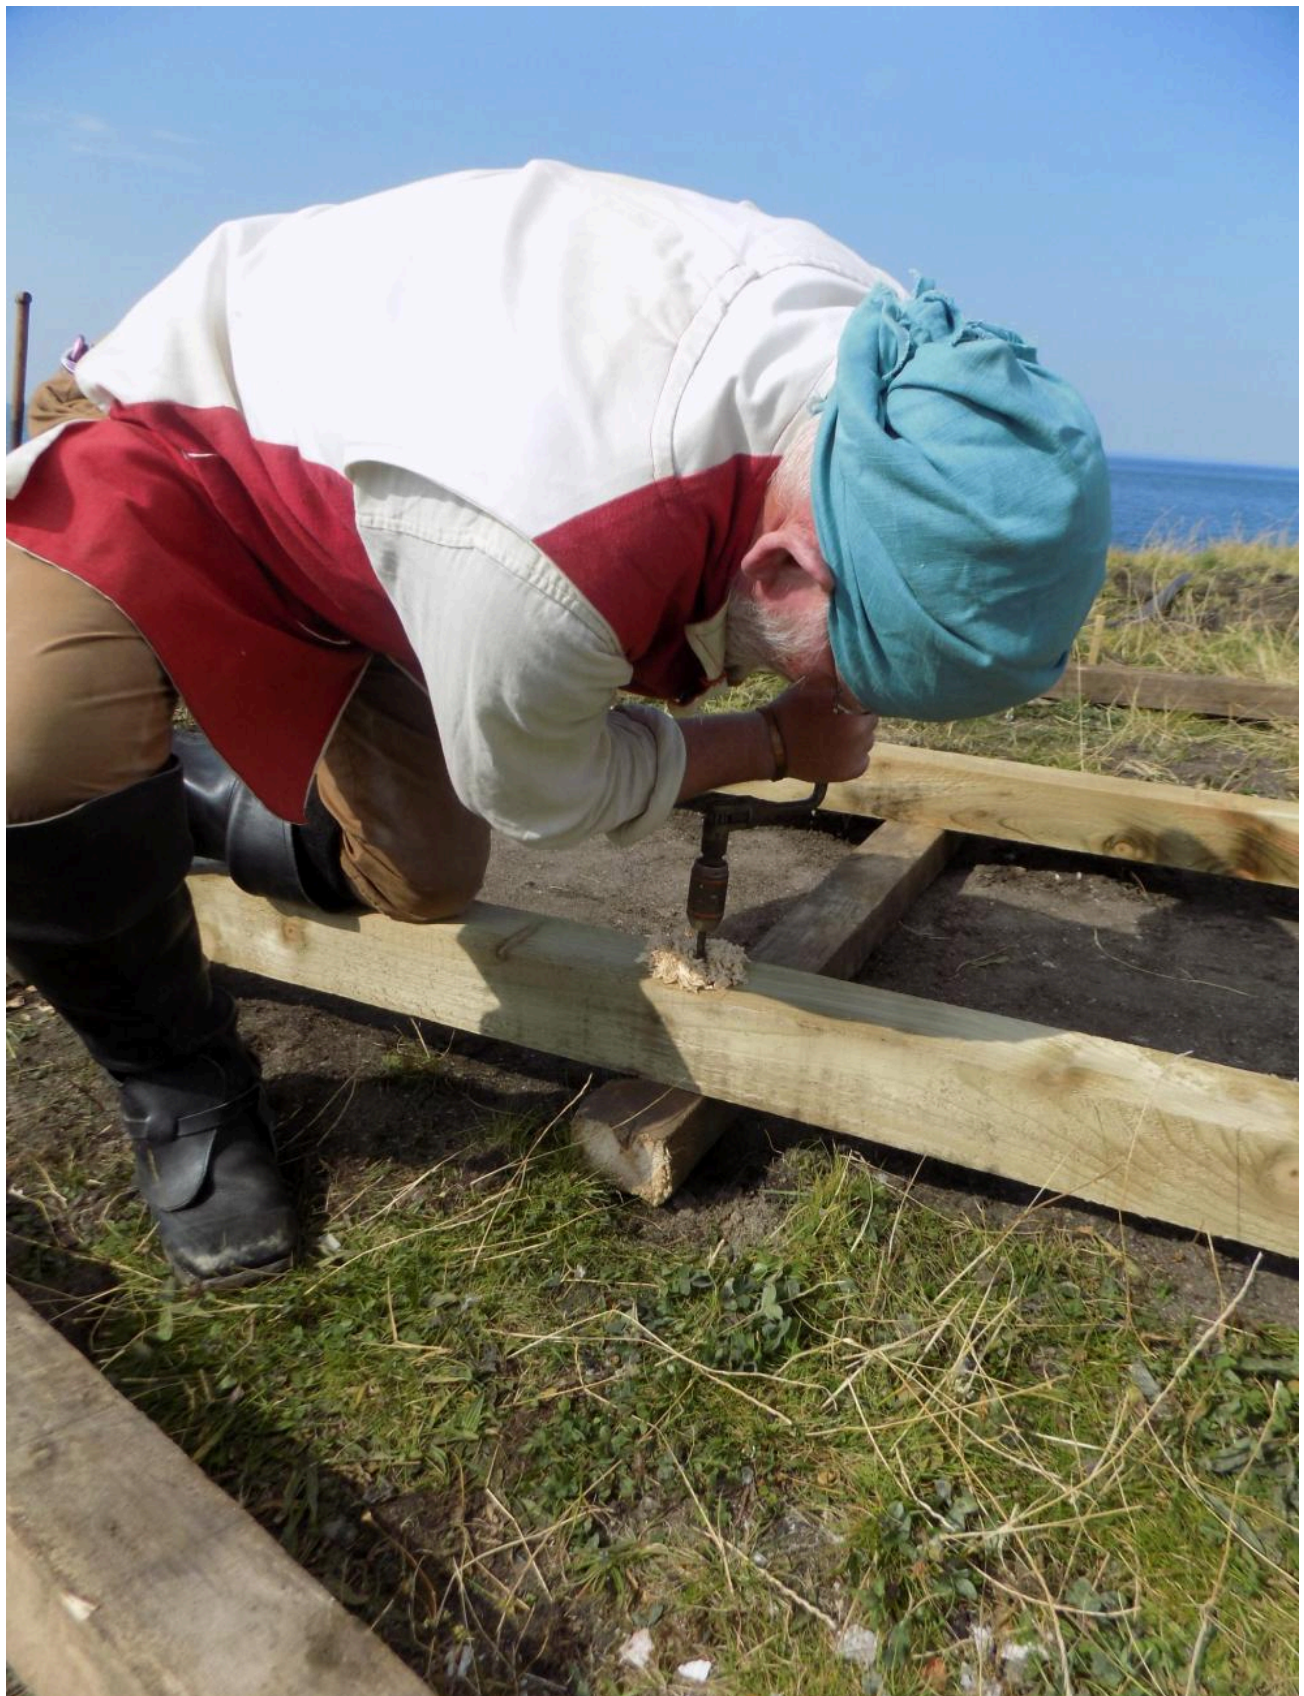
FIG 15. DRILLING HOLES FOR TRENAILS BY HAND THROUGH THE RAIL AND THE FULL THICKNESS OF THE SLEEPER. THIS PROCESS TOOK APPROXIMATELY 1MINUTE USING A CARPENTER'S BRACE. PHOTO BY ANTHONY DAWSON.

The rails were then pegged into place using trenails. These trenails were produced by hand using a drawknife and replica draw-horse. They were made as round as possible, broadening toward the head. However, examining archaeological examples suggests that four or six sided were more common, having a larger head than the body. At first the trenails were made over size and without any lubricant. They were found to jam whilst being driven home and did not pass all the way through the rail and into the sleeper. These had to be drilled out and trenails produced of a smaller diameter. They were also lubricated with candle wax as tallow was unavailable which made them easy to drive home with a wooden mallet while still retaining sufficient 'grip.' The stump of the trenail was then cut off using a saw and an adze. The saw left a very small nub, slightly proud of the running rail and gave the neatest finish. An adze did not leave a neat finish and left more of a stub of trenail, which was more ragged. The stubs of the trenails could then be hammered flush and were then caulked with a single blunt chisel stroke as best representing a trenail iron (See Figures 15 - 17).

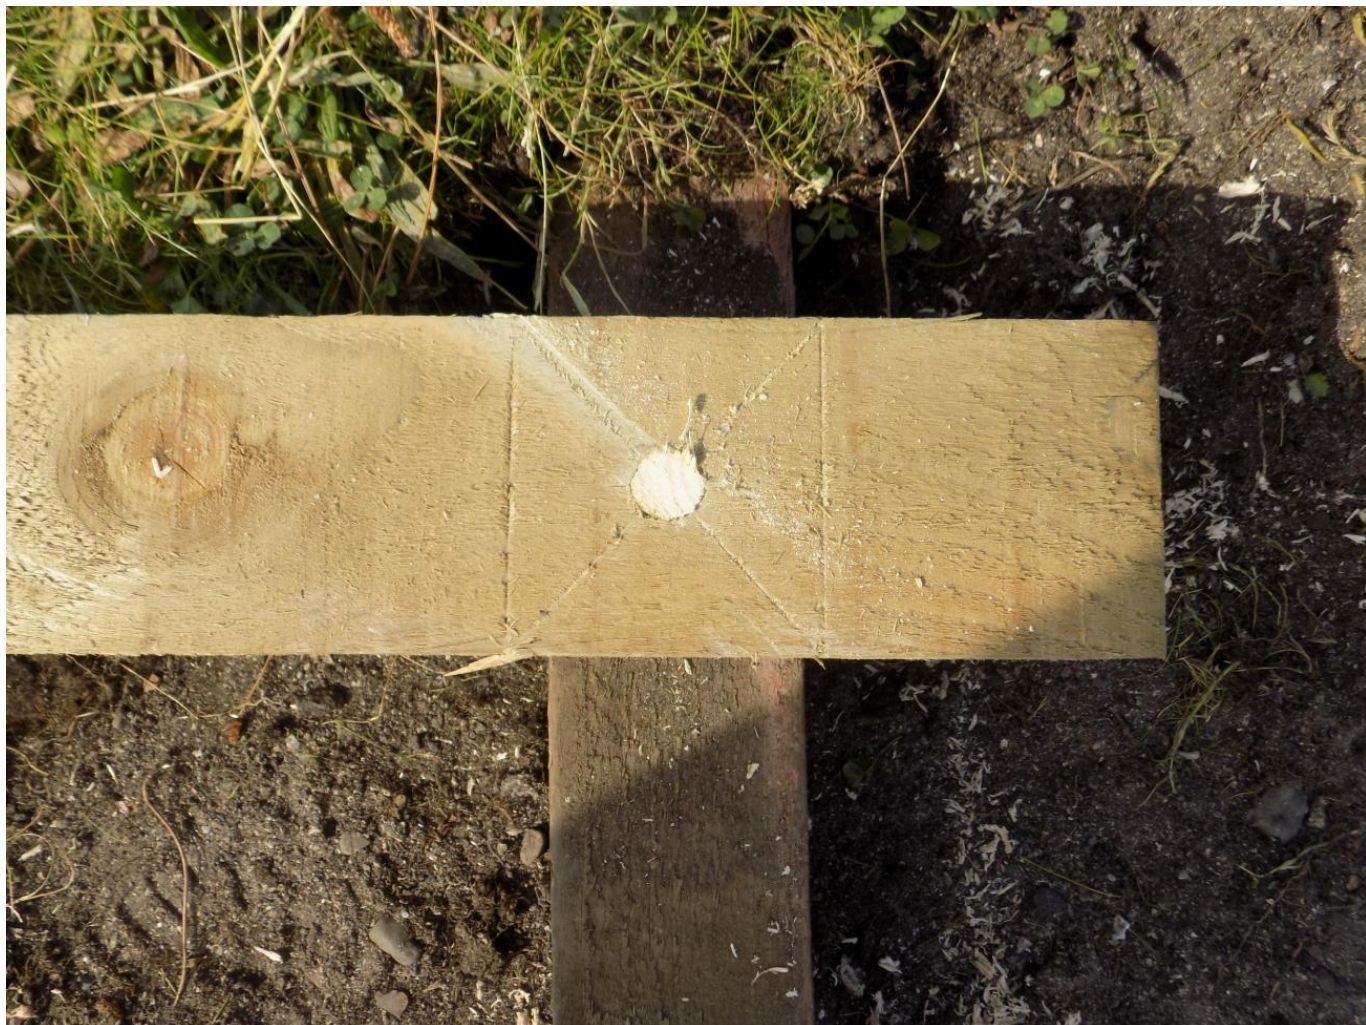
FIG 16. TRENNAILS WERE TRIMMED USING A SAW (HERE) AND ADZE. THE SAW LEFT THE NEATEST RESULT AND CREATED THE LEAST AMOUNT OF WASTE. IT ALSO LEFT A TELL-TALE SAW MARK AS A RESULT OF THE SAWING PROCESS. PHOTO BY ANTHONY DAWSON.

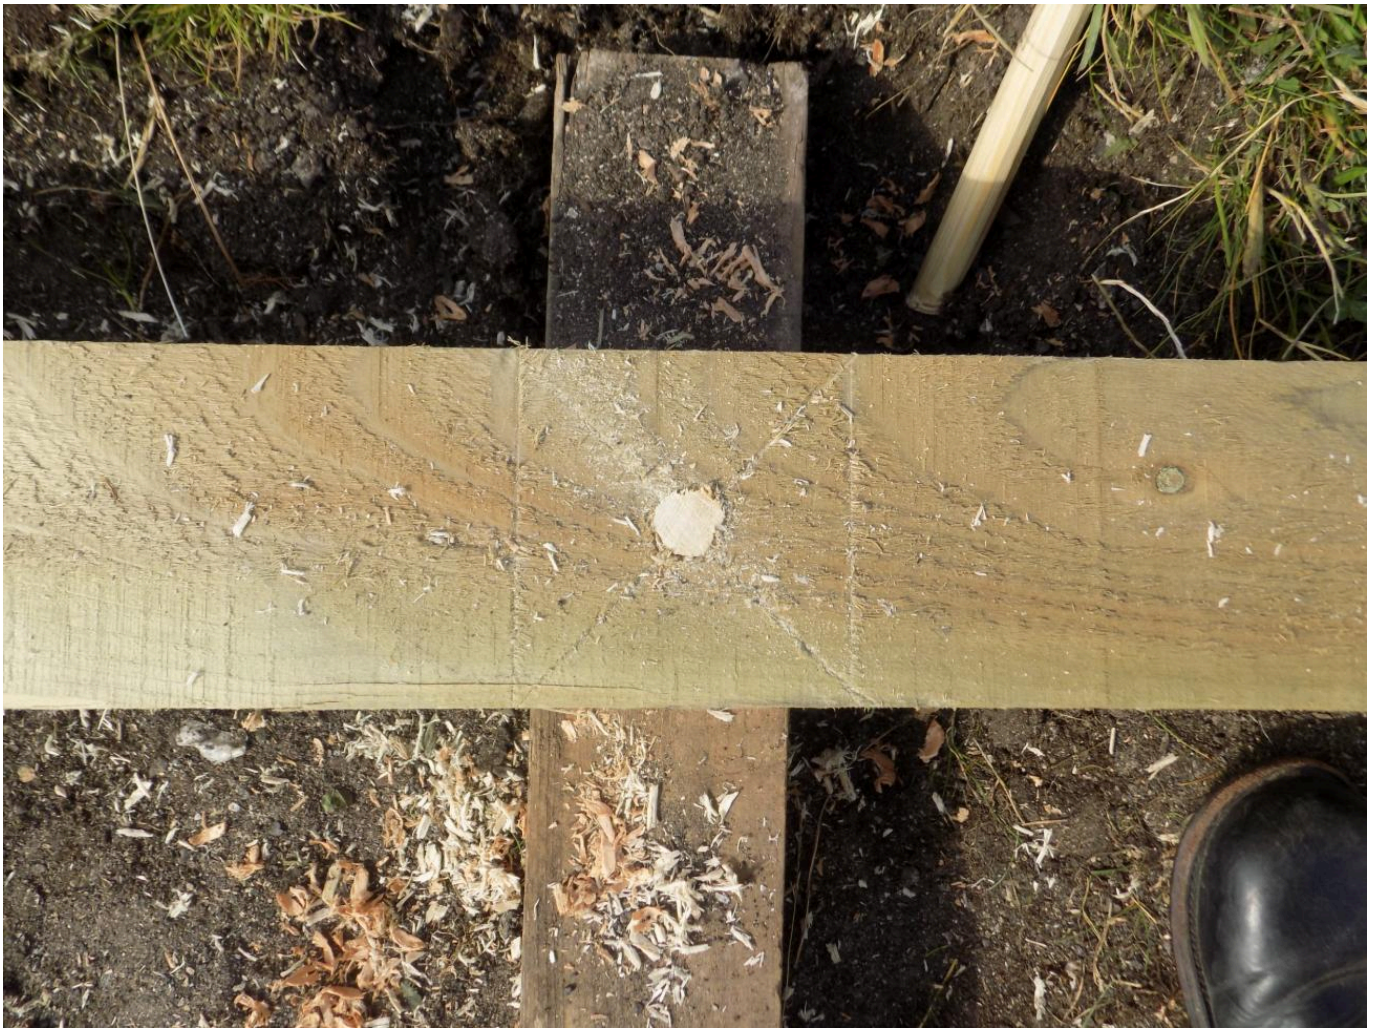
FIG 17. THE SECOND METHOD TO TRIM THE TRENAILS WAS USING AN ADZE. THIS LEFT MORE OF A STUMP; WAS LESS NEAT THAN A SAW; AND CREATED MORE WASTE MATERIAL. PHOTO BY ANTHONY DAWSON.

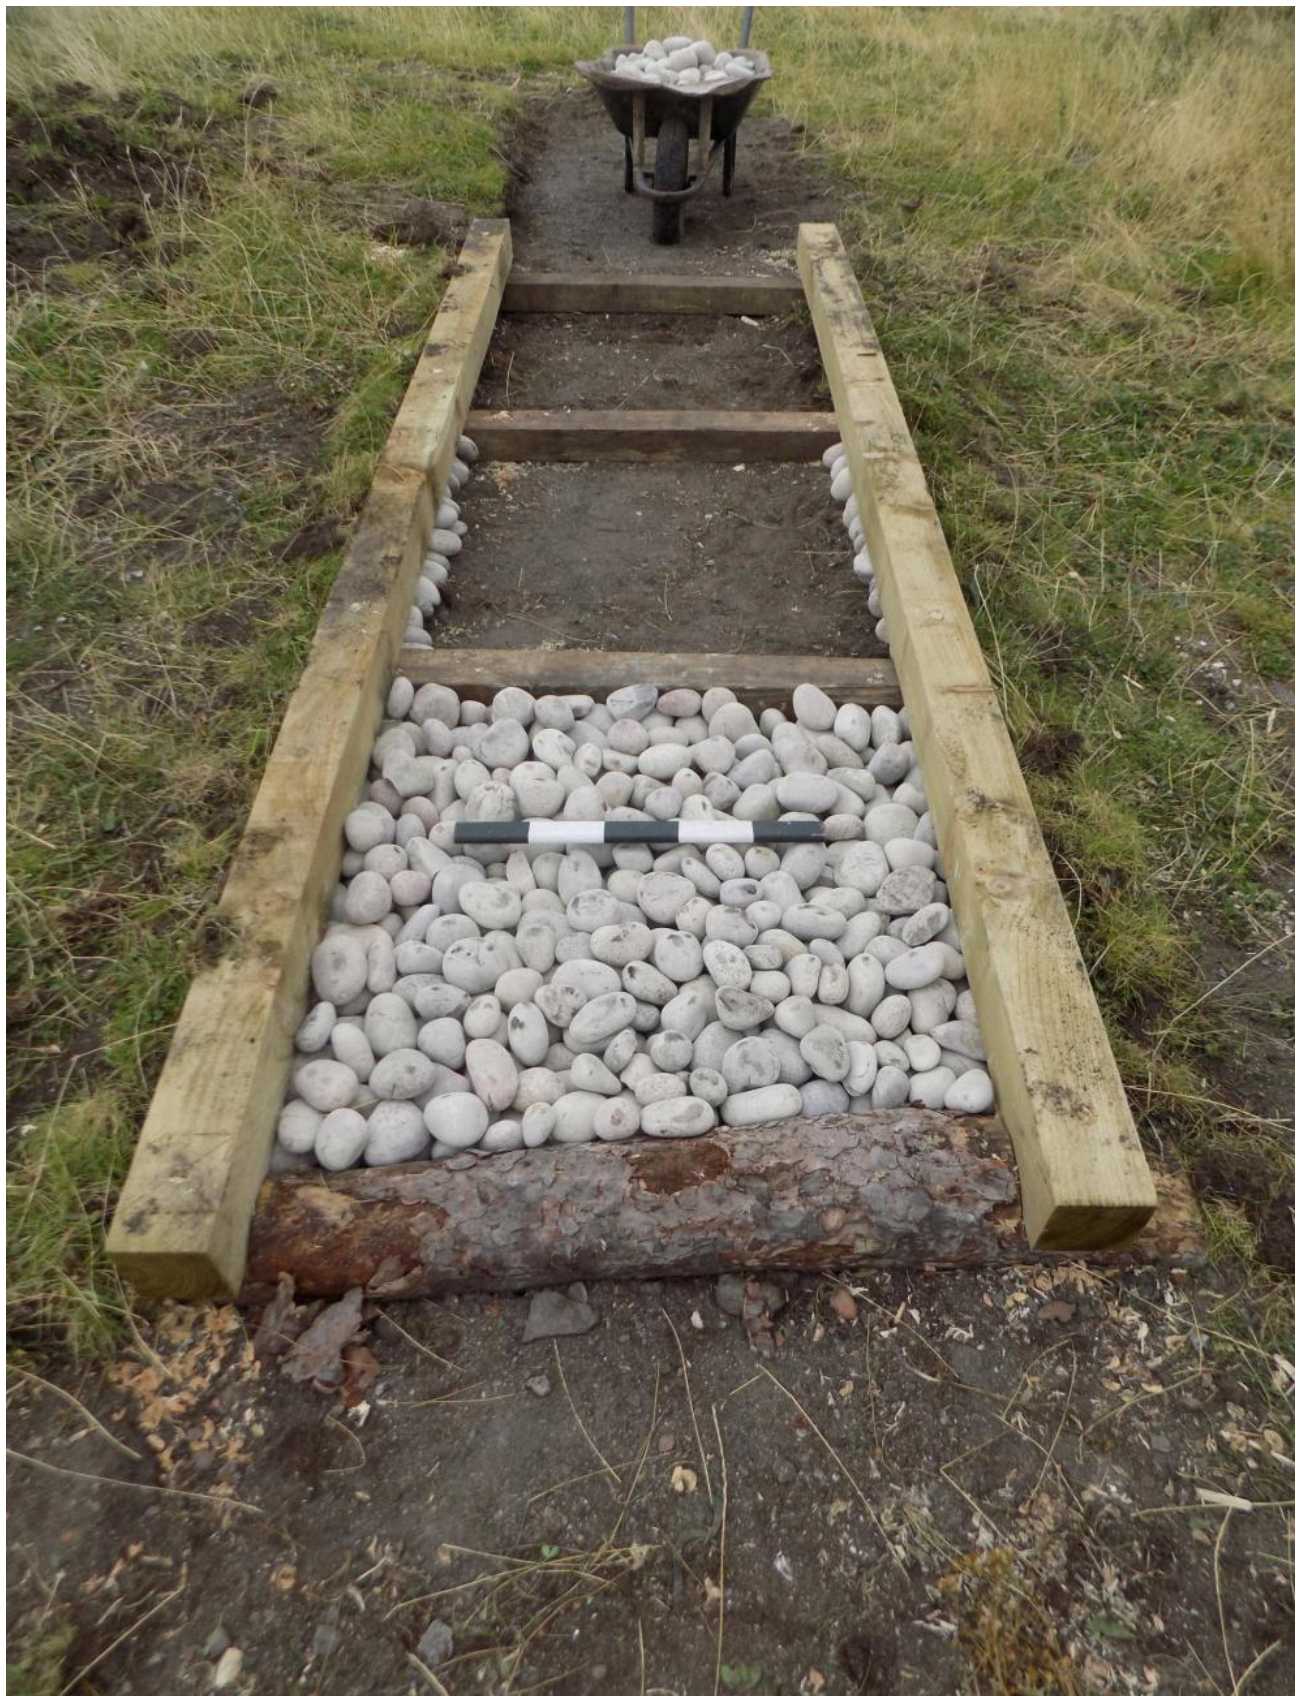
FIG 18. EACH 'COMPARTMENT' FORMED BY THE RAIL AND SLEEPER REQUIRED TWO MODERN BARROW LOADS OR APPROXIMATELY 180LITRES OF COBBLES AND BROKEN STONE TO FILL IT. THIS WAS THEN RAMMED AND PACKED WITH SPOIL TO CREATE A SOLID FOUNDATION. PHOTO BY ANTHONY DAWSON.

It was found that each compartment required two modern wheelbarrow loads of cobbles to fill it - approximately 180 litres of material based on one barrow holding 90 litres of heaped material. Eighteenth century barrows were much smaller and therefore would have required more barrow trips. Barrowing cobbles and broken stone to the worksite the 100m or so from the Waggonway Heritage Centre where materials had been delivered also created a delay which perhaps the original waggonway builders would not have experienced due to such materials having been brought to site as needed along the waggonway as it was constructed (See Figure 18).

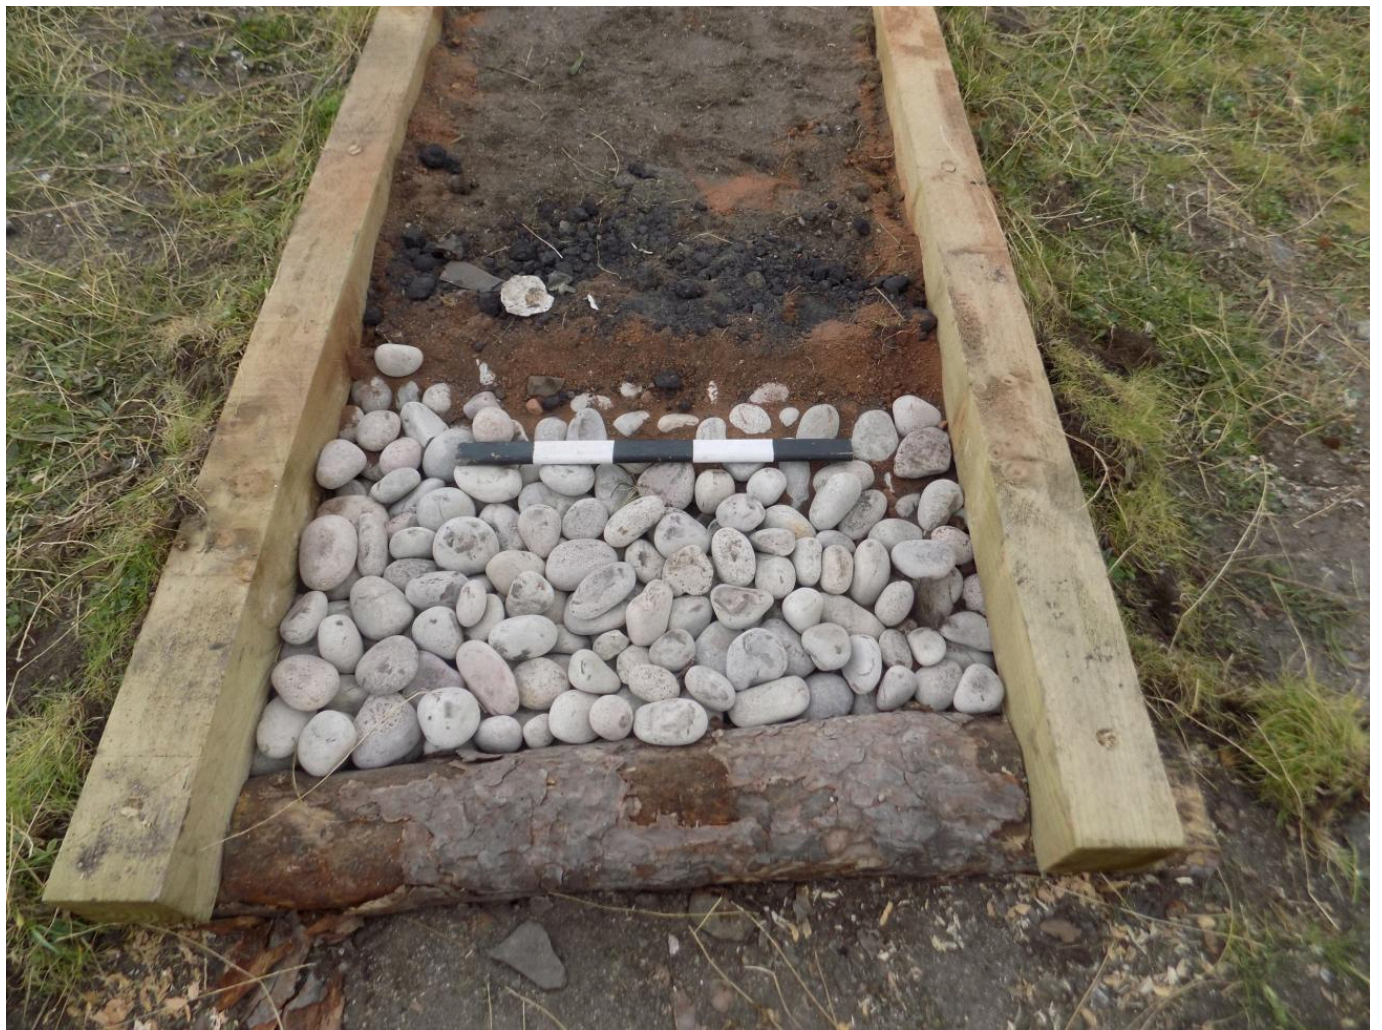
FIG 19. SMALL COAL, ASHES, CLINKER AND SPOIL FROM THE DITCHES WAS USED TO CREATE THE WALKING SURFACE OF THE HORSE TRACK. THIS WAS TRAMPLED UNDER FOOT AND RAMMED USING TIMBER POSTS TO MAKE THE FINAL SURFACE. PHOTO BY ANTHONY DAWSON.

Horse track material was bucketed onto the work site and tamped by foot and using large round timbers to compress the material. Wetting the horse track material helped it to 'run' into the spaces around the cobbles and broken stone beneath, and helped create a more uniform matrix of material (See Figure 19).

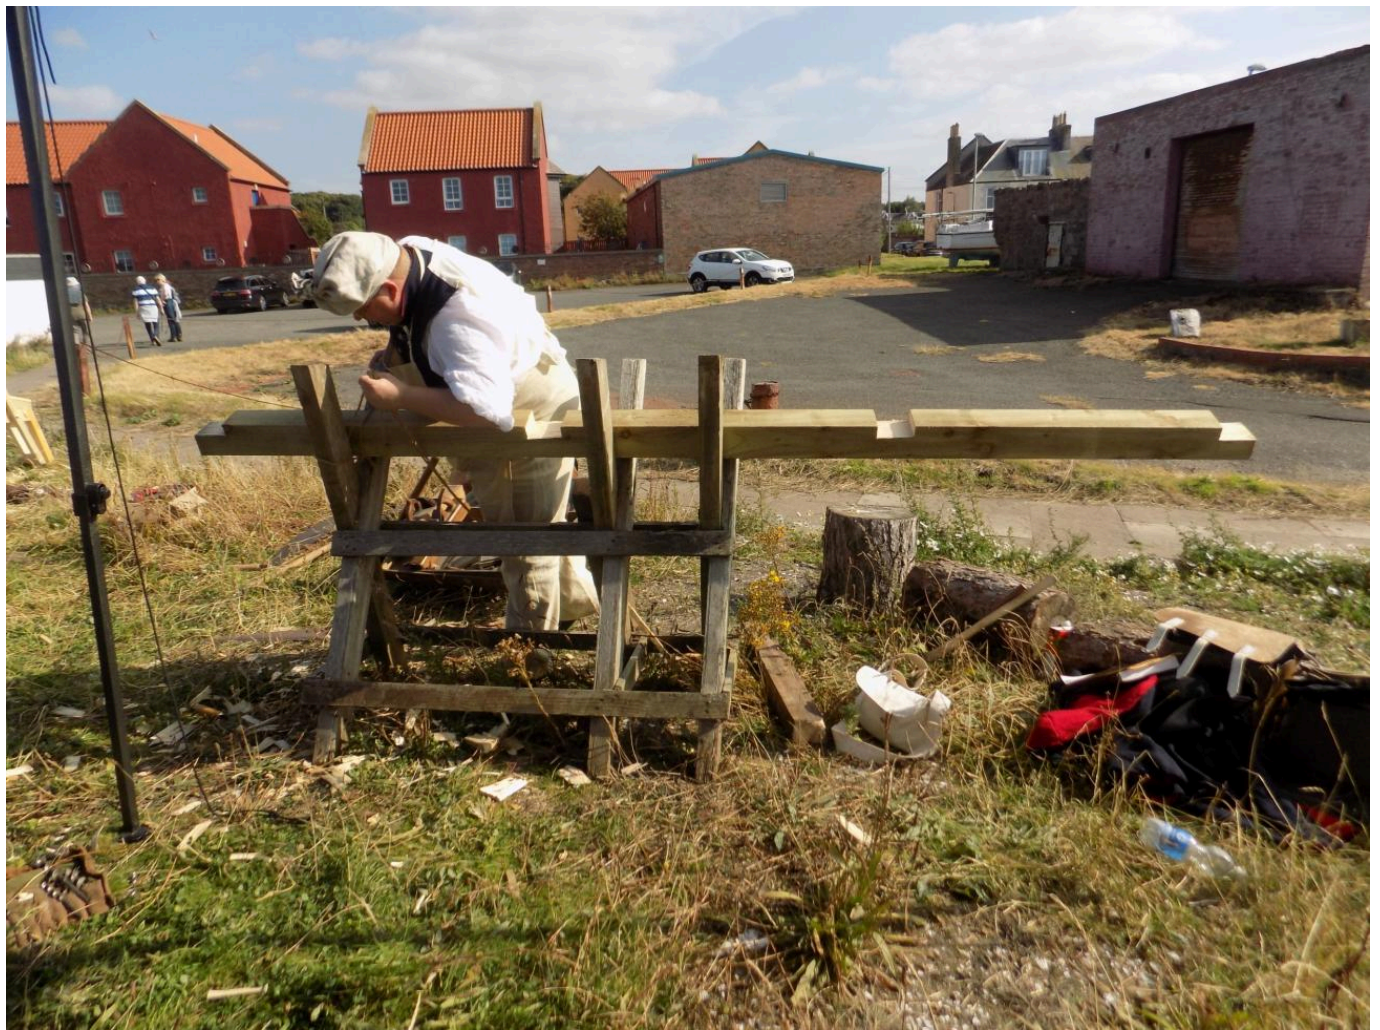
FIG 20. CUTTING HALF LAP JOINTS IN THE RAILS BY HAND. EACH JOINT TOOK ONE INDIVIDUAL 30 MINUTES TO CUT, A MORE EXPERIENCED JOINER MAY HAVE TAKEN LESS TIME. IT IS LIKELY RAILS WERE PREPARED OFF-SITE. PHOTO BY ANTHONY DAWSON.

Production of rails and sleepers for the double rail waggonway required more skill to cut the half-lap joints to fasten the rails and sleepers together as found archaeologically in 2021. However, the wooden railways excavated hitherto show no evidence of such complicated joinery, the rails simply being butt-jointed to the sleeper. The same timber as used for the single rail reconstruction was used for the rails, together with salvaged kiln dried 76mm x 100mm timber for the sleepers 1.50m long. All joints were cut by hand using traditional tools. A single individual - a trained joiner - was able to cut four half-lap joints in each 3m rail in two hours. They were cut with a tenon saw and chisels, with a marking gauge being used to set the depth of the joint. Each joint took approximately 30 minutes depending on the wood and the presence of any knots. Therefore, one man working alone, could cut the joints for the four rails required in eight hours. This time is rather longer than that suggested by Shirley who argues an experienced wood worker could produce such a joint in twenty minutes suggesting that the process may have been quicker historically. (Shirley, 2001, pp.71 - 72) (See Figure 20).

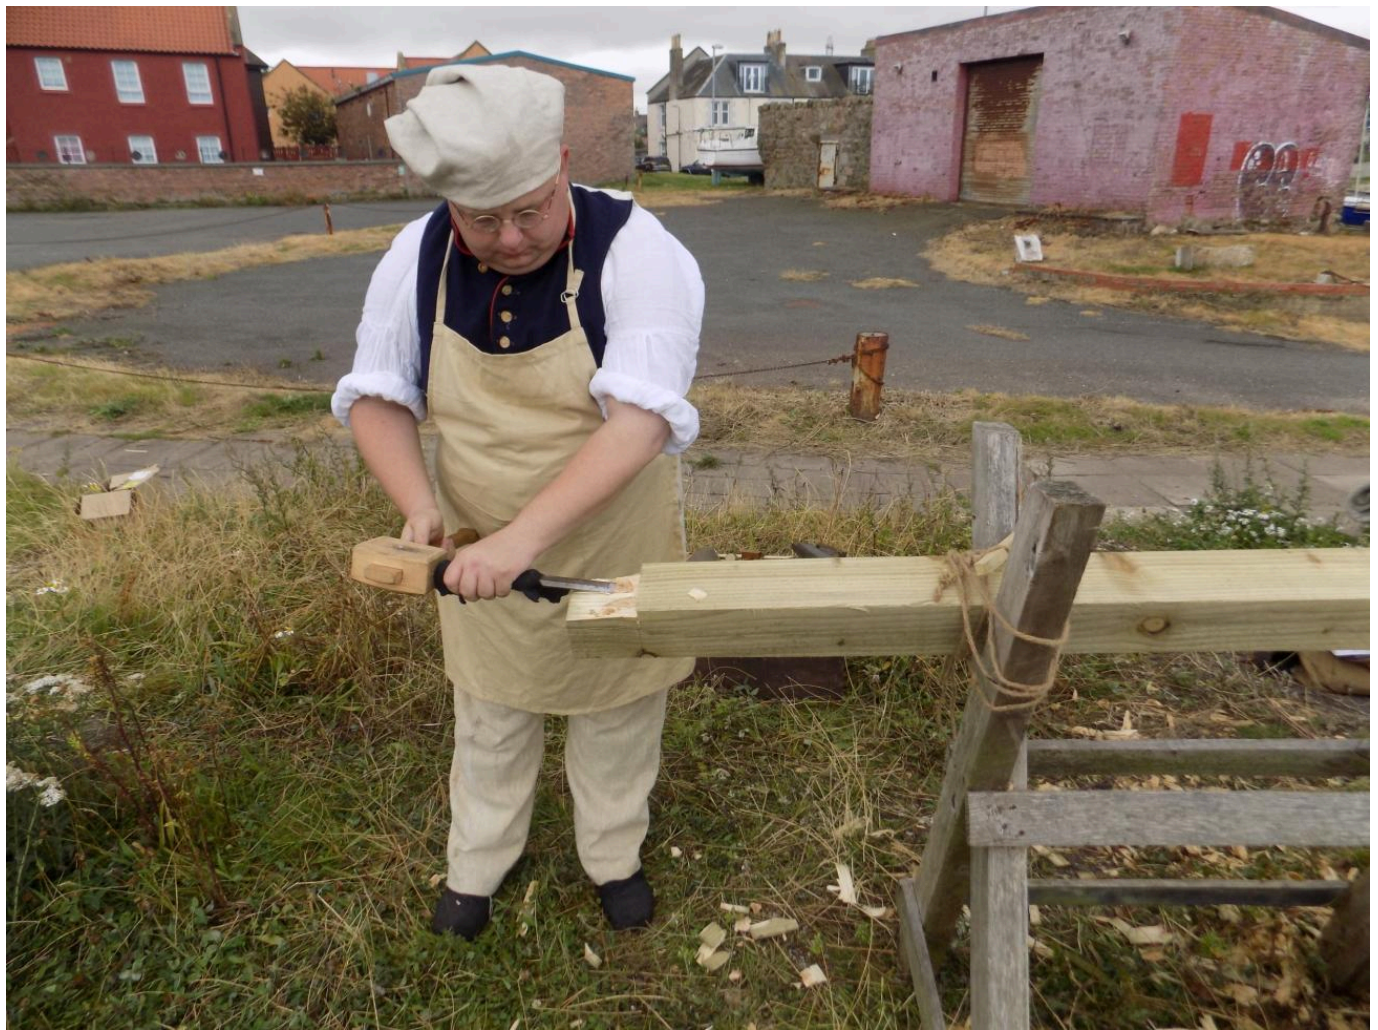
FIG 21. CUTTING JOINTS IN THE SLEEPERS. IT TOOK ONE INDIVIDUAL 40 MINUTES TO PRODUCE ONE SLEEPER WORKING ON THEIR OWN USING HAND TOOLS. AS WITH RAILS, IT IS LIKELY THEY WERE PREPARED OFF-SITE. PHOTO BY ANTHONY DAWSON.

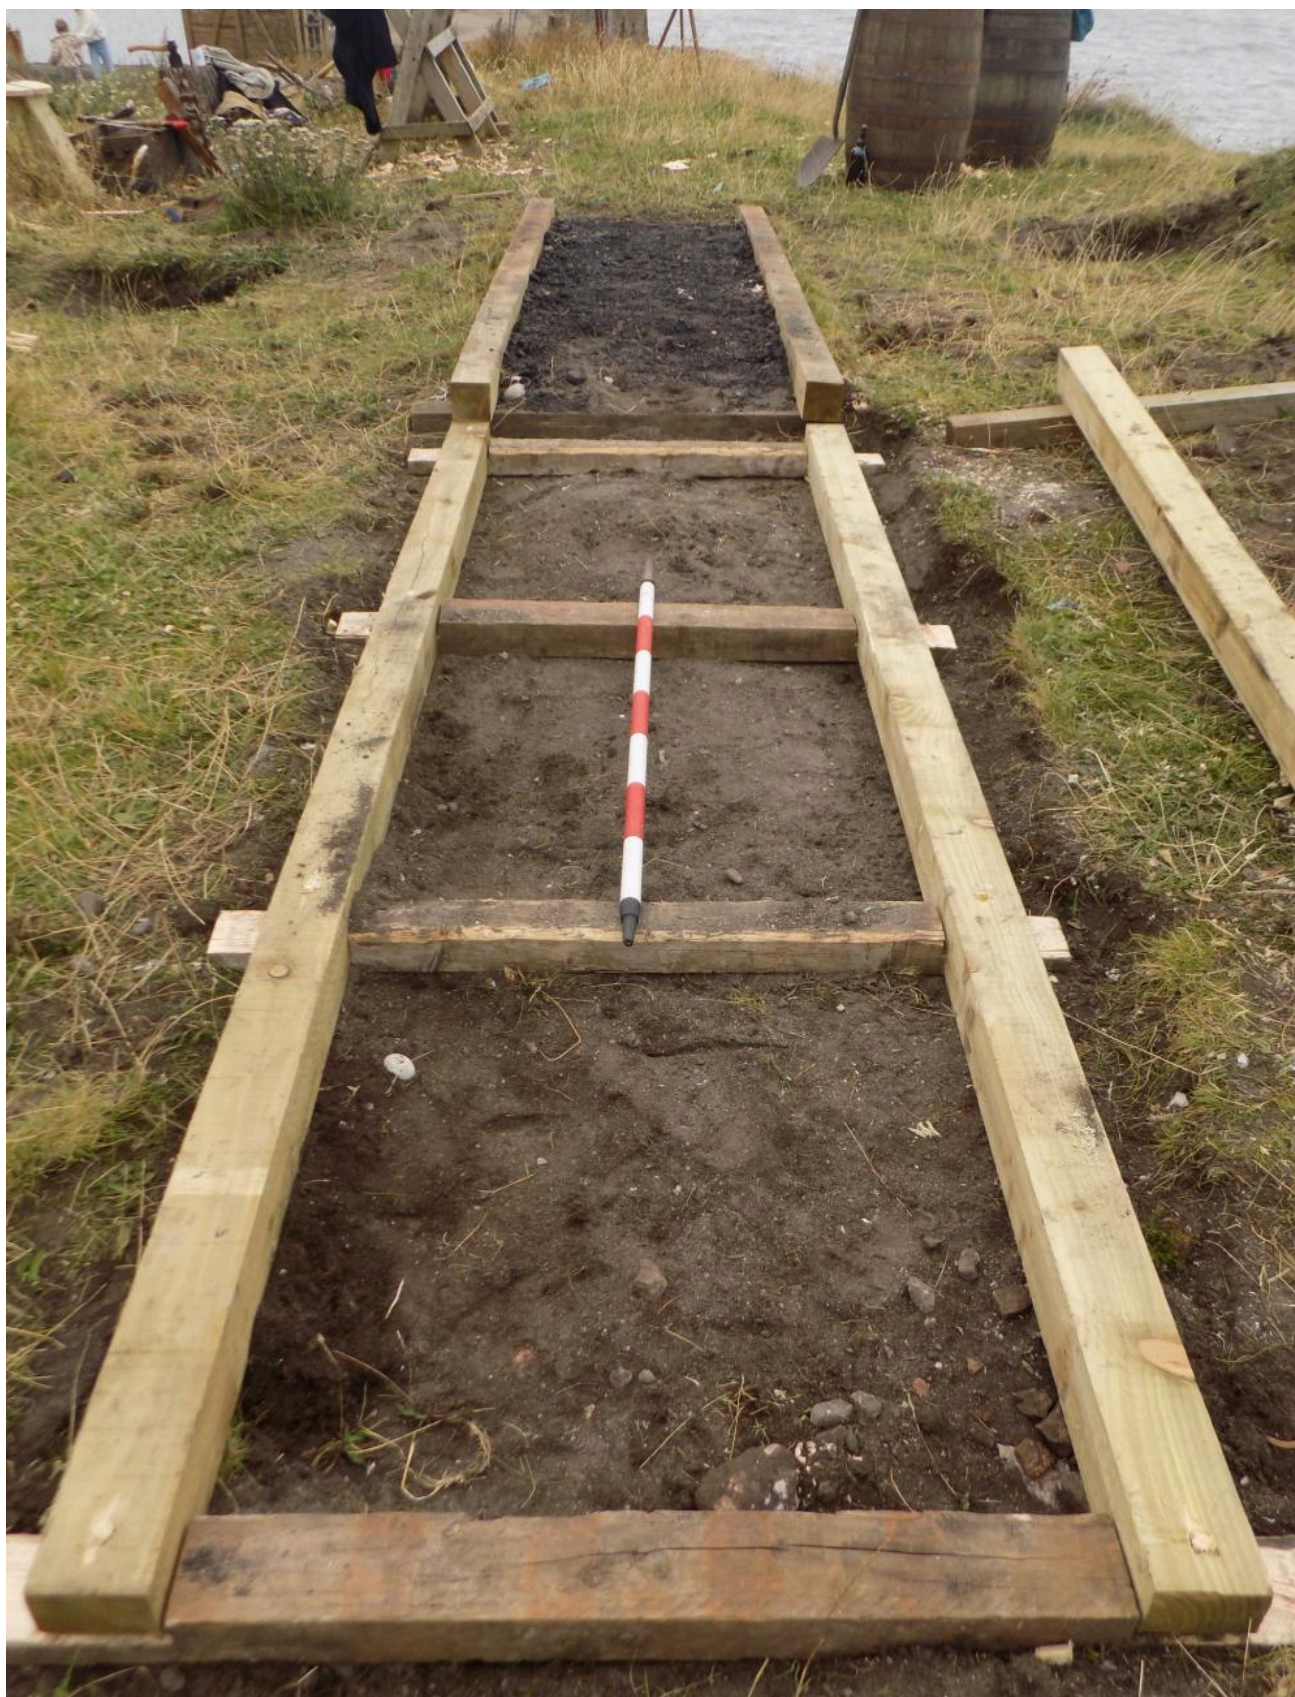
FIG 22. THE LOWER SET OF RAILS SECURED IN POSITION WITH TRENAILS. THE MORE ROBUST CONSTRUCTION COMPARED TO THE SINGLE-PHASE WHERE RAILS WERE SIMPLY MATED ONTO ROUGHLY PREPARED SLEEPERS IS EVIDENT. AGAIN, HOWEVER, THE SKILL REQUIRED TO PRODUCE SUCH A WAGGONWAY WAS RELATIVELY LOW. PHOTO BY ANTHONY DAWSON.

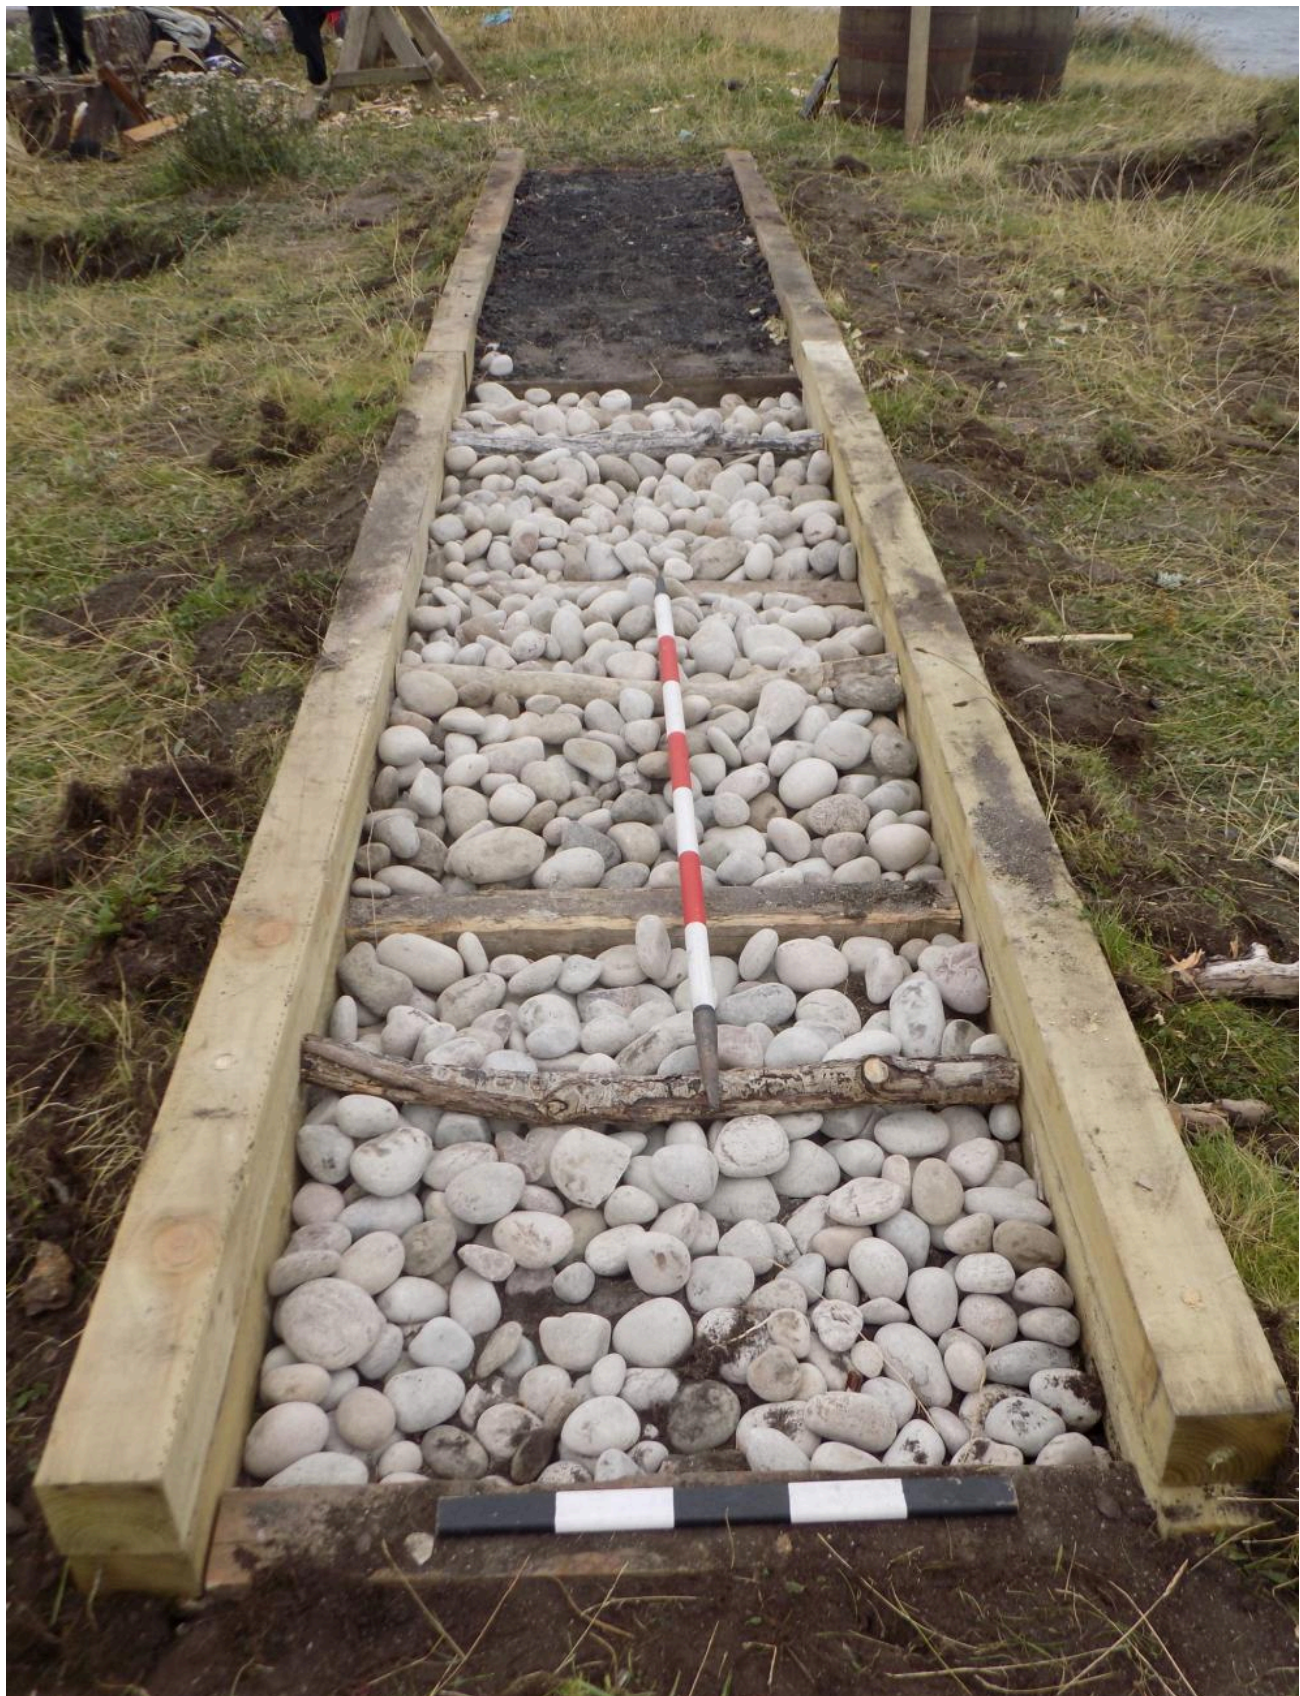
FIG 23. THE UPPER OR RUNNING RAILS SECURED IN POSITION, AND BALLASTED WITH BROKEN STONE AND COBBLES. ALSO EVIDENT ARE THE INTERMEDIATE SLEEPERS SUGGESTED BY THE ARCHAEOLOGY. PHOTO BY ANTHONY DAWSON.

The frame was packed and levelled with cobbles filling each 'compartment' and was then ready to receive the upper or running rail. This was marked to take holes for the trenails which joined the upper rail to the lower. It was observed that whilst the lower level was tied together with sleepers to provide lateral strength, to stop the rails from spreading under the load of wagons running over then, and from the outward pressure of the ballast, that the upper rails would need similar cross ties to support the structure. Without sleepers the whole structure was somewhat flimsy, with nothing to constrain the upper rails and stop them spreading. Lewis demonstrates that material was often piled up against the sides of the structure or indeed it was partially buried which would help prevent the structure from spreading laterally and thus keep the rails to gauge (Lewis, 1970, p.167). However, this was not observable archaeology. Therefore, it was proposed that a second row of sleepers was needed for the upper rail, jointed and pegged in place using tree branches with joints cut on either end as suggested in the archaeology (See Figures 23 and 24).

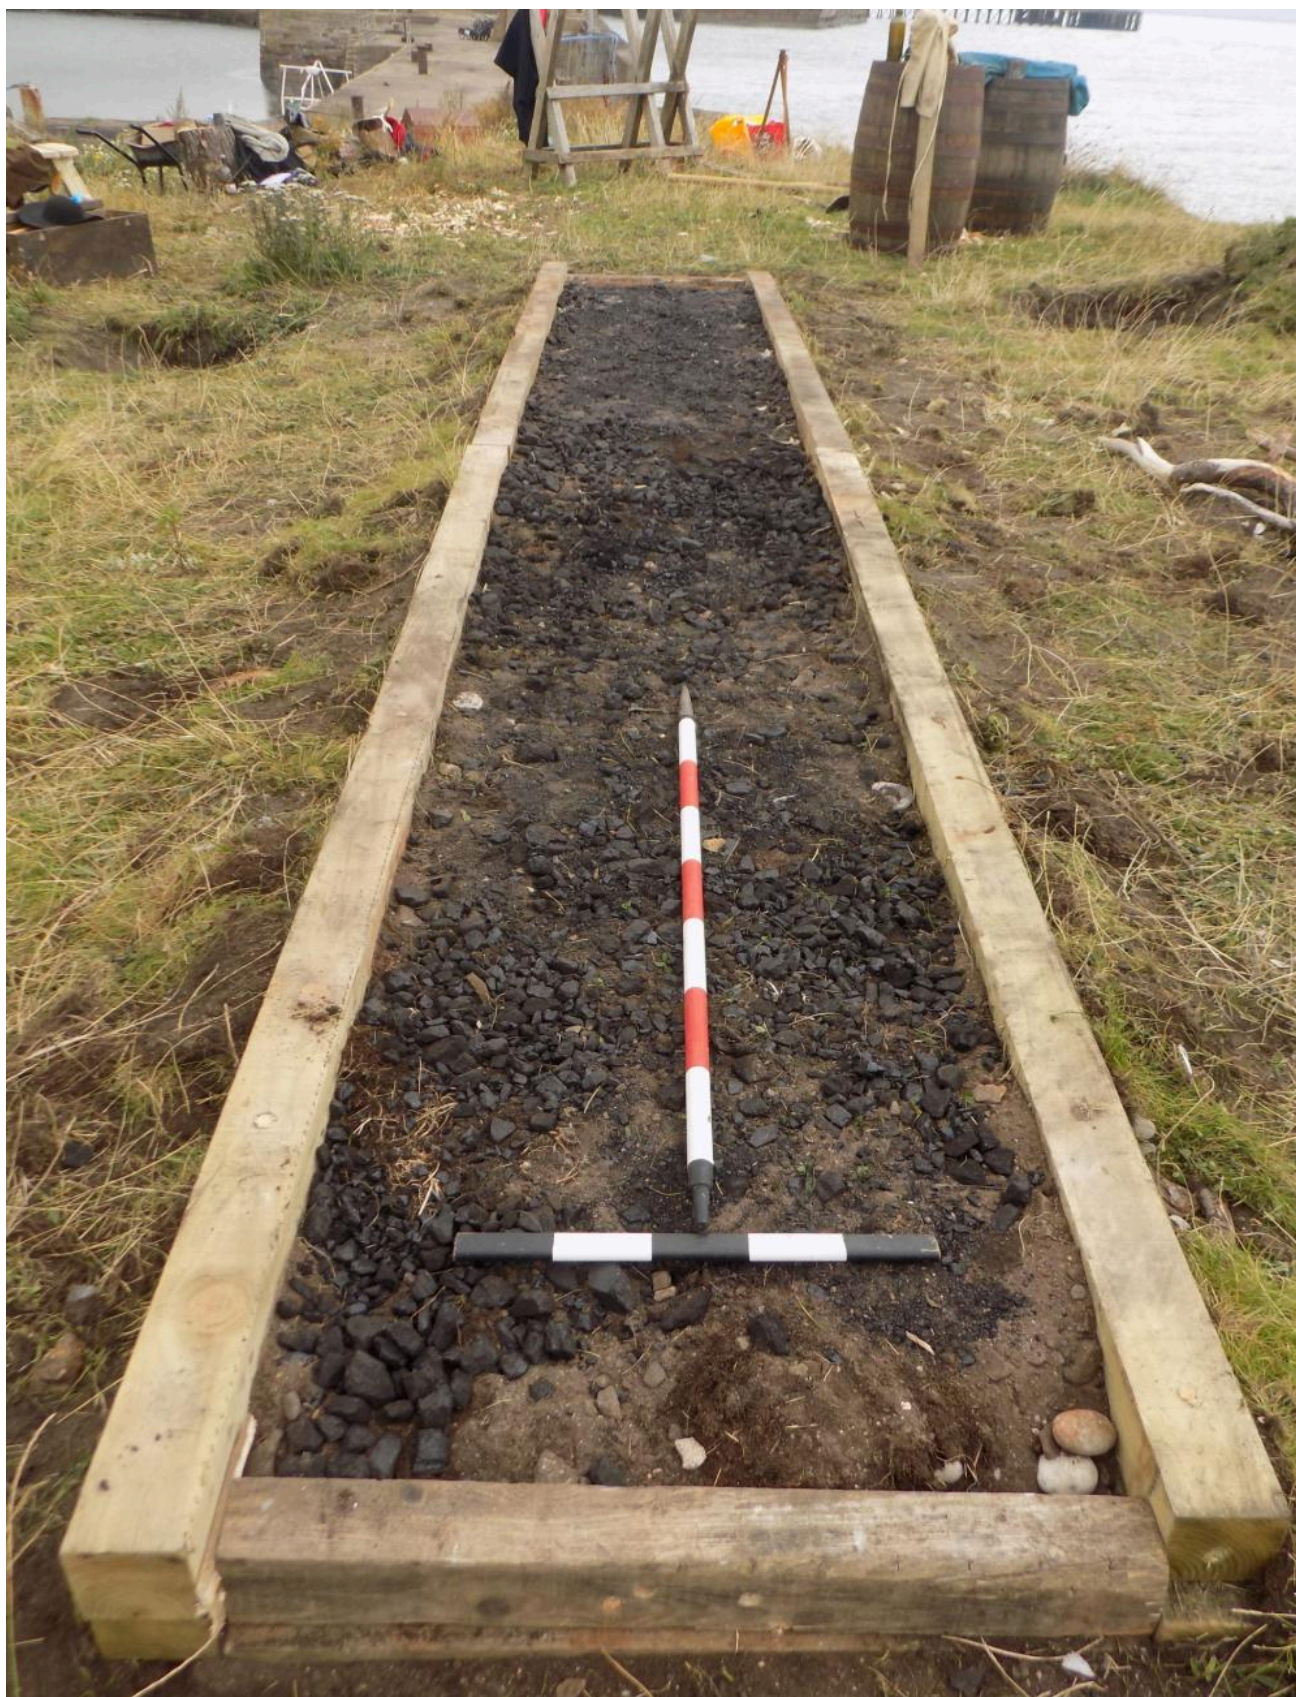
FIG 24. THE COMPLETED RECONSTRUCTION SHOWING THE TIMBER RAILS STANDING PROUD OF THE RAMMED EARTH FOOT WAY EITHER SIDE, AND THE SMALL COAL HORSE TRACK. THE PERHAPS EPHEMERAL NATURE OF THE STRUCTURE SHOULD BE NOTED COMPARED TO THE EARTH WORK FEATURES OF THE DITCH. PHOTO BY ANTHONY DAWSON.

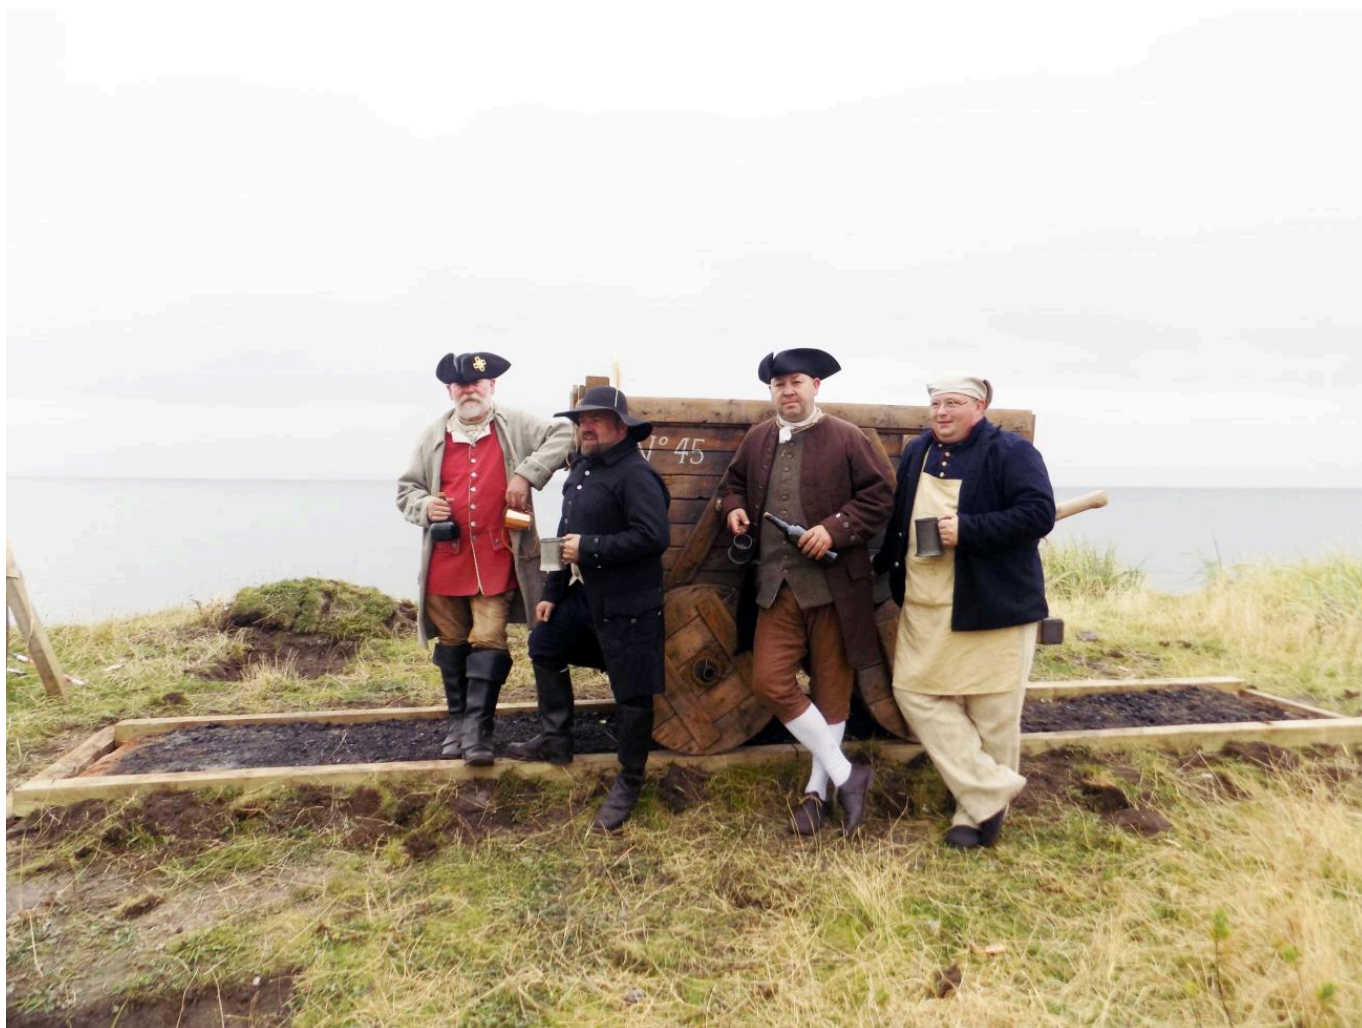
FIG 25. MEMBERS OF THE RECONSTRUCTION TEAM WITH A REPLICA WAGGON PLACED ON THE TRACK. THE WAGGON WAS RUN BACKWARDS AND FORWARDS SEVERAL TIMES AND PERFORMED WELL: THE WHEELS HAVING FLAT TREADS HAD AN IMPROVED RELATIONSHIP WITH THE WOODEN RAIL THAN THE IRON WHEELS AT BEAMISH. PHOTO BY ANTHONY DAWSON.
