### An Energy Saving House from 3400 Years Ago

EXARC Journal Issue 2016/3 | Publication Date: 2016-08-15

Author(s): Irene Staeves<sup>1</sup>

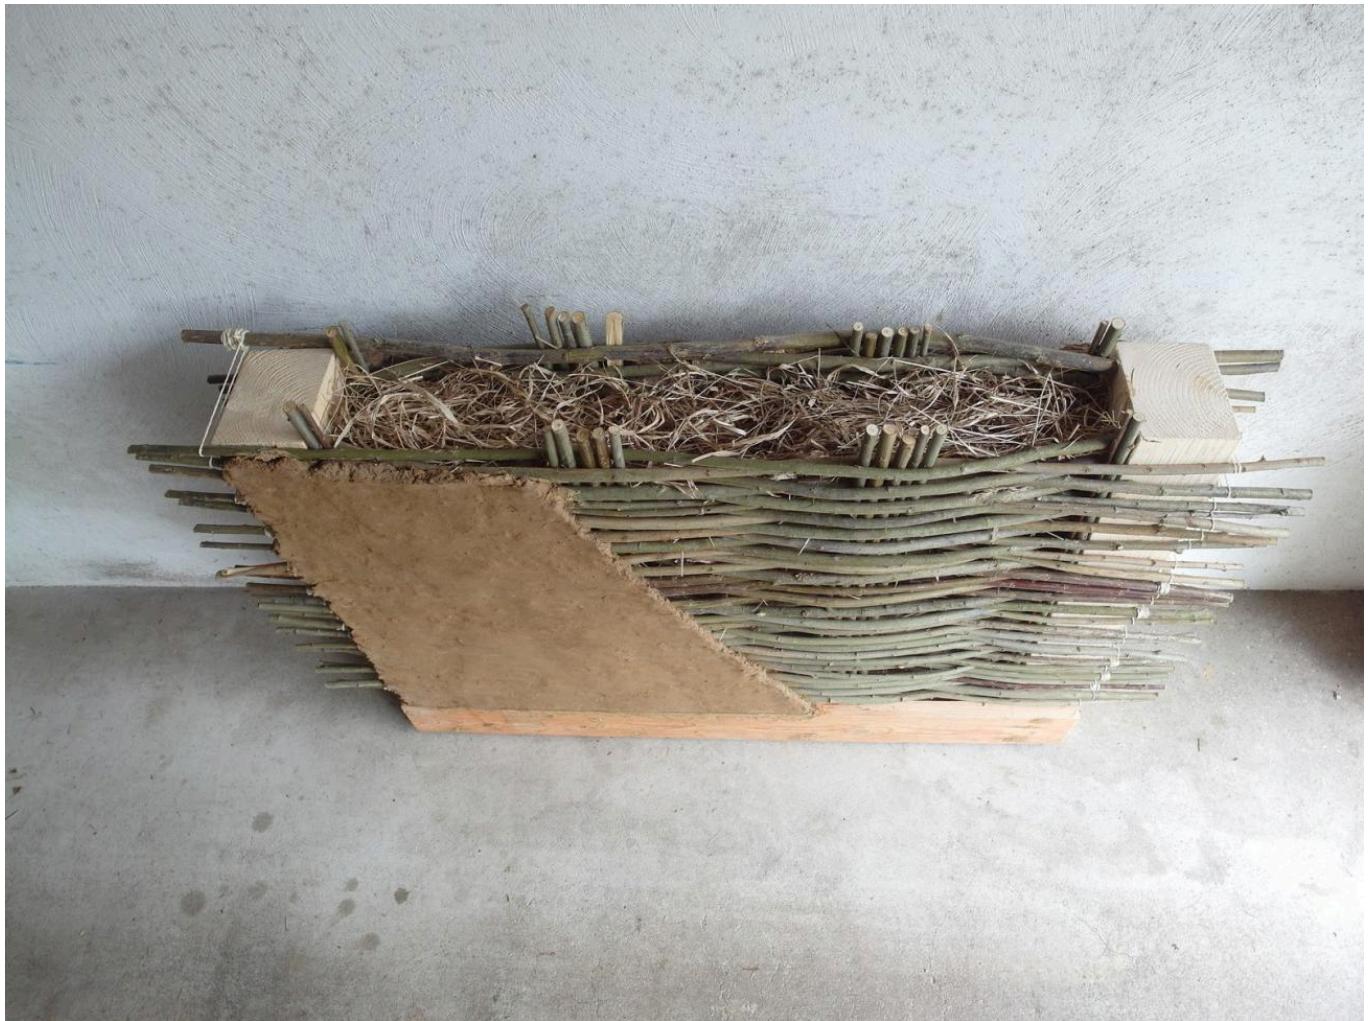
FIG 1. RECONSTRUCTION OF ENERGY SAVING WALL

us conclude how the wattles were fixed in the upholding construction. This will be described in the next five chapters. In the following section, a review will be given concerning the findings that explain the two wattle constructions (See Figure 1 and 2).

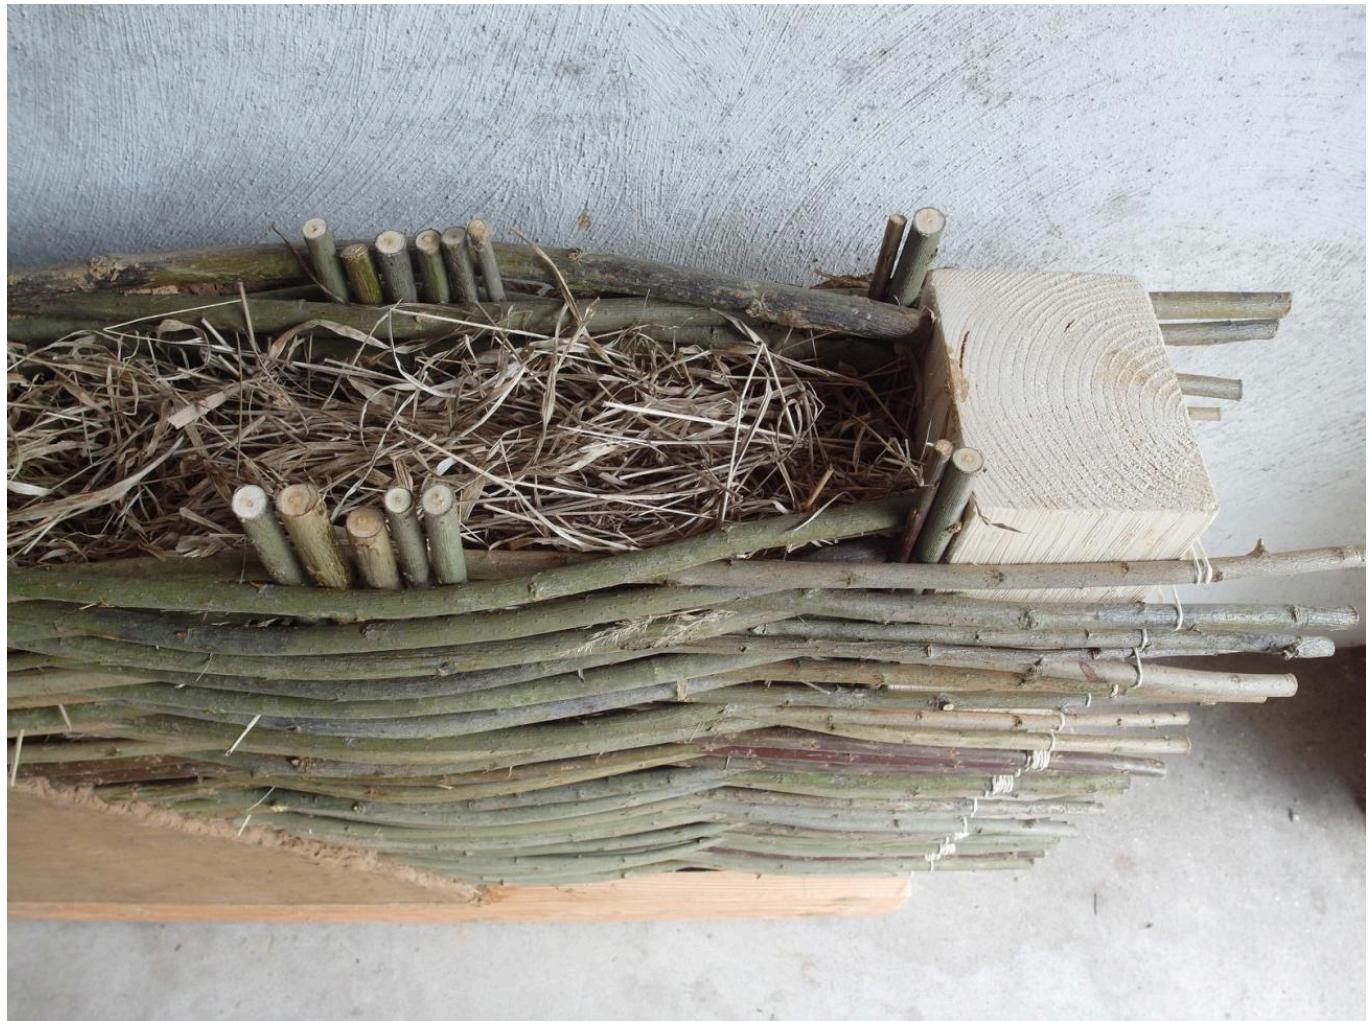
FIG 2. VIEW FROM ABOVE ONTO THE WALL WITH BEAM, TWO WATTLES AND GRASS FILLING.

cm. With two wattles there is no such problem as the two wattles can be adjusted to fit to the width of the beams (See Figure 2).

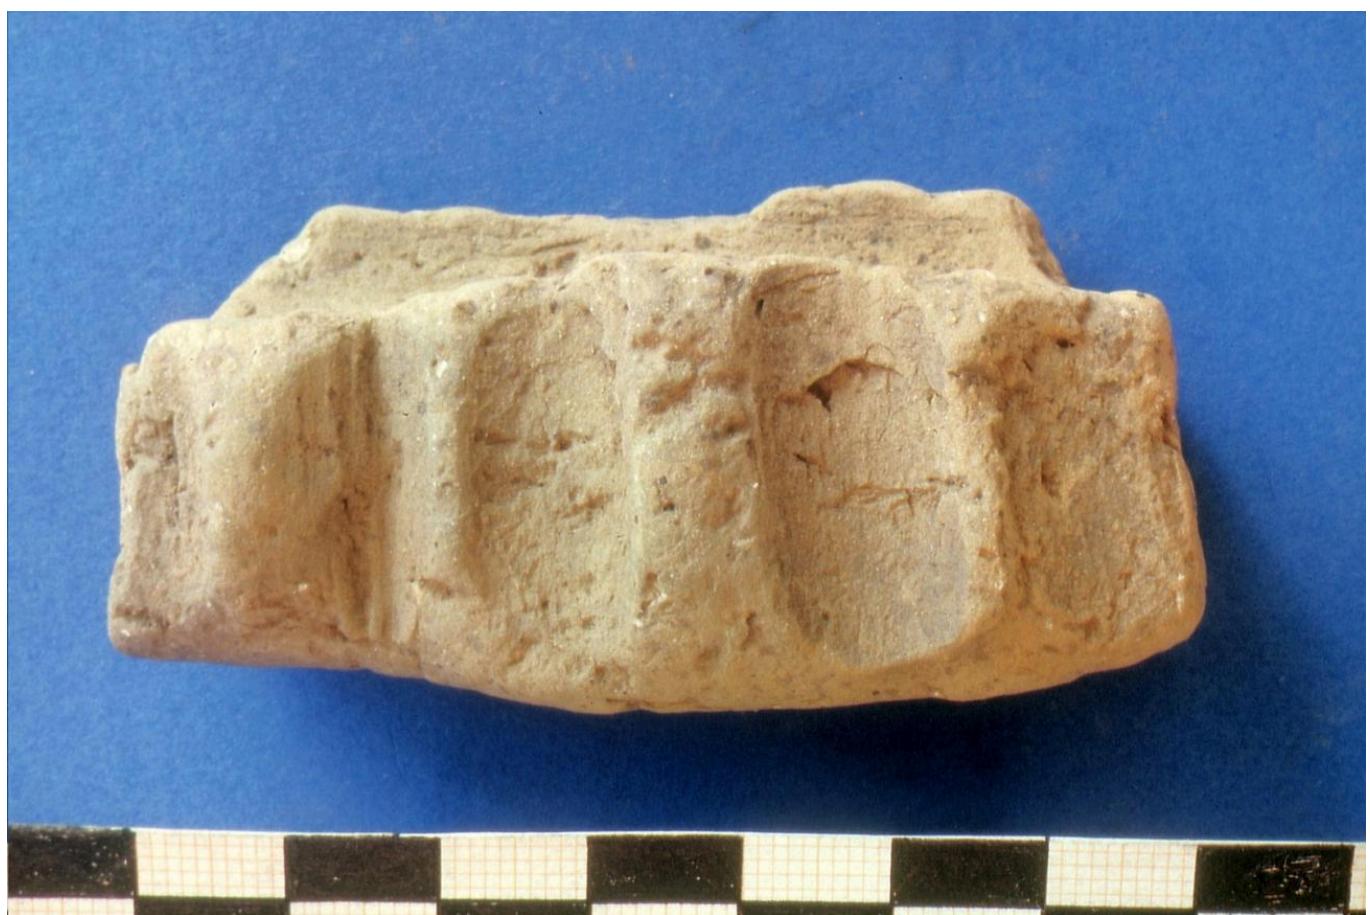
FIG 3. IMPRINTS OF FIVE POLES WITH CROSSING RODS. ONE POLE IS SPLIT ACROSS ITS LENGTH. (VIEW FROM ABOVE)

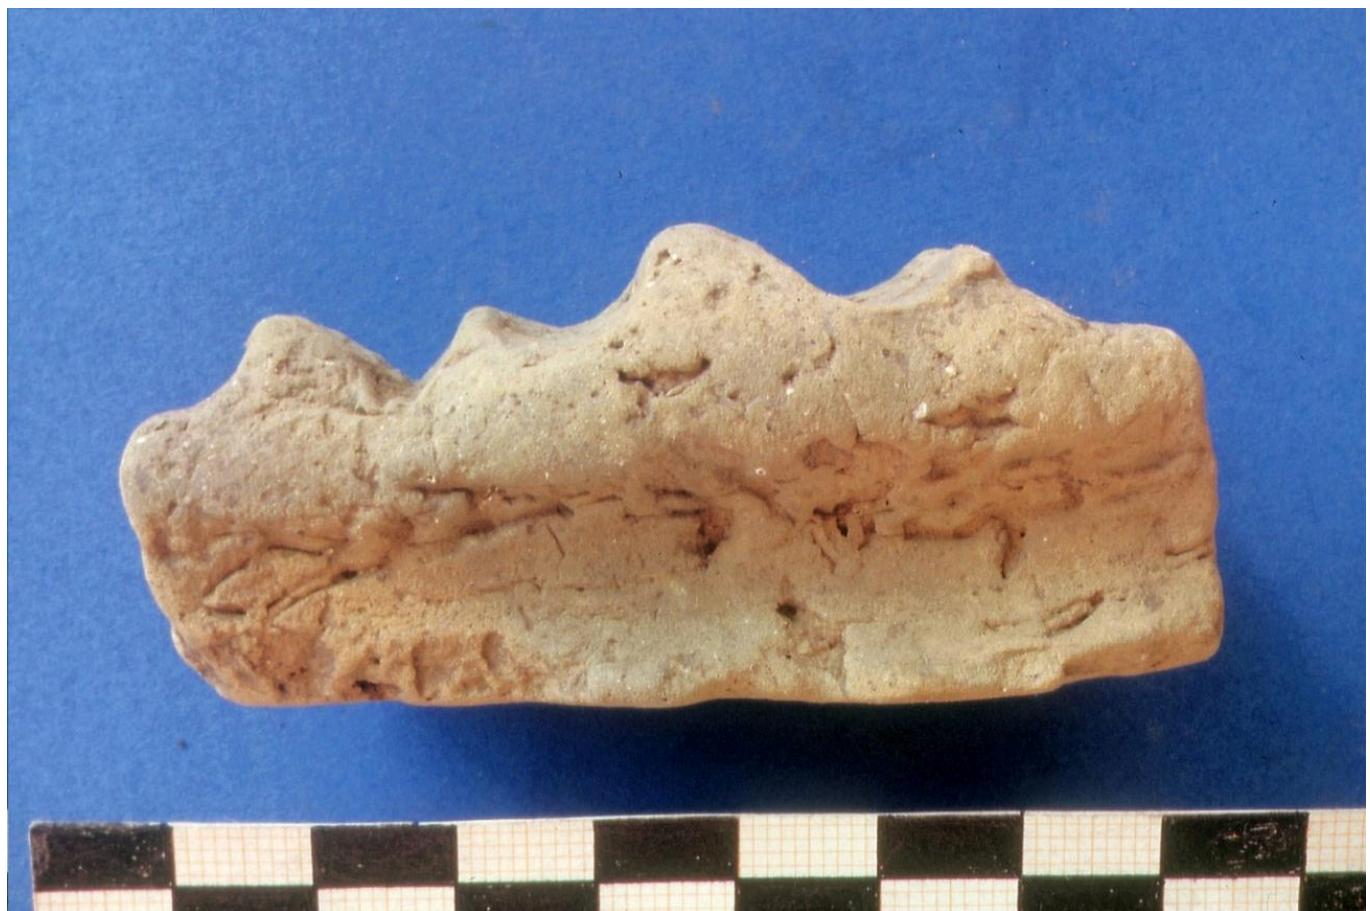
FIG 4. AS FIG. 3, VIEW FROM THE SIDE.

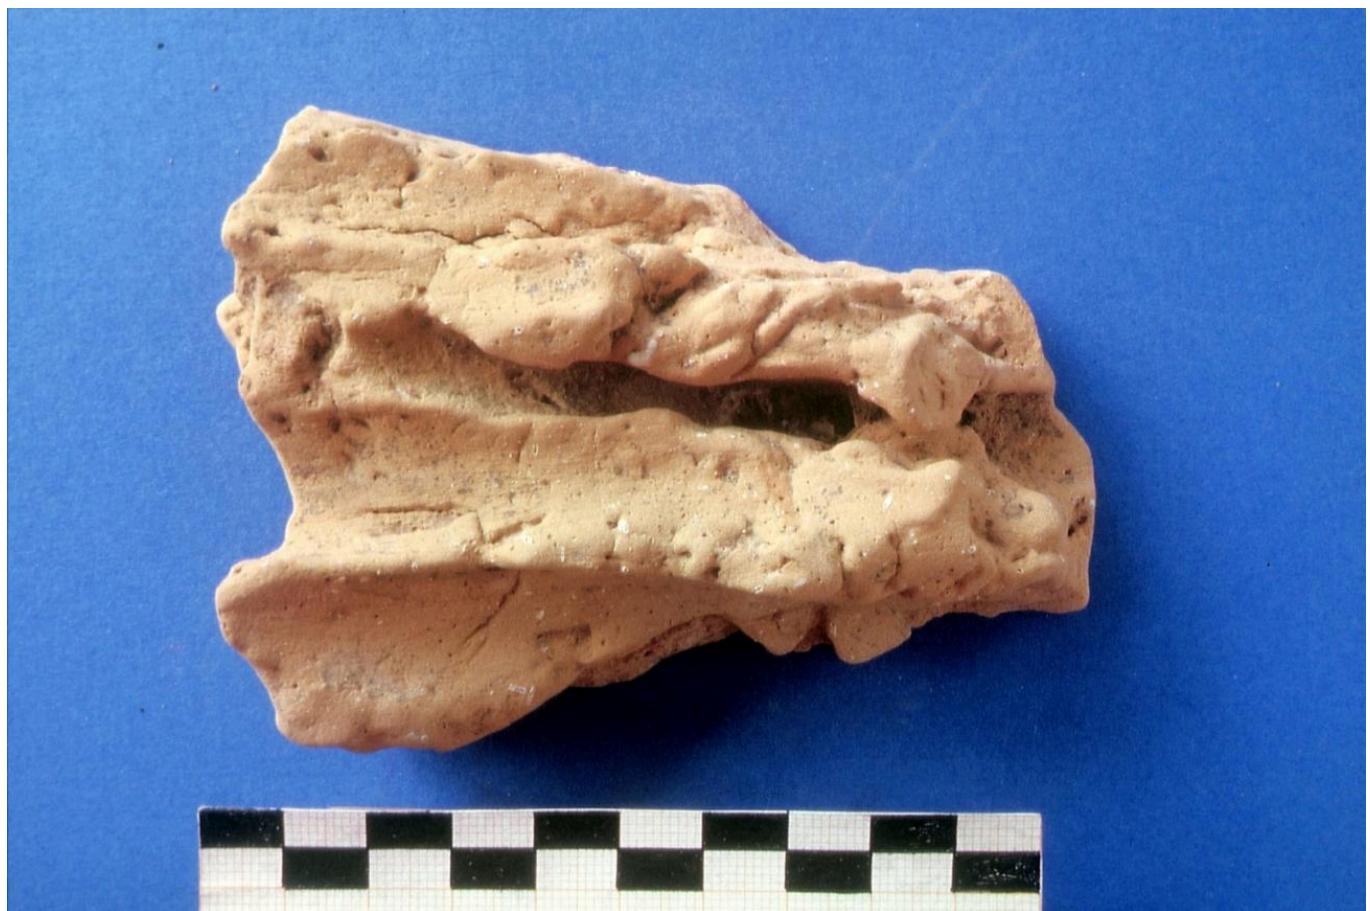
FIG 5. IMPRINTS OF RODS CROSSING EACH OTHER.

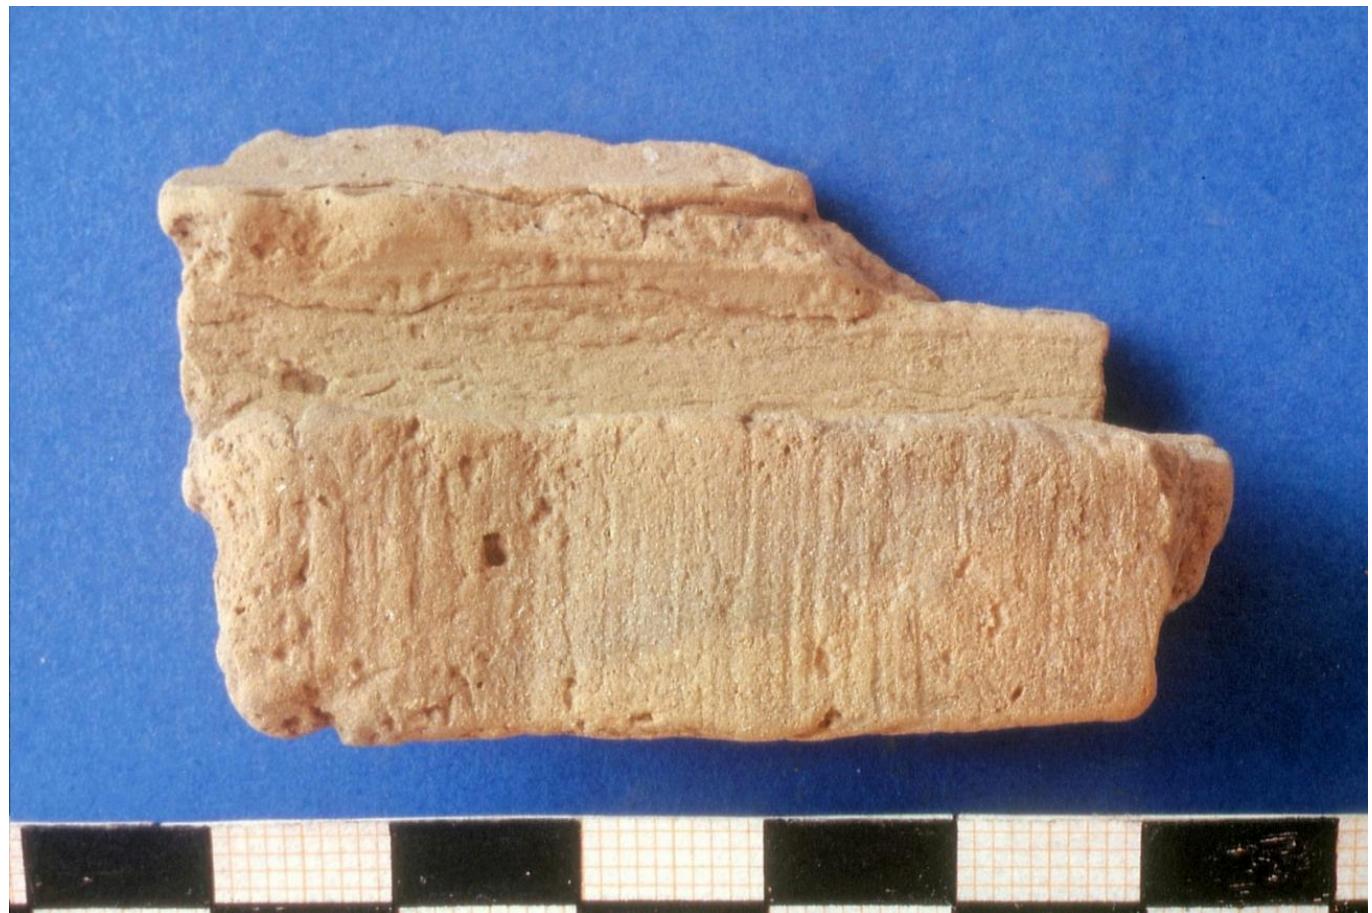
FIG 6. IMPRINTS OF FINE WOOD GRAIN, OTHER SIDE SMOOTHED SURFACE, IMPRINTS OF RODS ON THE UPPER AND THE LOWER PART. INV. 63

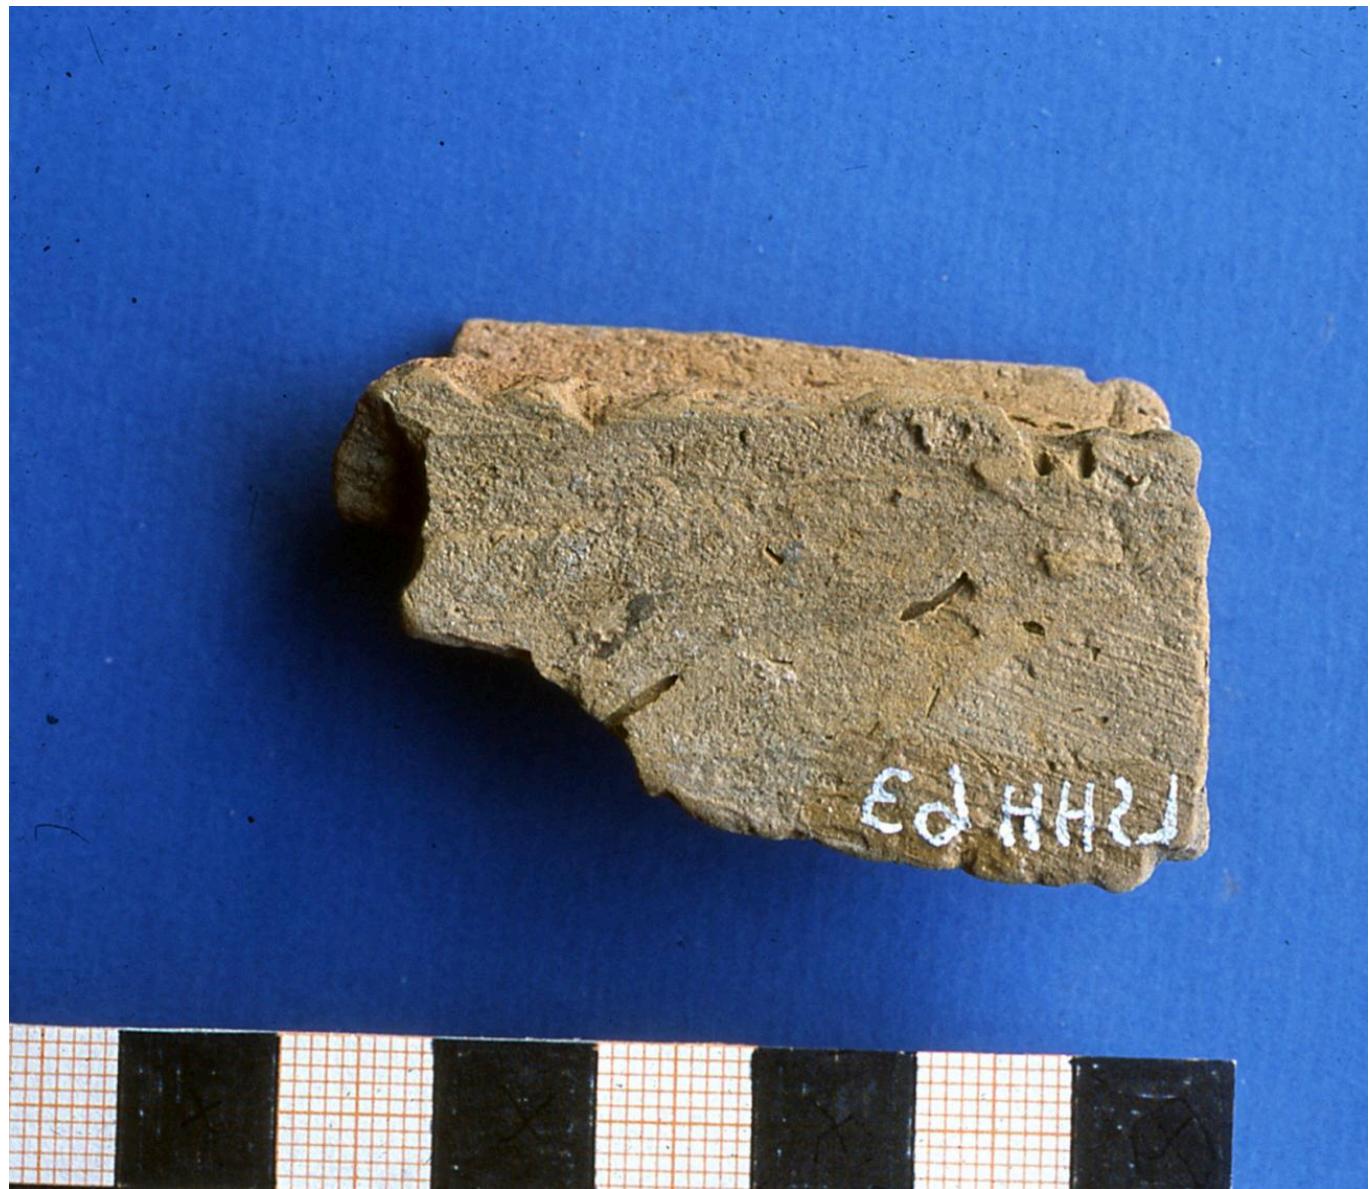
FIG 7. AS FIG. 6, OPPOSITE SIDE WITH SMOOTHED SURFACE. INV. 63

imprints of horizontal rods

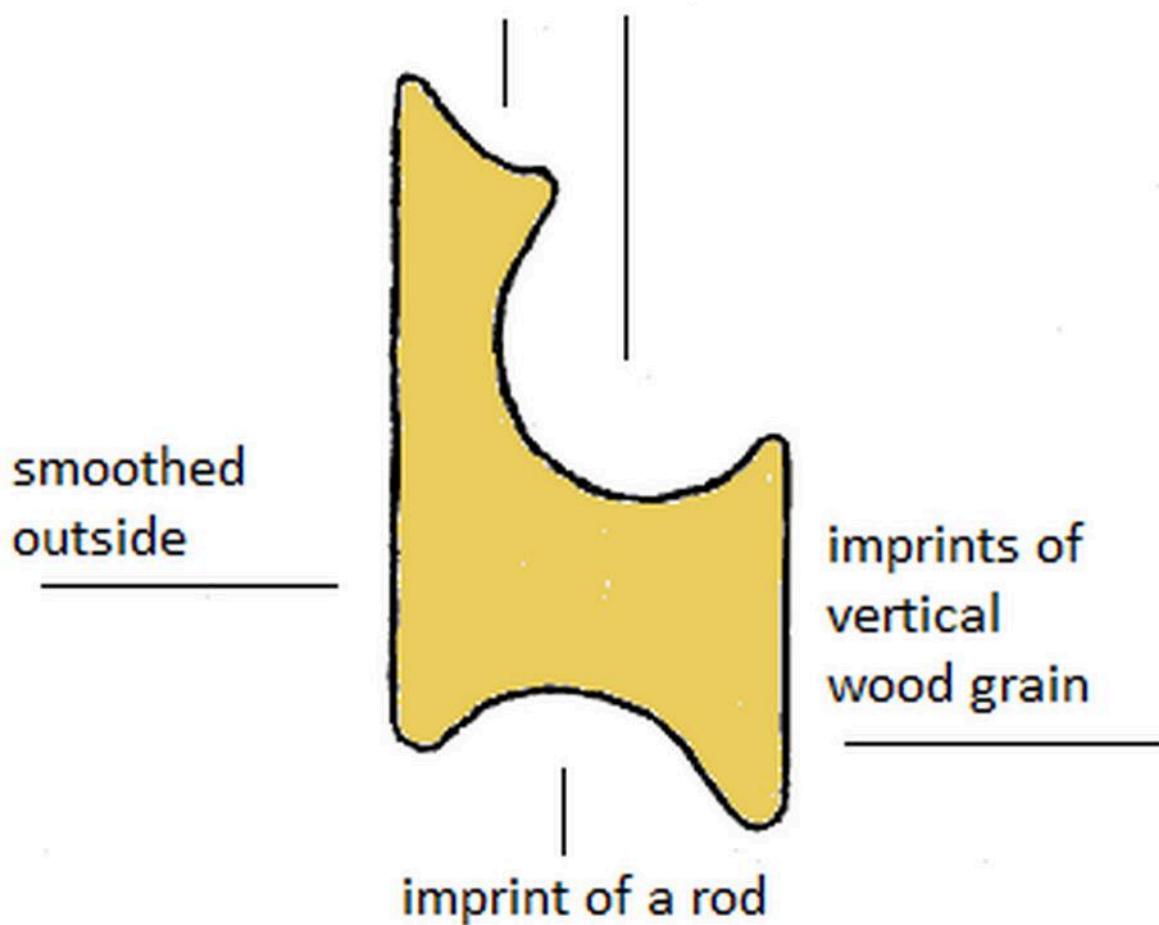
FIG 8. FRAGMENT INV. 63, FIG. 6 AND 7 IN CROSS SECTION

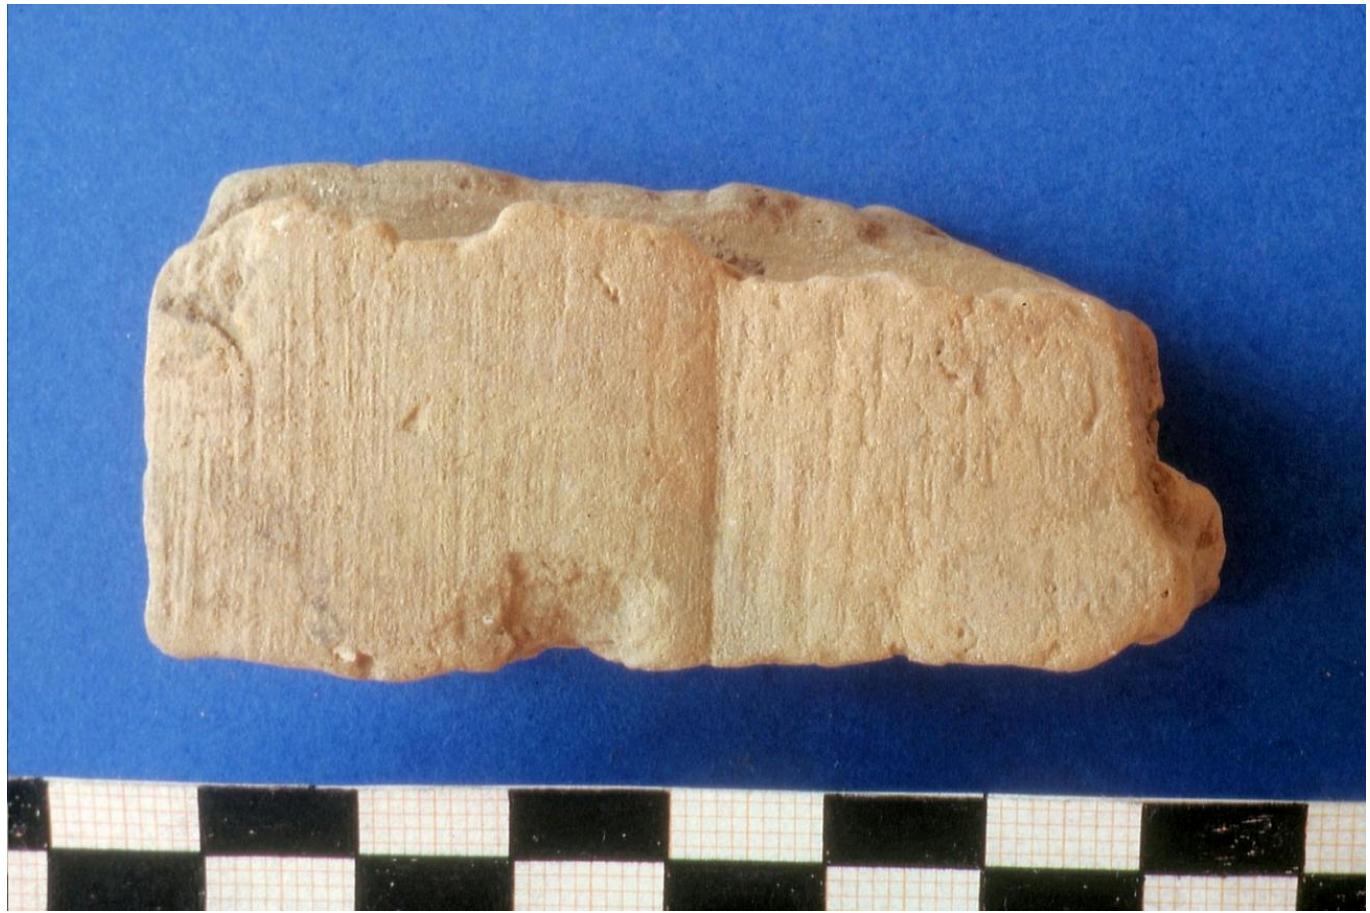
FIG 9. IMPRINTS OF FINE WOOD GRAIN, OPPOSITE SIDE SMOOTHED SURFACE, IMPRINTS OF RODS ON THE UPPER AND THE LOWER PART. INV. 64

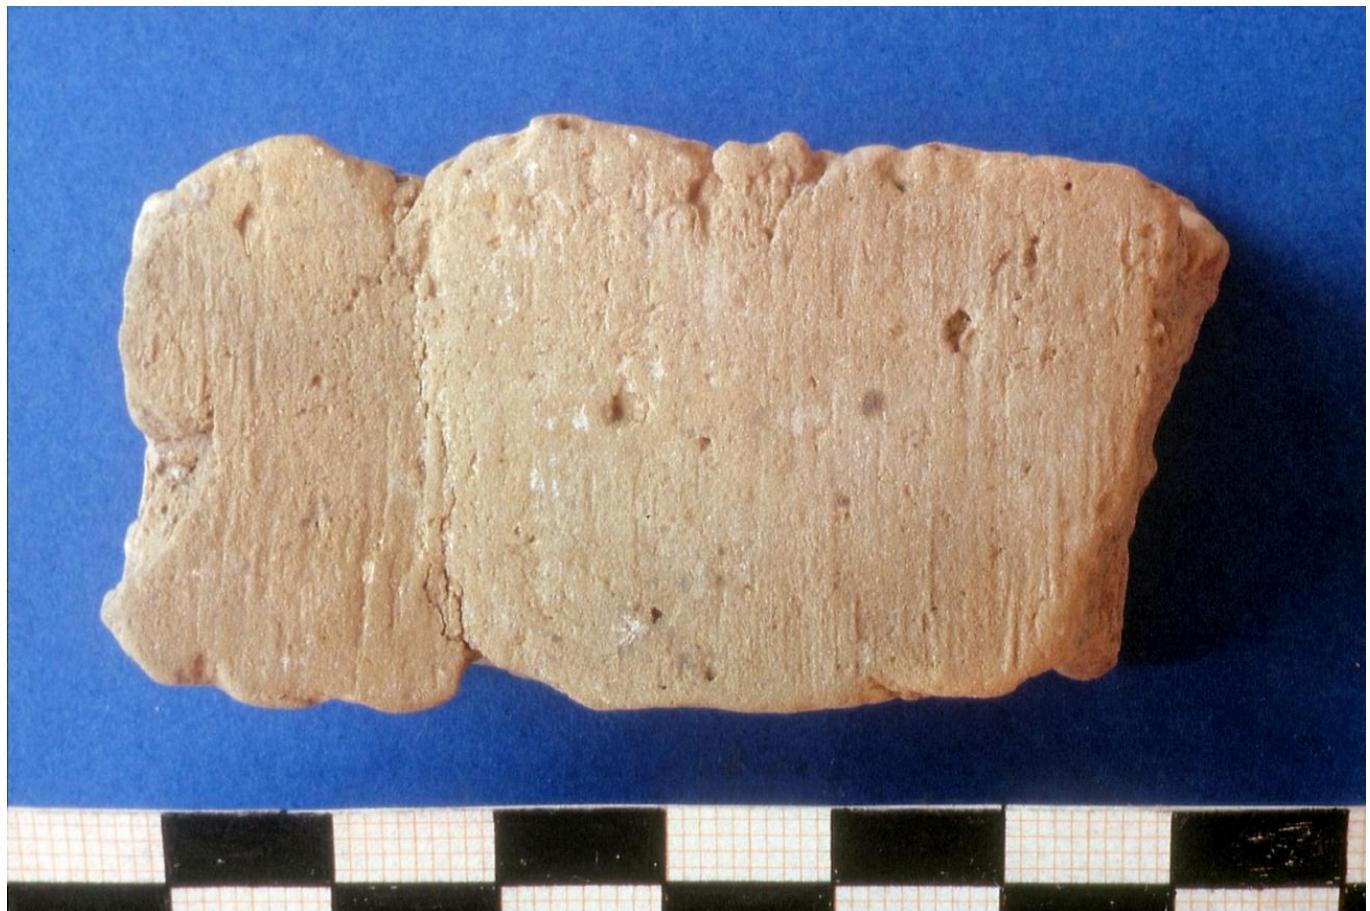
FIG 10. IMPRINTS OF FINE WOOD GRAIN, OPPOSITE SIDE SMOOTHED SURFACE, IMPRINTS OF RODS ON THE UPPER AND THE LOWER PART. INV. 62 (SKIP PERHAPS)

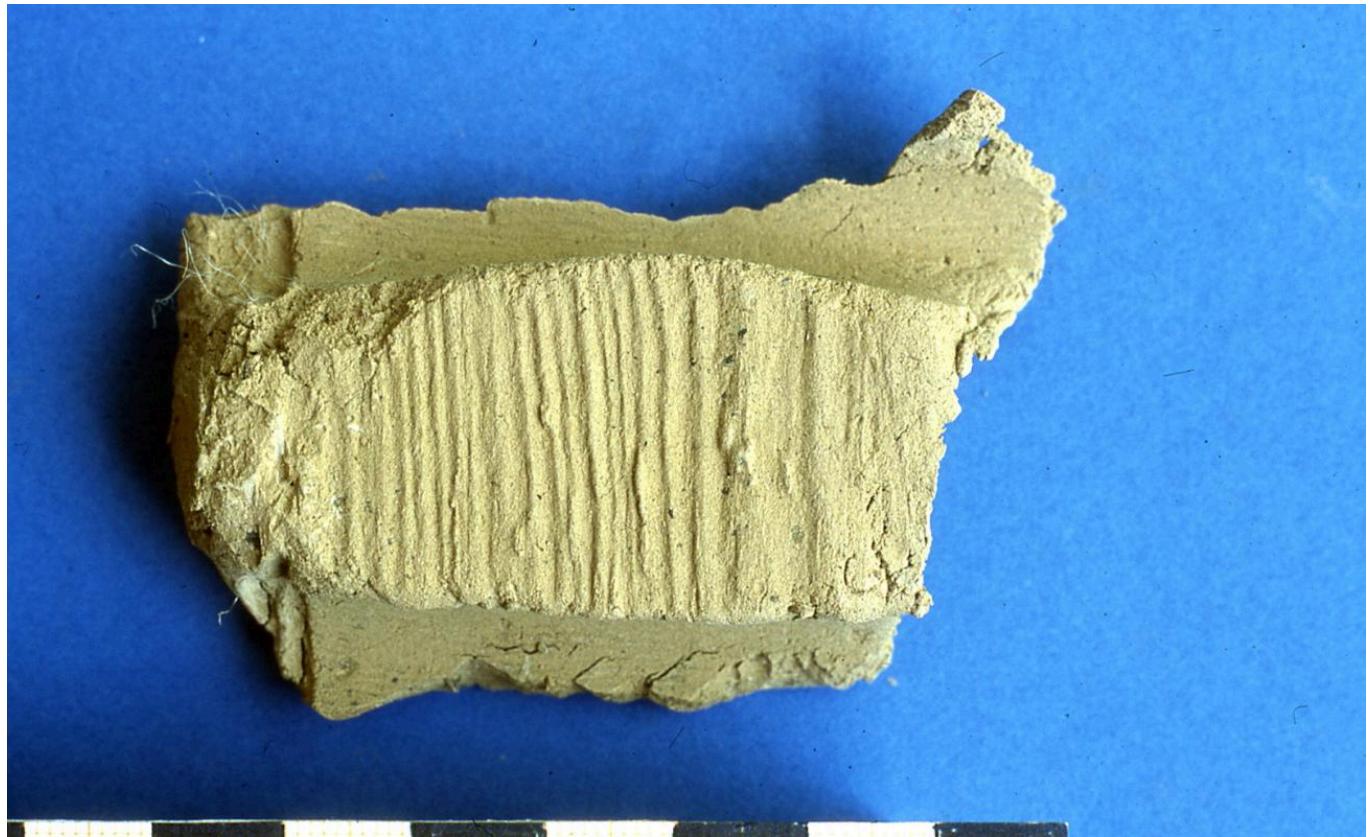
FIG 11. CLAY WAS THROWN ON A BEAM WITH CROSSING RODS AS PART OF AN EXPERIMENT. RESULTS SHOW THE SAME STRUCTURES AS THE BRONZE AGE CLAY.

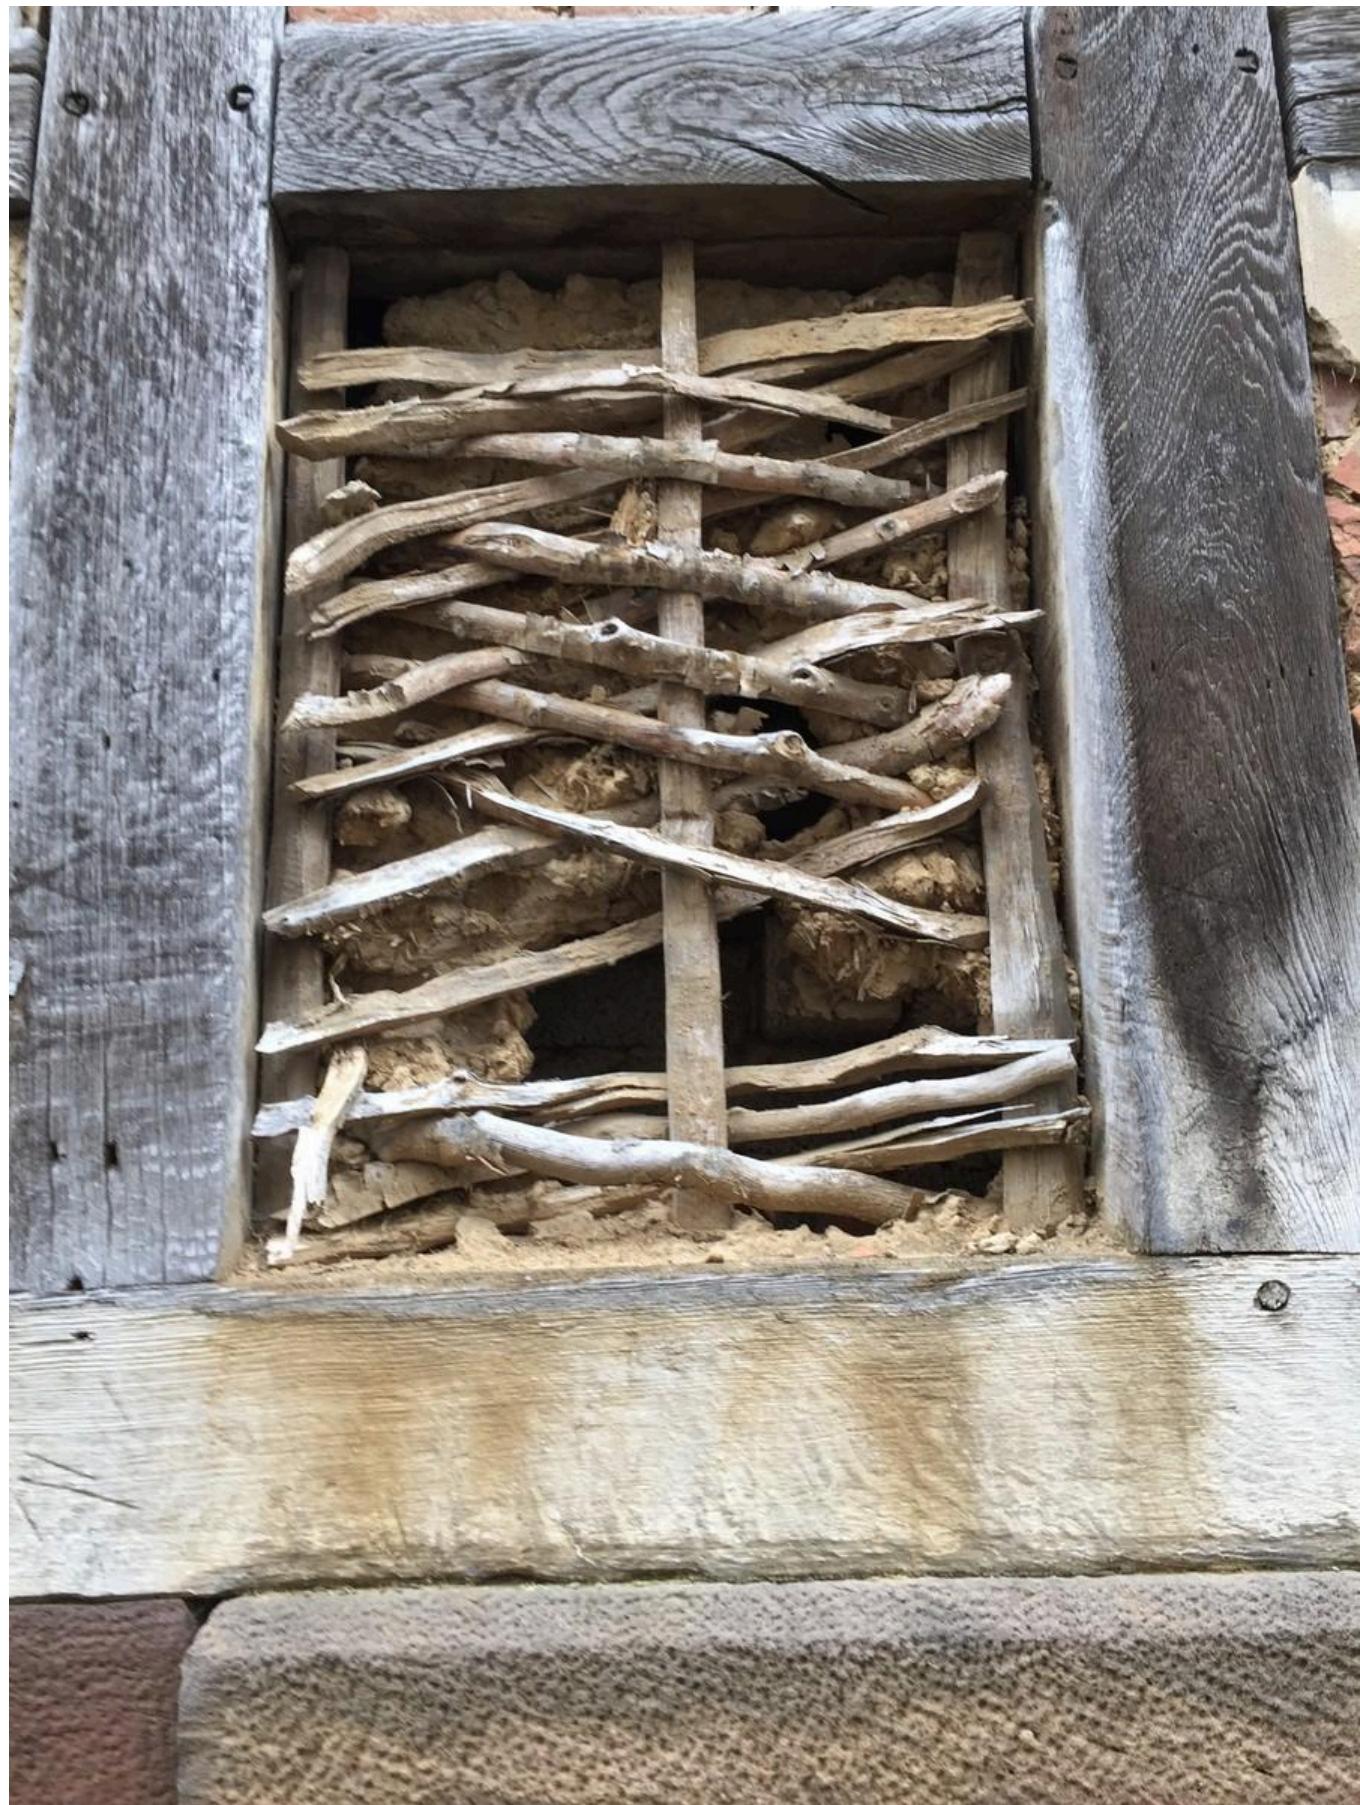
FIG 12. WATTLE OF A BARN IN RAUISCHHOLZHAUSEN (HESSIA). TWO POLES ARE SIDE BY SIDE NEXT TO THE VERTICAL BEAMS. BOTH POLE ENDS ARE CLAMPED IN A GROOVE IN THE UPPER AND LOWER BEAM. THE RODS ARE CLAMPED BEFORE AND BEHIND THESE POLES.

barn in Rauischholzhausen (Hessia), where we can find this pattern of construction (See Figure 12).

Here we find in the infill of the frames a similar wattle to those described above however the rods are of coarser quality. These rods were stabilized with the help of poles running parallel right next to the beams. The horizontal rods in the timber frames corresponding to the rods in the Bronze Age walls were pressed in front of and behind the poles in an alternating fashion. It must have been similar with the double wattle wall in the Bronze Age. Every second rod was led along the front side of the beam while the others were clamped behind a pole next to the beam. This resulted in a firm connection between the beams and wattles (See Figures 13, 14 and 15).

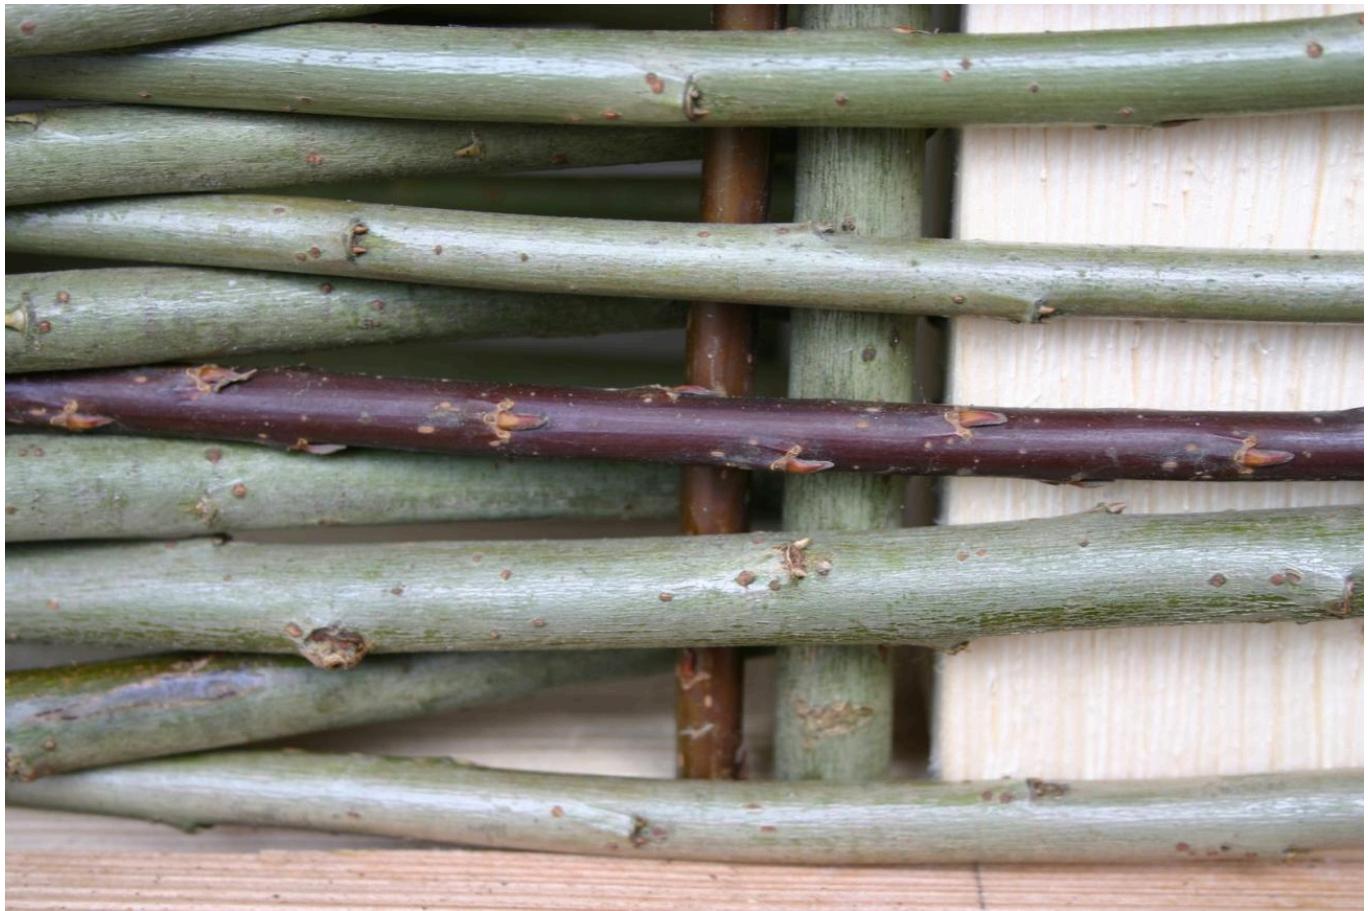
FIG 13. RECONSTRUCTION: RODS LED ALONG THE OUTSIDE OF A BEAM CONNECT THE WATTLE WITH THE SUPPORTING CONSTRUCTION.

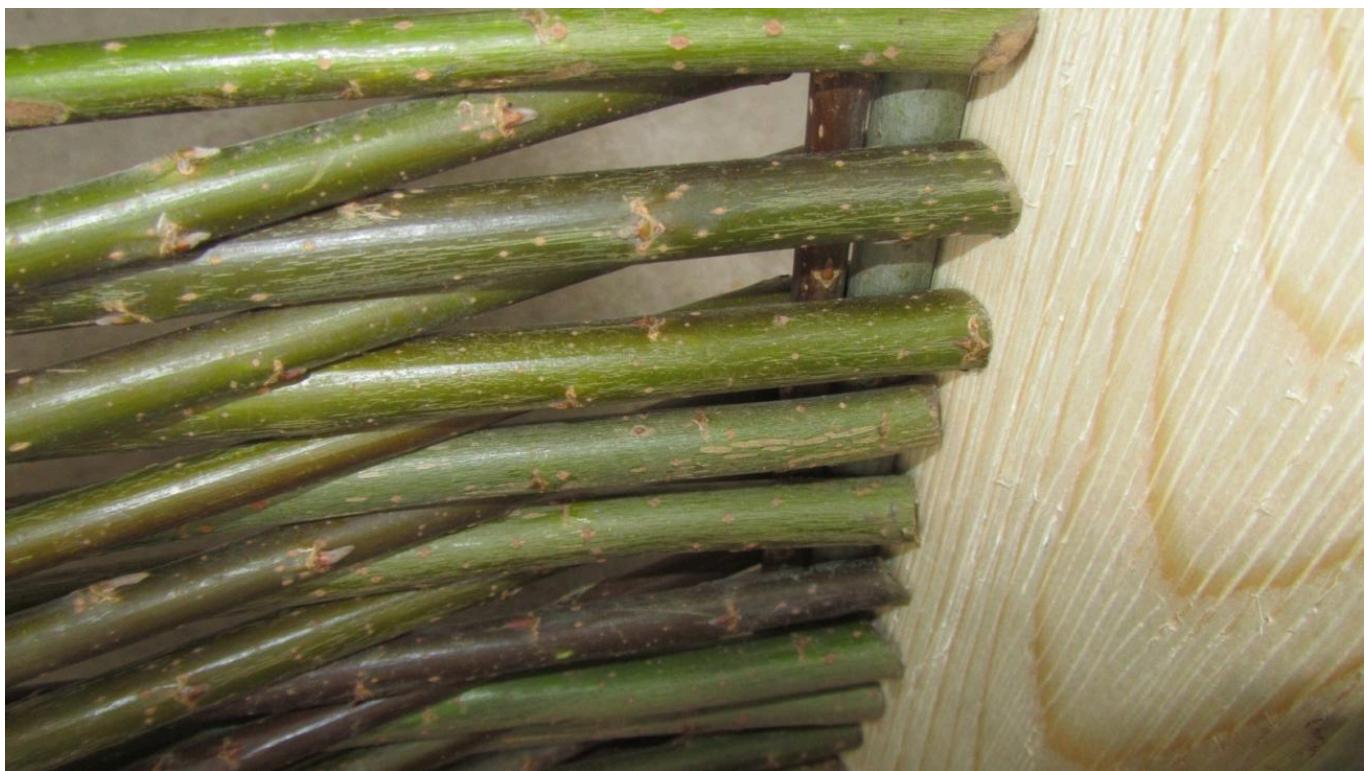
FIG 14. RECONSTRUCTION: RODS THAT STAY INSIDE ARE CLAMPED BEHIND THE POLES NEXT TO THE BEAM.

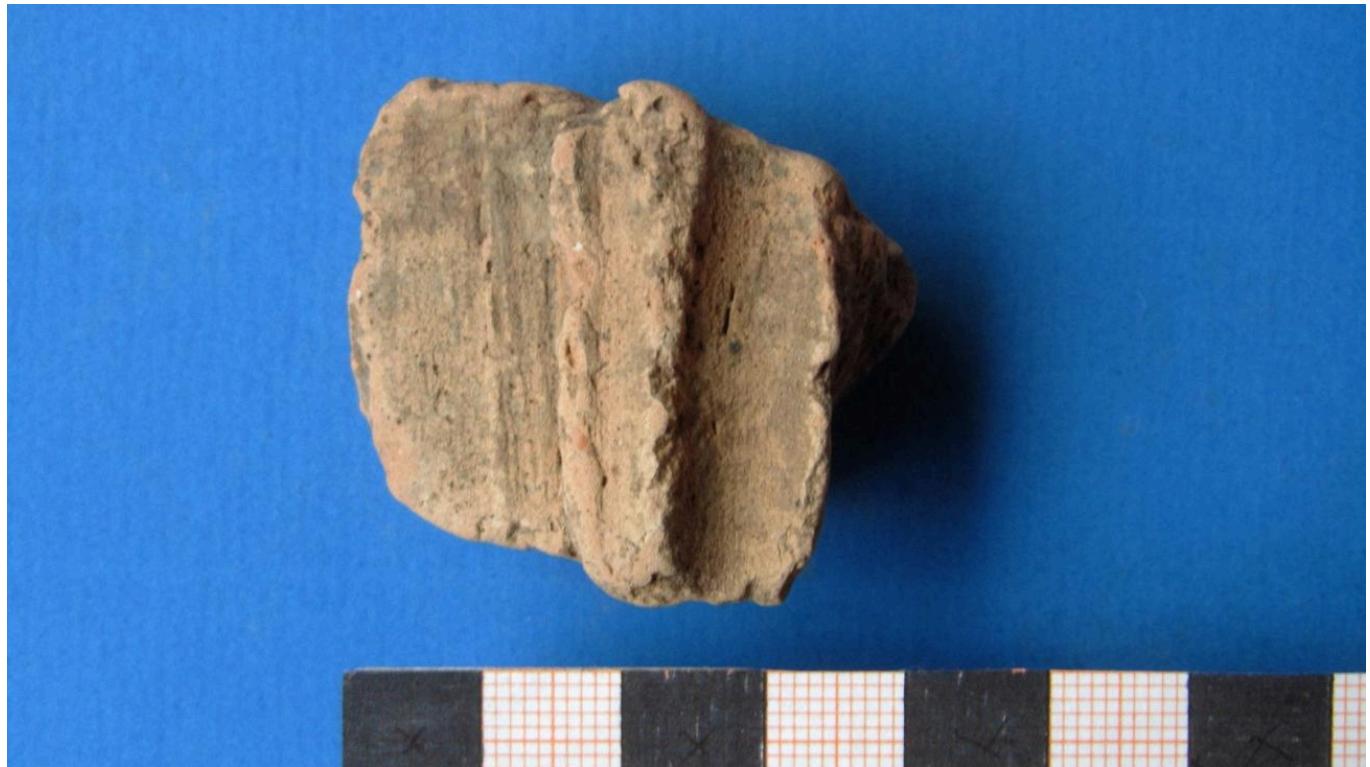
FIG 15. BRONZE AGE FRAGMENT POSSIBLE SHOWING RODS SIDE BY SIDE NEXT TO A BEAM?

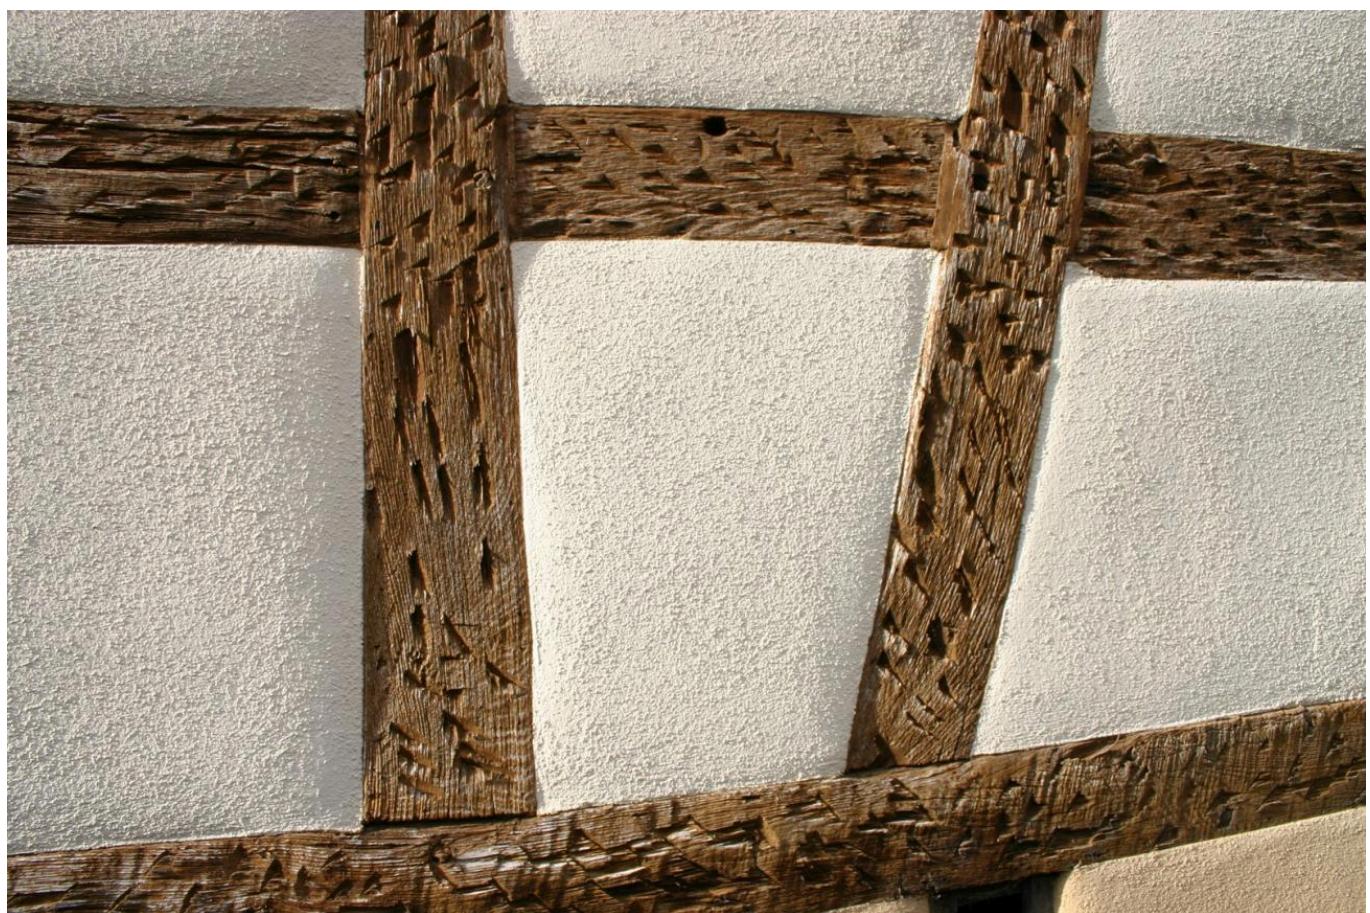
FIG 16. BLOWS/CUTS FROM AN AXE ROUGHENED THE SURFACE OF THE BEAMS TO ENSURE THE PLASTER WOULD STAY ON THE WOOD. OLD TIMBER FRAMED HOUSE IN GELNHAUSEN (HESSIA).

The fragments with smoothed clay on the one side and wood grain on the backside show that the walls as well as the beams were obviously completely covered with clay. The effect is that the building is more fire resistant. This is also why timber framed houses were covered with plaster in former times. Nowadays, the framework of such houses is mostly uncovered. The uncovered beams of such houses often show deep cuts of axe blows. They were used to ensure that the plaster would stay on the wood (See Figure 16). The Bronze Age houses did not need to be worked with an axe as the rods running around the beams in a horizontal direction kept the clay in place.
