### An Energy Saving House from 3400 Years Ago

EXARC Journal Issue 2016/3 | Publication Date: 2016-08-15

Author(s): Irene Staeves<sup>1</sup>

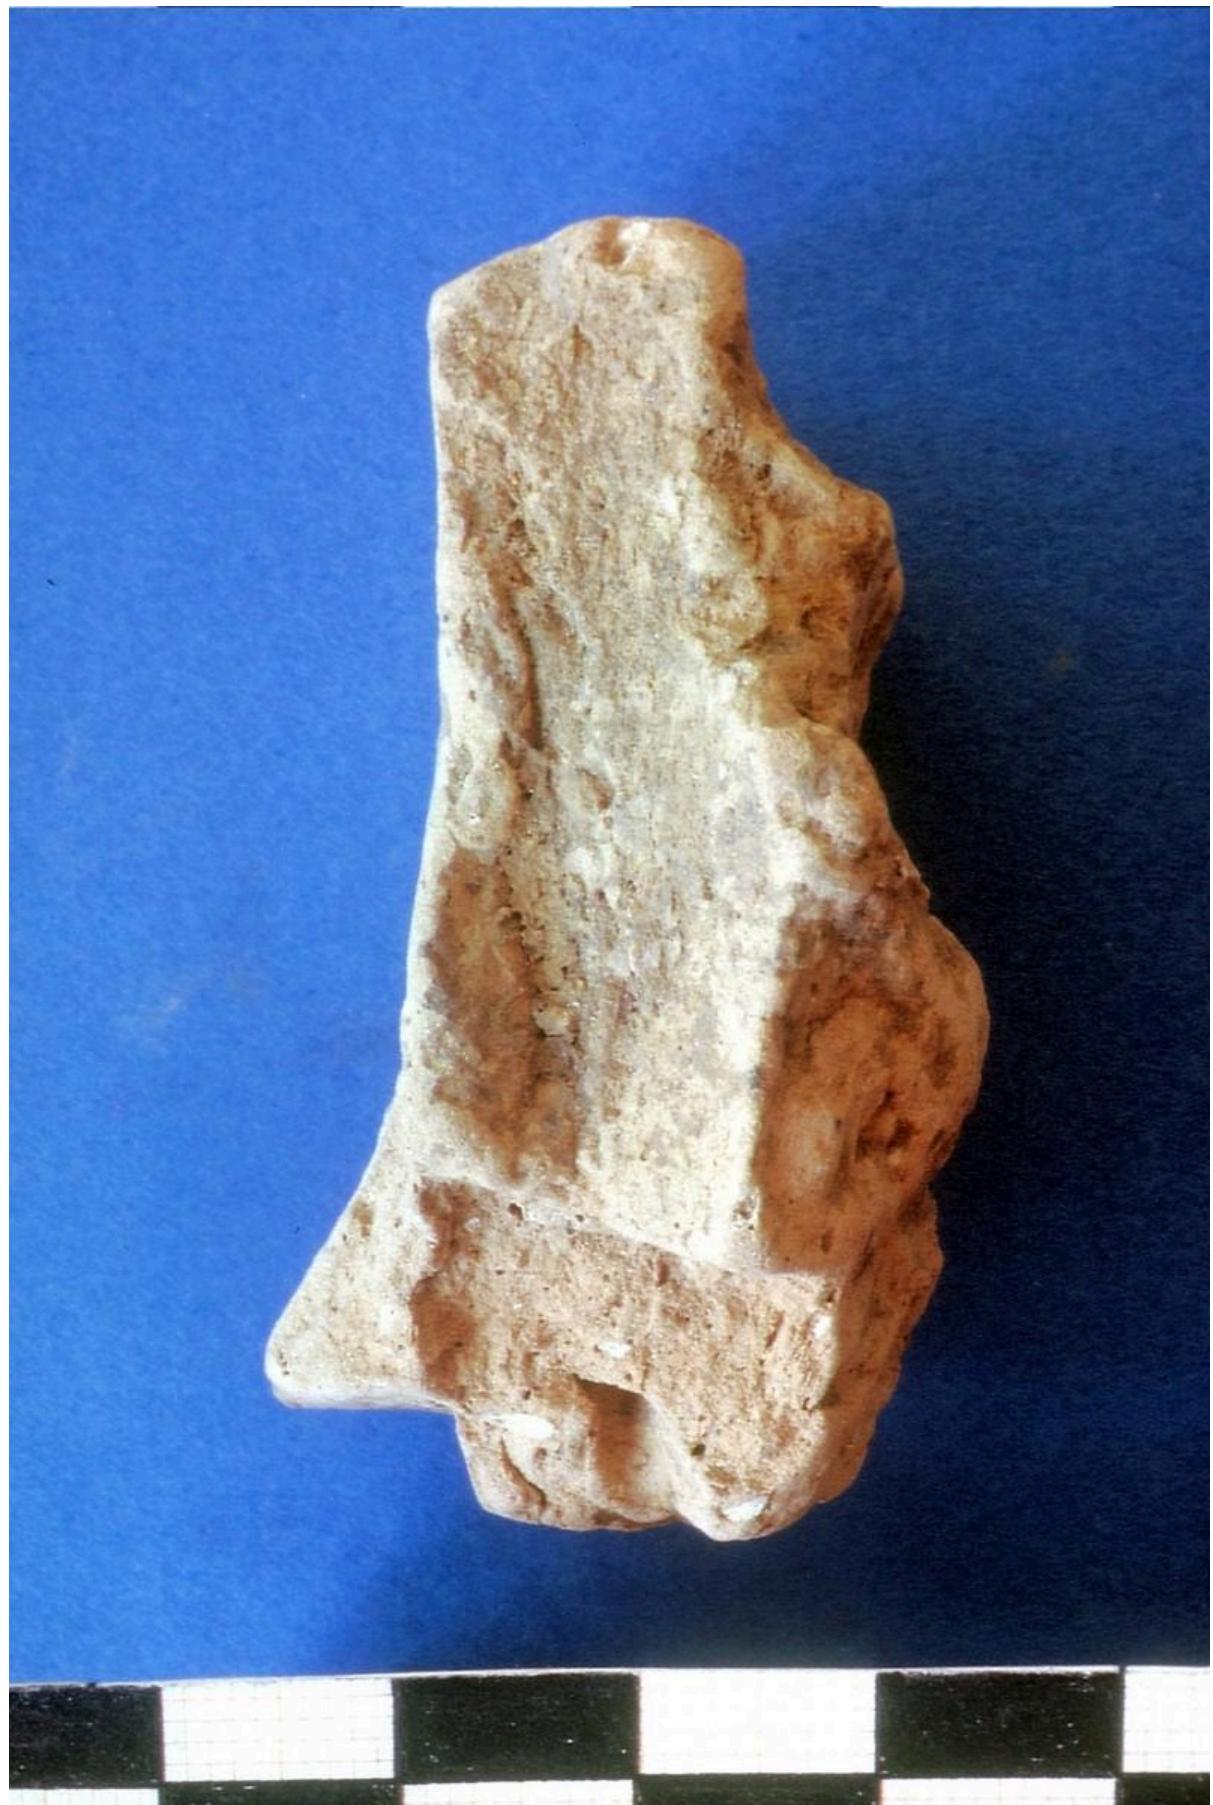
FIG 17. THE ANGLE LEFT BELOW IS THE IMPRINT OF AN EDGED WOOD. THE IMPRINTS OF A POLE AND THREE RODS (OR A ROD AND THREE POLES) ABOVE INDICATE THAT THESE WERE CLAMPED BEHIND. IT IS NOT CLEAR IF THE WOOD WAS BUILT HORIZONTALLY OR VERTICALLY. INV. 10.

Nevertheless, the imprints show that poles or rods of the wattle were cramped behind a piece of edged wood in a vertical as well as a horizontal direction. It is difficult to decide to which part of the construction this piece of edged wood belonged, perhaps to a door or window. Whether this wooden edge was horizontal or vertical can only be concluded by one fragment: Here a clay drop fell on the hollow profile indicating that this piece of wood had a horizontal position (See Figures 17 and 18).

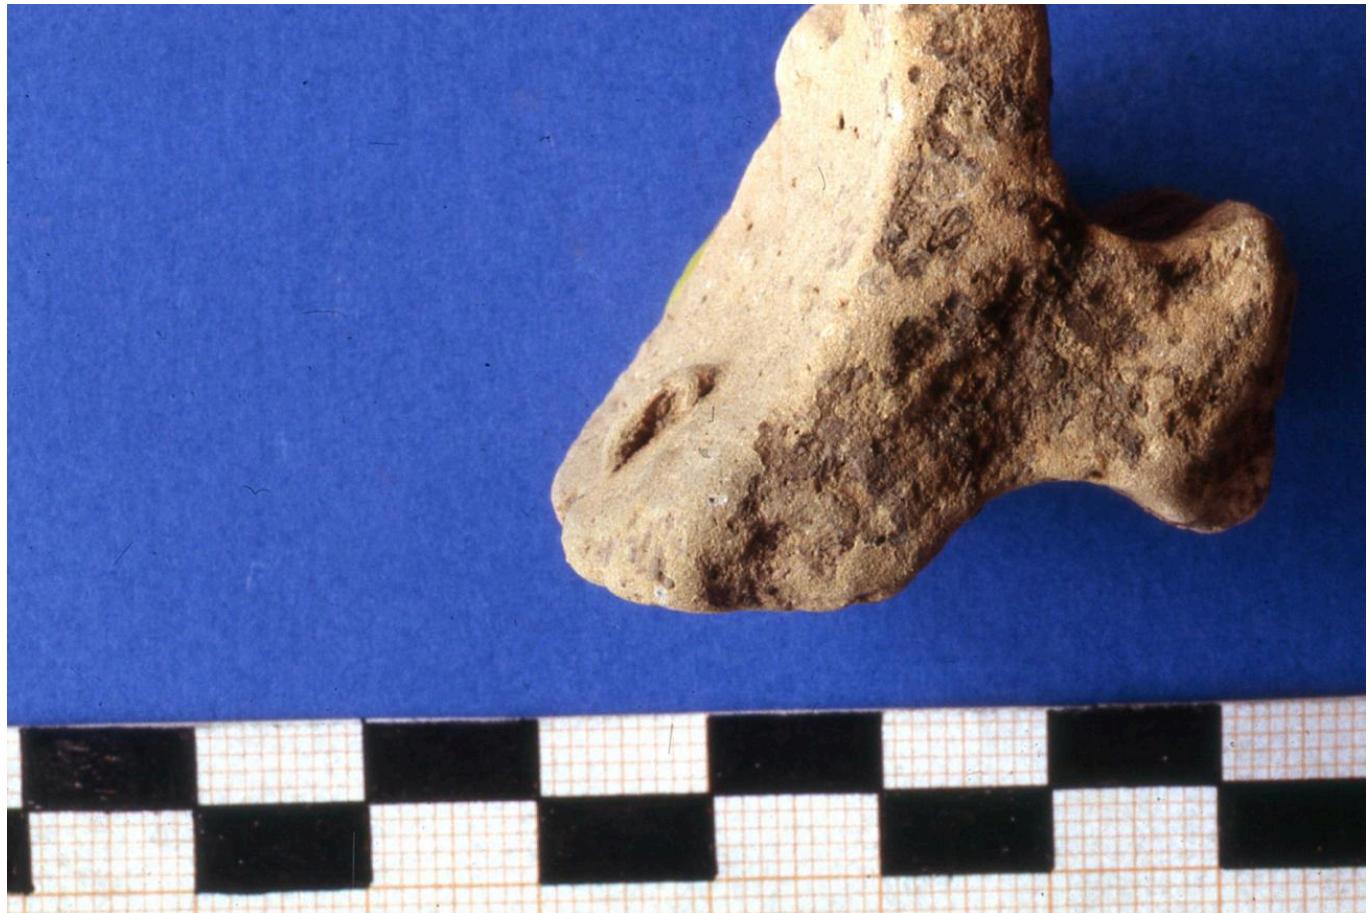
FIG 18. HERE A HOLLOW PROFILE WAS FORMED OVER AN EDGED OR FLAT PIECE OF WOOD WITH TWO PARALLEL RODS. WHILE SMOOTHING, A DROP OF WET CLAY FELL DOWN AND INDICATED THAT THIS WOOD WITH THE RODS WAS HORIZONTAL.

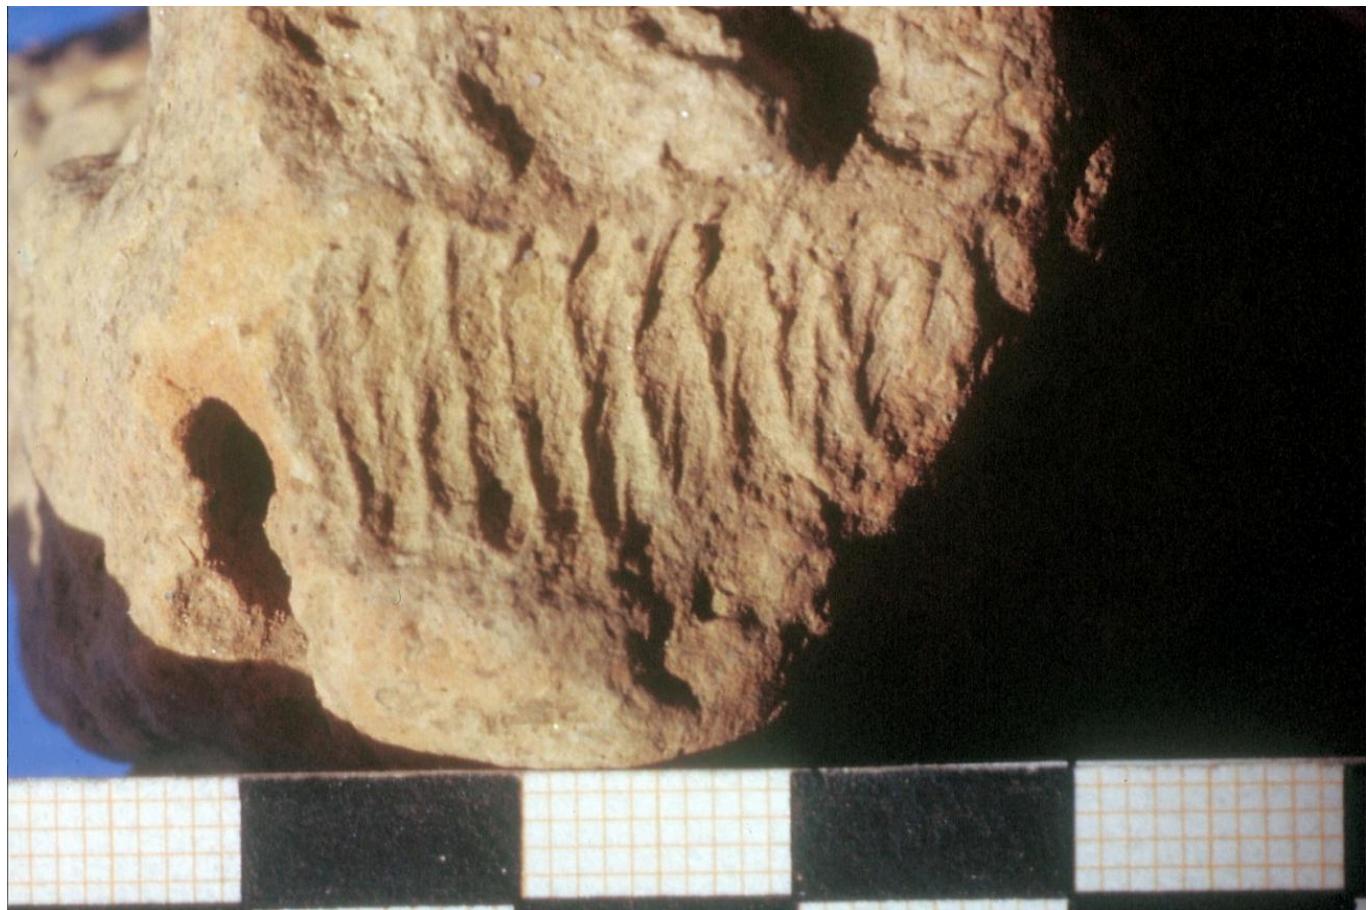
FIG 20. IMPRINTS OF CORD WINDINGS

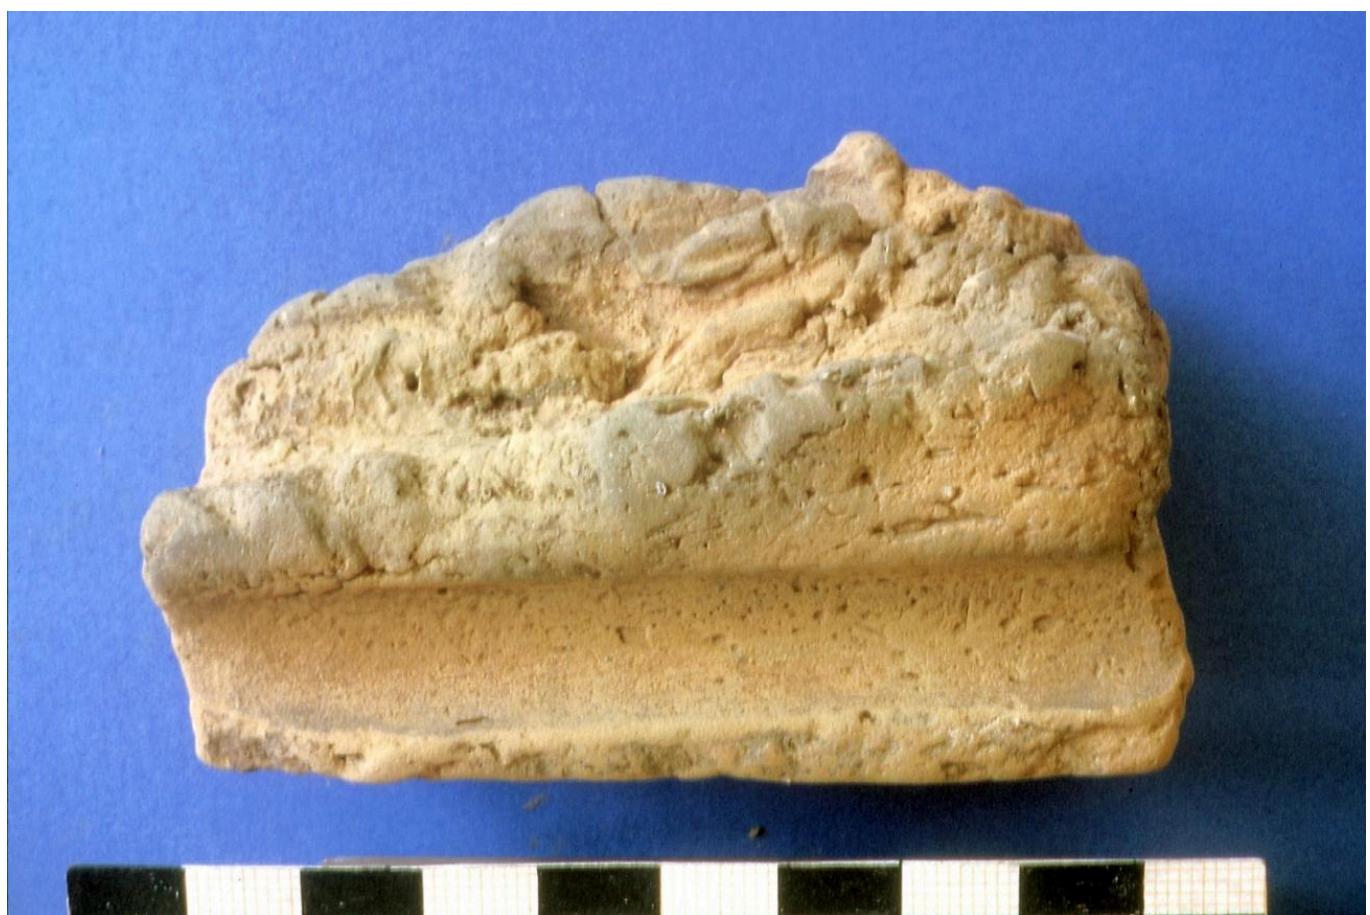
FIG 21A. THIS FRAGMENT SHOWS THE COMPLETE THICKNESS OF THE WATTLE: SMOOTHED OUTSIDE, IMPRINTS OF RODS PASSING ON BOTH SIDES OF THE POLE, BULGES WITH IMPRINTS OF GRASS. VIEW FROM ABOVE WITH IMPRINTS OF RODS, BULGES AND IMPRINTS OF GRASS. INV. 14

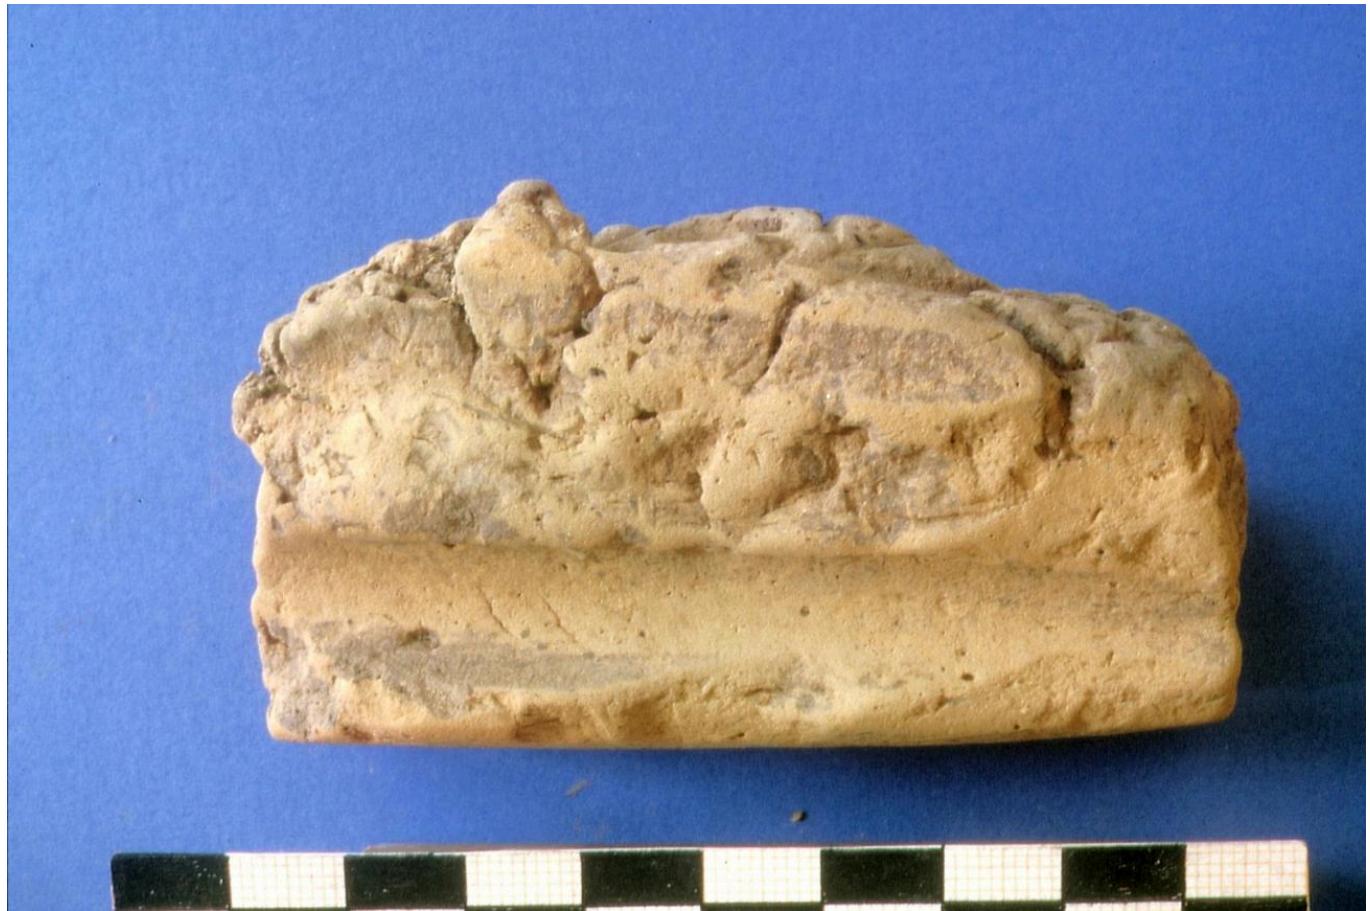
FIG 21B. SMOOTHED OUTSIDE.

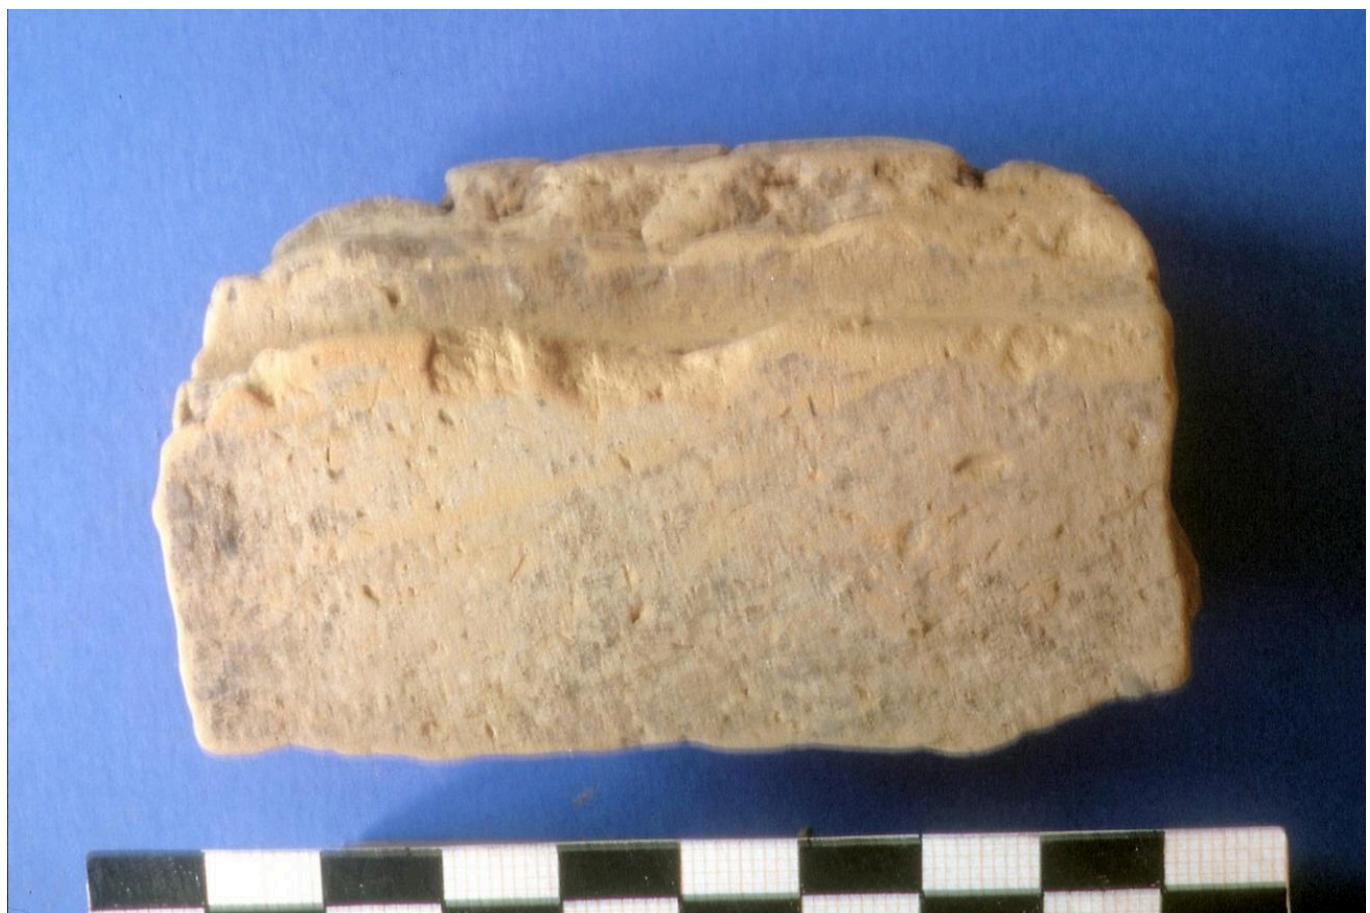
FIG 21C. VIEW FROM BENEATH WITH IMPRINTS OF RODS AND BULGES.

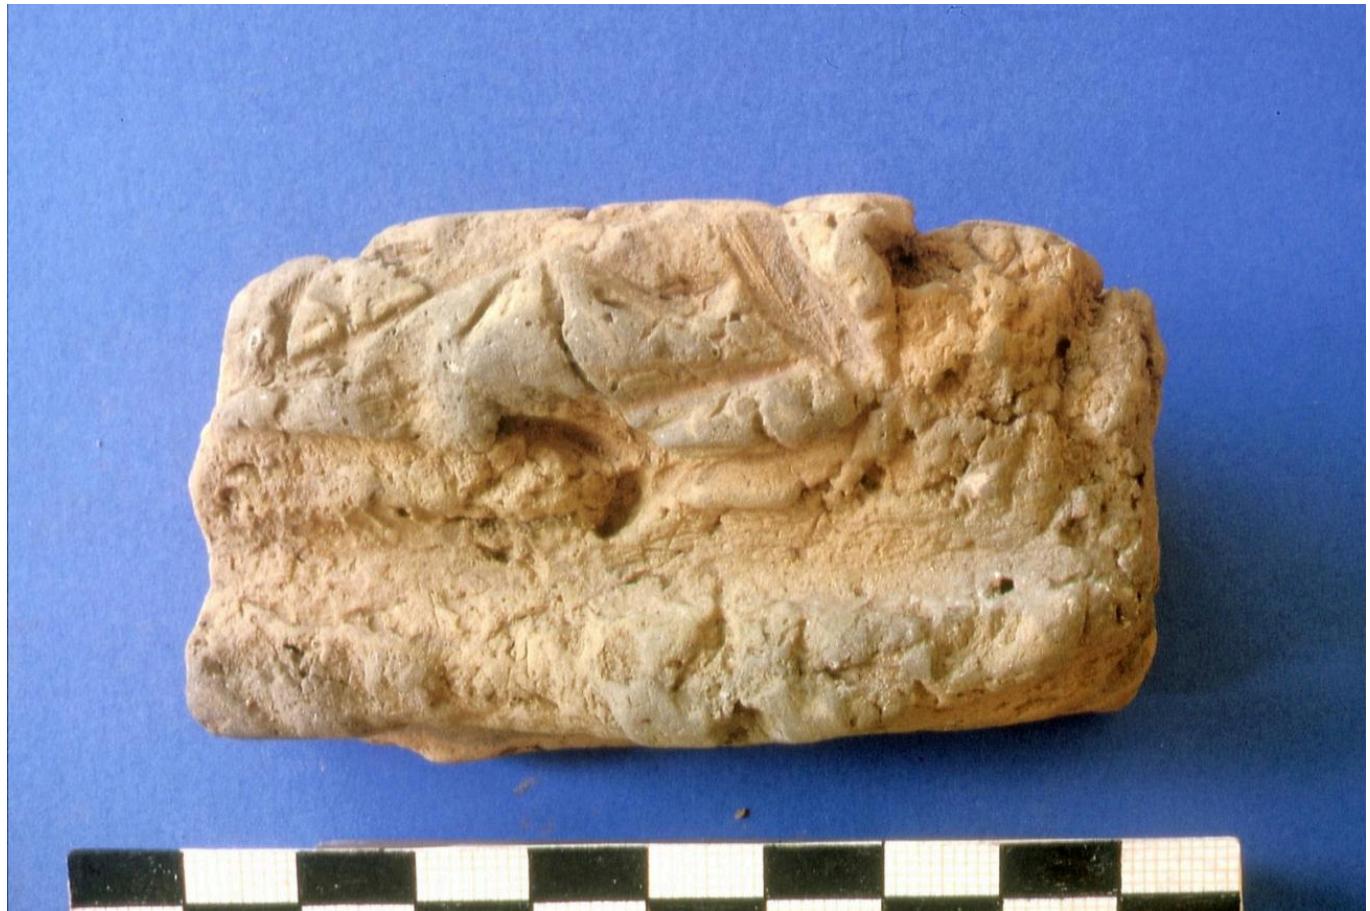
FIG 21D. BULGES AND IMPRINTS OF GRASS ON THE SIDE THAT IS ADJACENT TO THE GRASS FILLING.

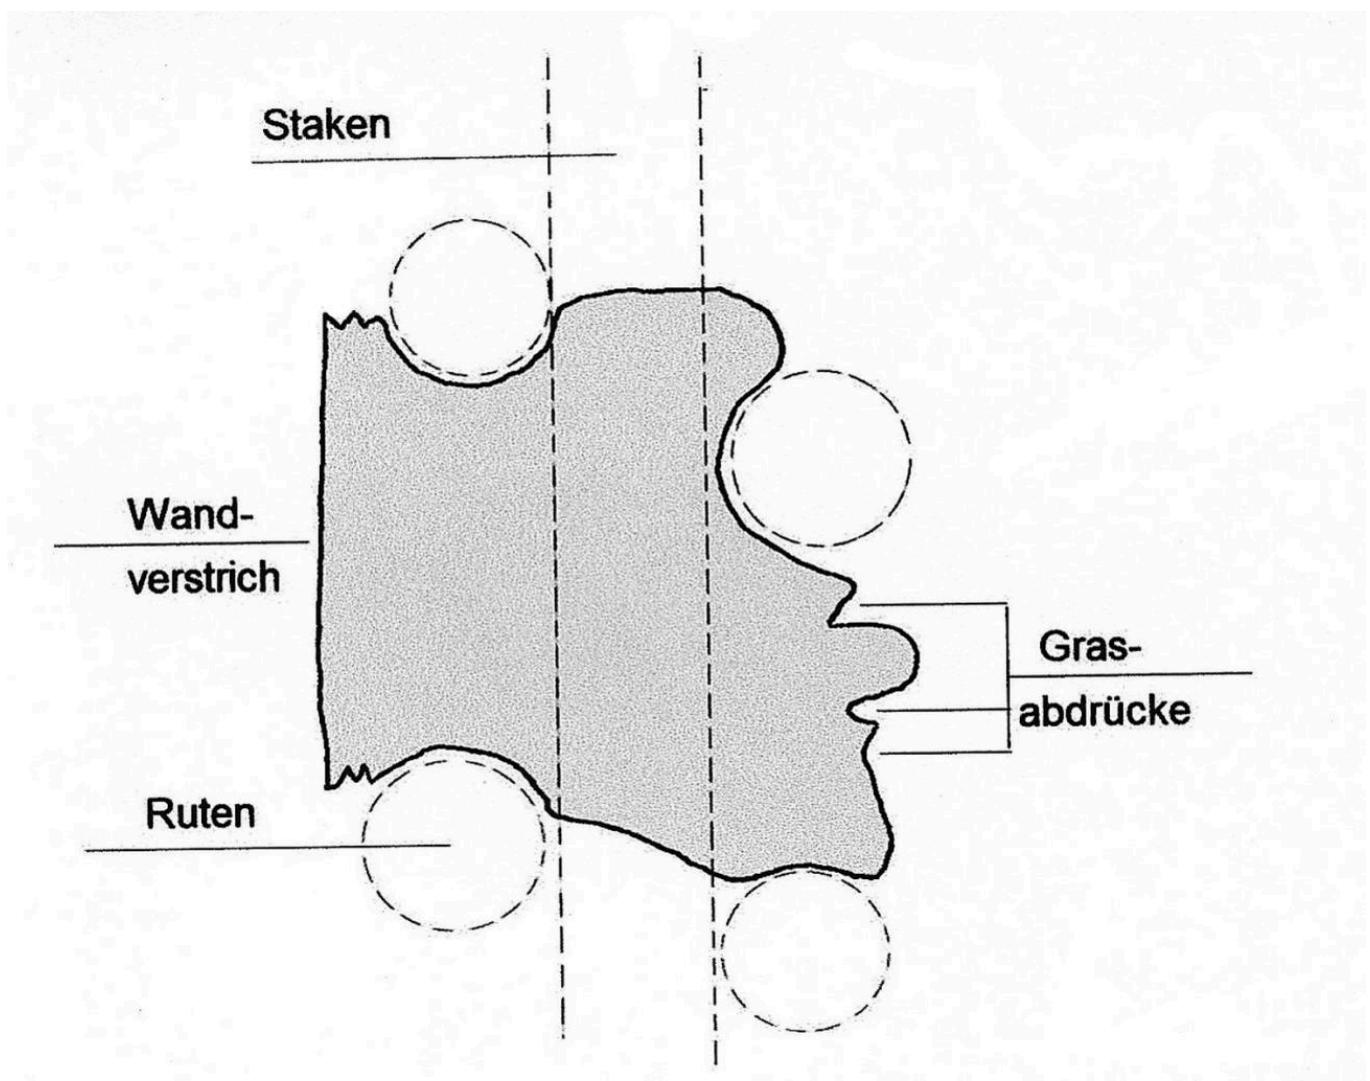
FIG 22. CROSS-SECTION THROUGH FRAGMENT ABB. 21, INV. 14

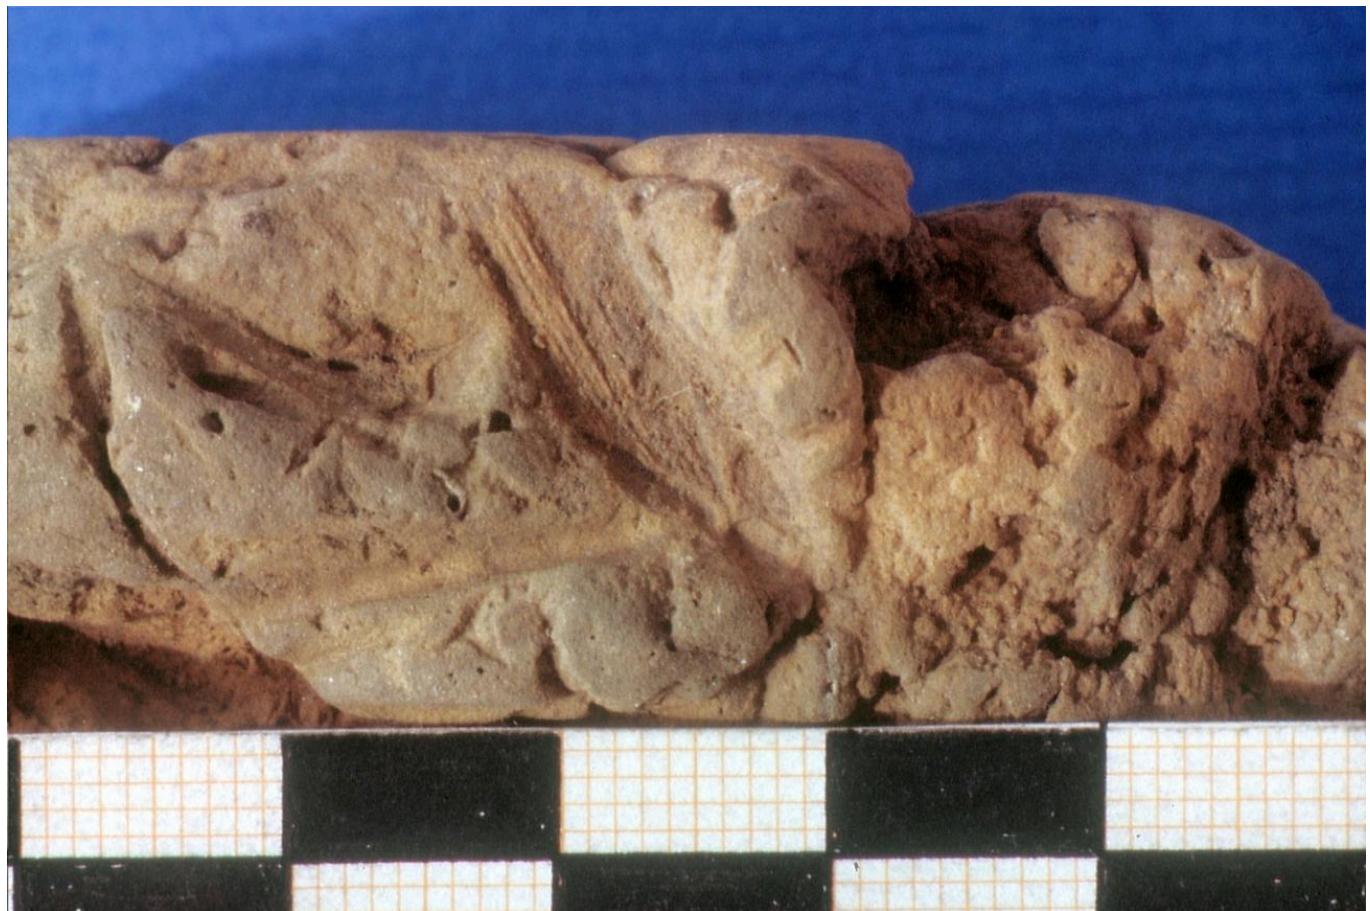
FIG 23. DETAIL FIG. 21D, ENLARGED IMPRINT OF A GRASS BLADE.

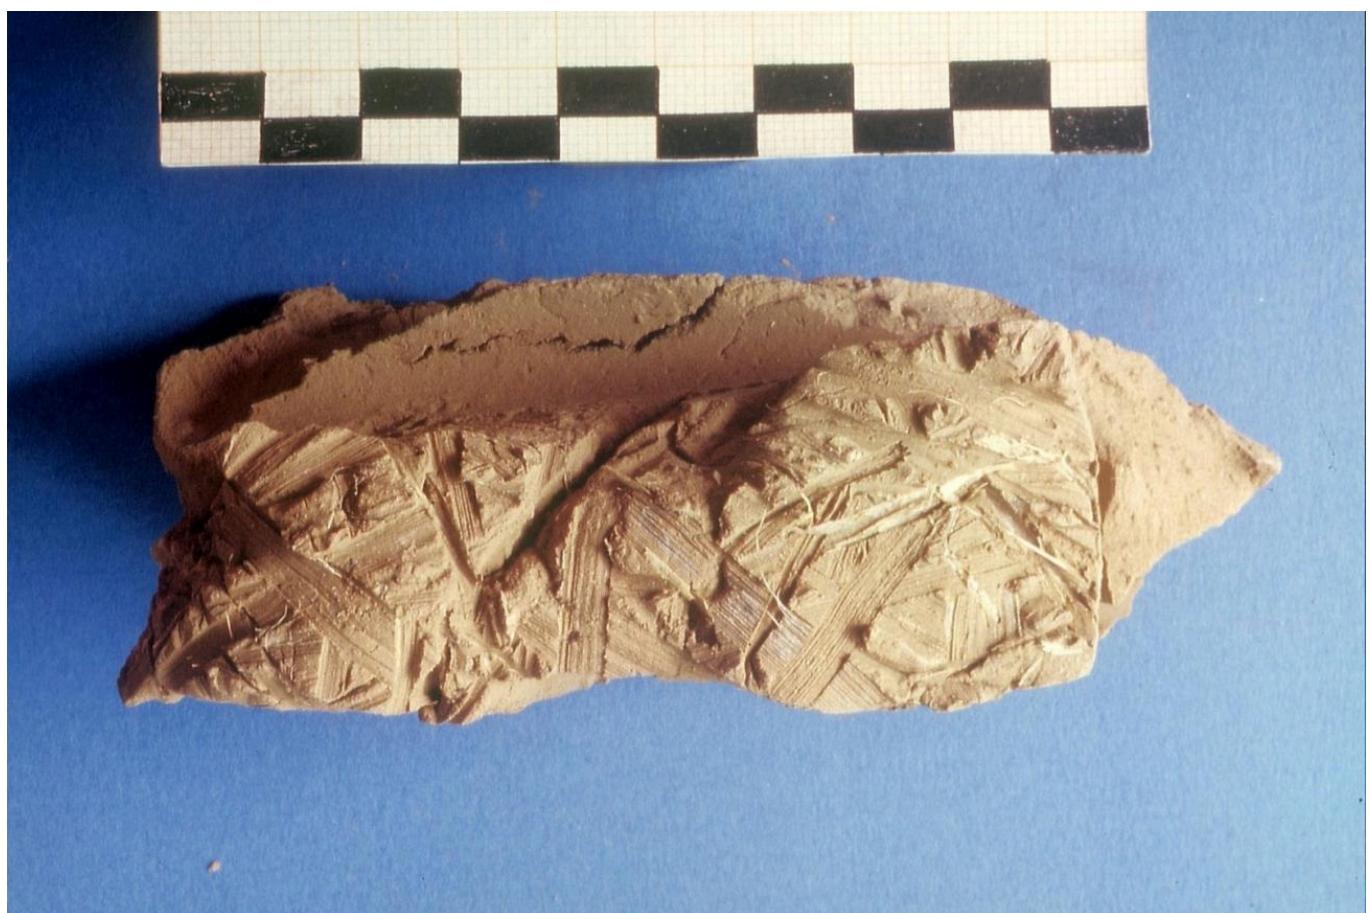
FIG 24. GRASS IMPRINTS OF THE RECONSTRUCTION. THEY ARE SIMILAR TO THOSE FROM THE BRONZE AGE.

In order to verify the described conclusions concerning the structures on the clay fragments, a double wattle was built using willow rods. It was filled with grass and the outside covered with moist clay. After drying, this clay showed the same structures as the excavated fragments. It showed the smoothed side as well as the same bark structures of the woven wattle we can see on the ancient fragments. In places where the clay squeezed through the rods there were also visible bulges (See Figure 25). On these bulges we can find grass imprints just like those on the Bronze Age clay. The number of the grass however imprints is very small. They could only come into existence in places where there was a certain distance between the horizontal rods. Here, where the clay could penetrate deeply inside and where the grass offered enough resistance, the imprinting lines could emerge.

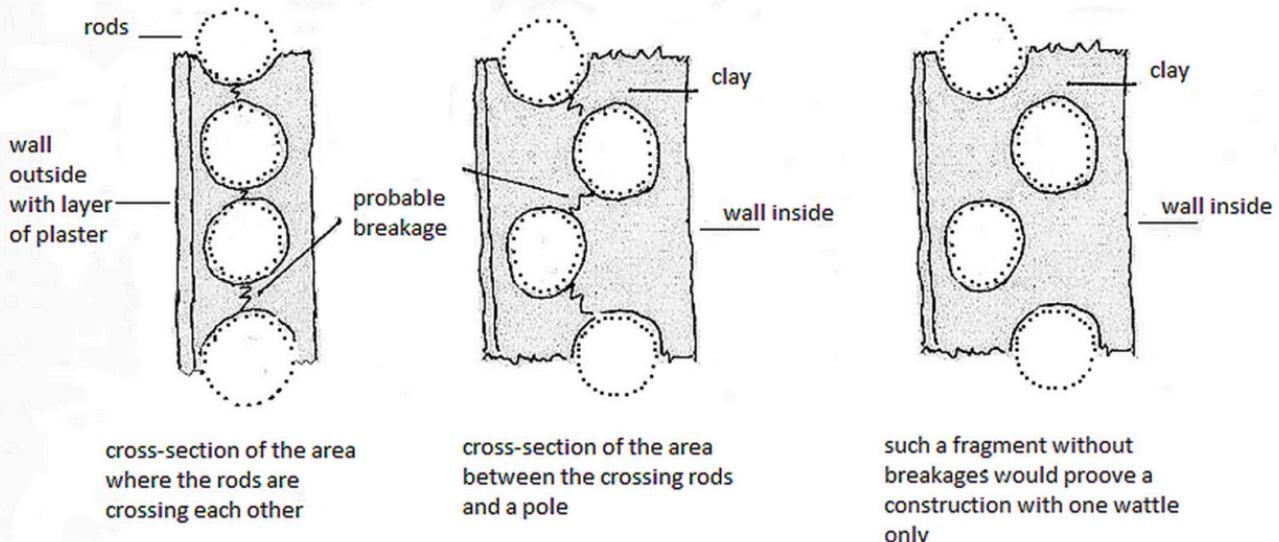
**Fragments from a wall consisting of one wattle**

FIG 25. CROSS SECTION OF FRAGMENTS FROM CONSTRUCTION WITH ONE WATTLE

Breakages of the clay near a rod can result from a two wattle construction as well as from a one wattle construction. A clear proof for a construction with one wattle would be a fragment that shows both smoothed outsides with the cavities of the rods in between. (See Figures 25 and 26)

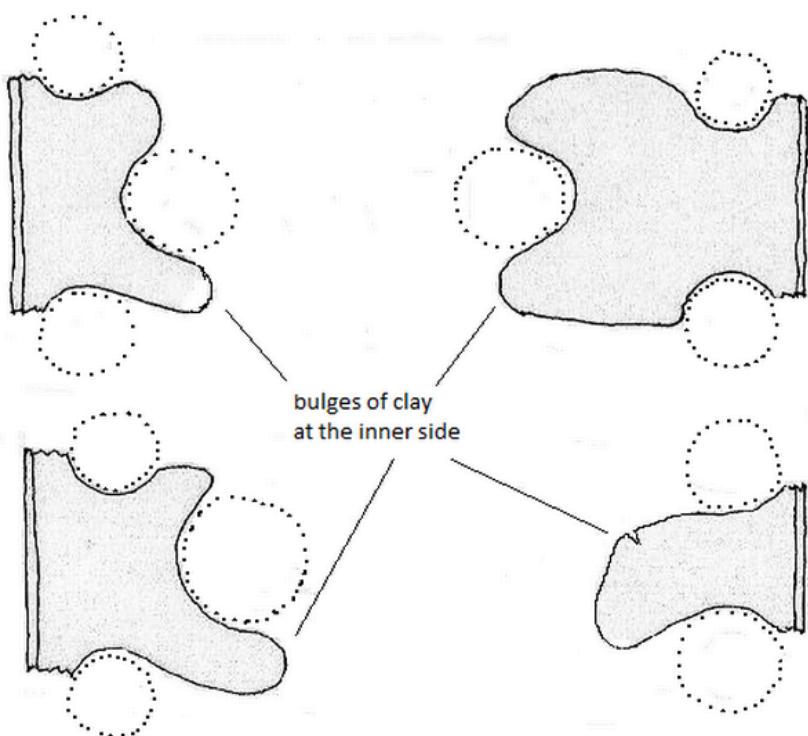
Fragments like those from only one wattle result from double wattles as well. But bulges at the inside indicate that the clay had no obstacle at the opposite side when it was thrown on or smoothed down. Even if they do not have imprints of grass, the bulges show that there was just the insulating air but no second layer of clay.

FIG 26. CROSS SECTION OF FRAGMENTS FROM CONSTRUCTION WITH TWO WATTLES

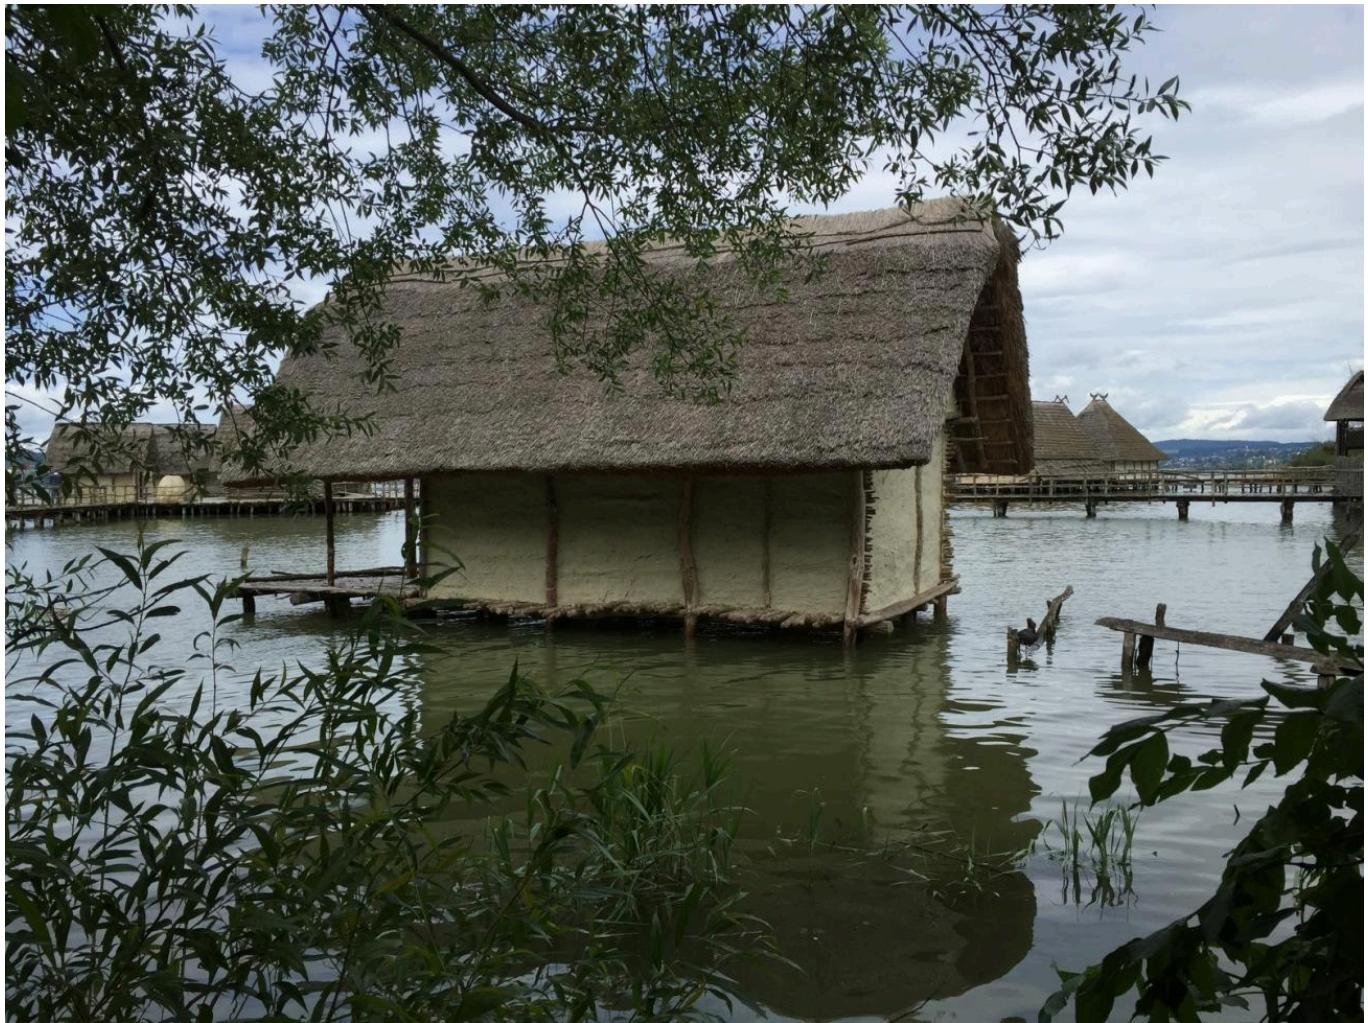
FIG 27. UNTERUHLDINGEN HORNSTAADHAUS

Settlements near the banks of rivers and lakes cannot really be compared to those in higher positions. One experiment is however impressive: The reconstructed lake dwellings (See Figure 27) in Unteruhldingen on Lake Constance were tested as a means of habitation. The experiment shows that the walls did not hold the heat well. They consisted of only one layer of parallel branches of 4-5 cm width, not woven. On both sides they were covered with a thin layer of clay (See Figure 28). It took a long time until the fire warmed up the interior of the hut. From about 9 p.m. the inside temperature started to sink, caused by the colder night temperatures outside. After 10 p.m. when the fire was extinguished the temperature sank rapidly (Kaus, Schöbel, Walter 1998/99).

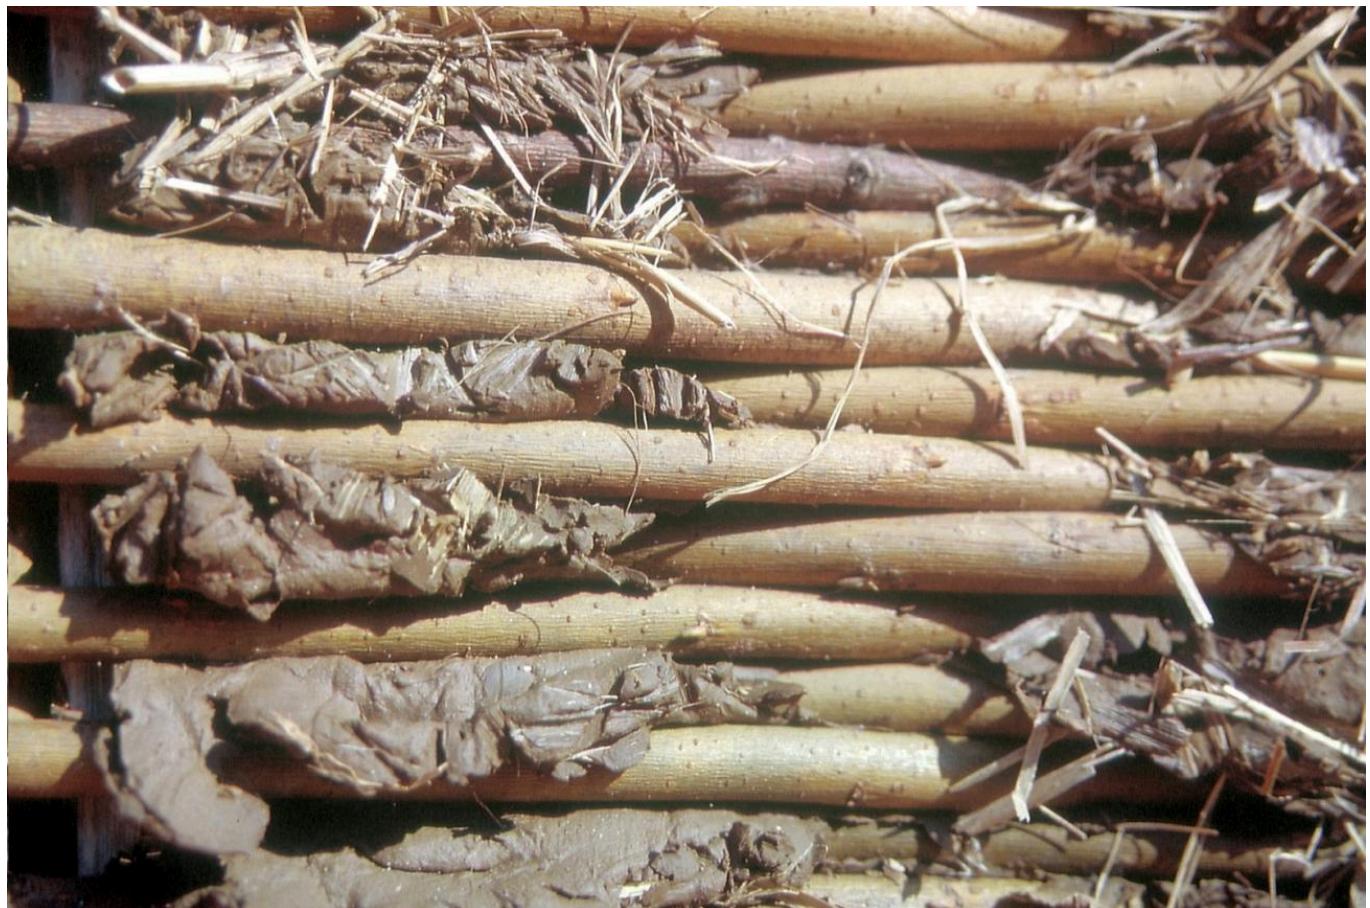
FIG 28. DETAIL OF THE INNER SIDE OF THE WATTLE. THE WET/MOIST CLAY IS THROWN ON FROM OUTSIDE AND SQUEEZED THROUGH THE GAPS BETWEEN THE RODS SO THAT THE GRASS BLADES ARE IMPRINTED ON THE CLAY.
