# Destruction Mechanisms of a Sunken Floored House

**This article describes observations on the burning down of a (re)constructed Iron Age house and follows the developing archaeological situation over the following months.**

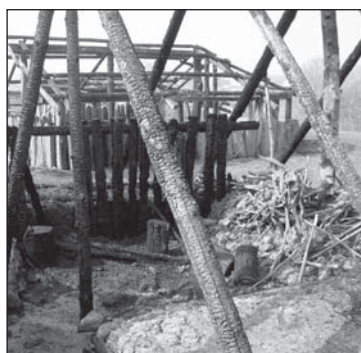
■ Fig. 1 Interior of the sunken house after the fire

After the fire a 30 cm thick layer of cinders from the burnt reed and wood covered the floor of the whole house and was spread in its vicinity to distance of about 0.5 m. After a month of rainy weather the layer had settled down to about half of its original thickness. At the end of the year before snowfall it was about 5 cm thick. Around the perimeter of the house the layer was covered with soil from its surroundings, mostly organic soil but also a sandy clay.

Lumps of daub were after the fire singed only on the surface to a

depth of 3-5 mm, of ochre-orange colour. Bigger bits of daub with a diameter of more than 5 mm had brown-black unfired centre. This contradicts the usual archaeological situation of homogeneously ochre coloured lumps of daub from infill or deposits in Celtic buildings. These therefore probably represent the remains of domed kilns and could be part of the infill of the structures after they were abandoned, mostly by natural erosion.

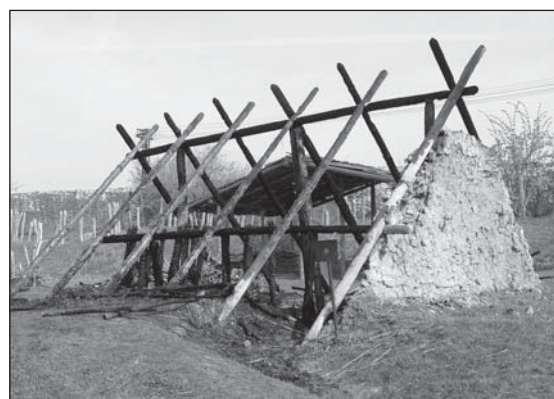
■ Fig. 2 After 45 minutes only a badly singed skeleton was left standing

At that time the roof had already burnt through and collapsed into the house. After approximately 45 min. only the load-bearing structure, badly singed, remained standing while the plank walls had mostly burnt through. Soon afterwards a fire crew arrived and put out the remaining fire. This account illustrates the easy and quick burning of Celtic buildings, whole villages or oppida.
