# Roar Ege: The Lifecycle of a Reconstructed Viking Ship

EXARC Journal Issue 2020/2 | Publication Date: 2020-05-25

Author(s): Triona Sørensen <sup>1</sup> ✉, Martin Rodevad Dael <sup>1</sup>

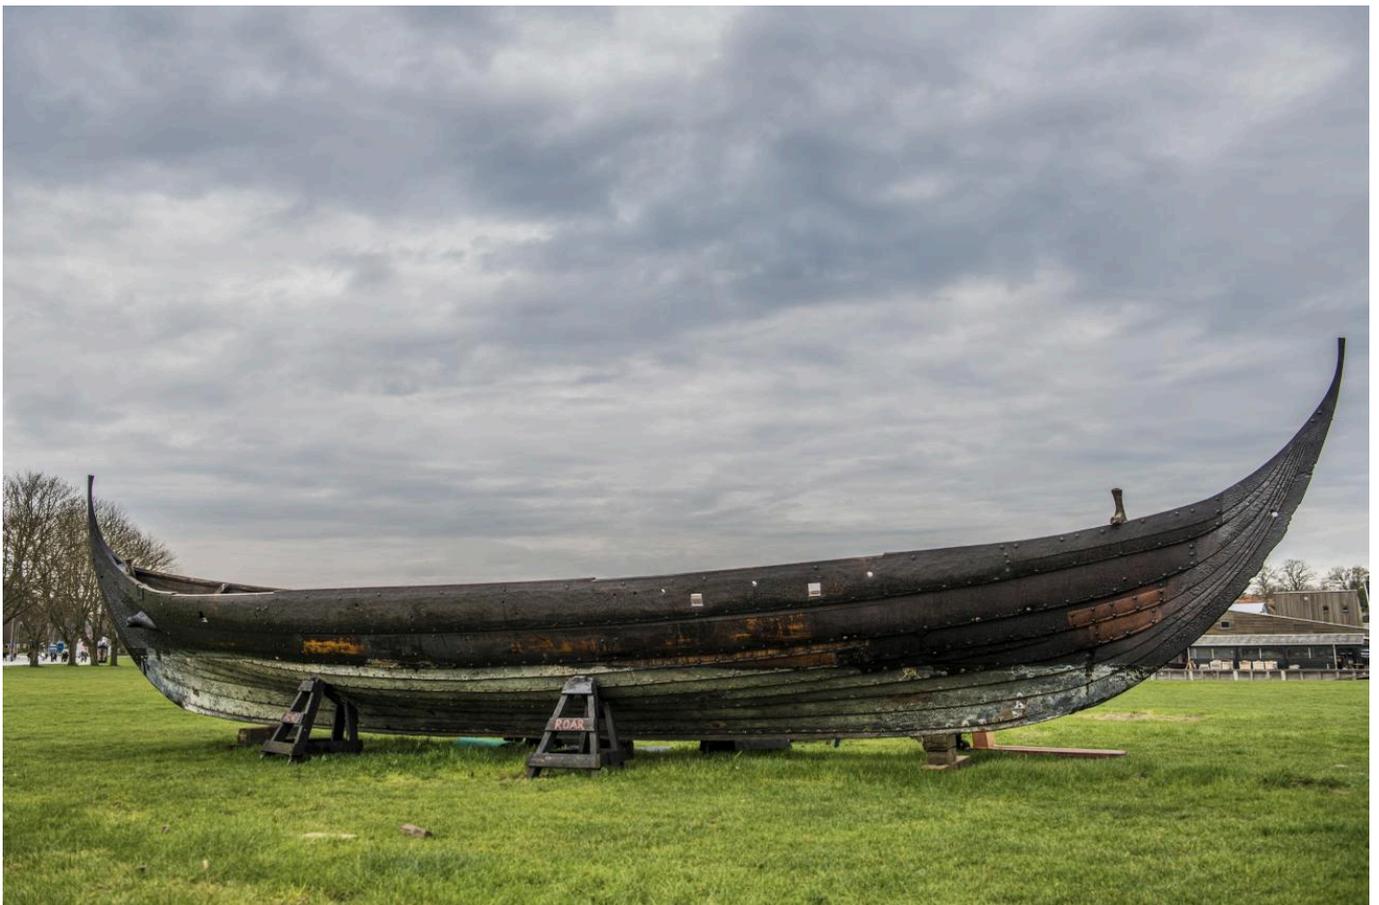
The last major repair to *Roar Ege* was carried out in 2014 and saw the replacement of the fifth and sixth strakes as well as several major internal components (See Figure 10). It had been hoped that this repair would keep *Roar Ege* on the water for another five to ten years but unfortunately, this was not to be the case. By 2015, the state of the hull had deteriorated significantly below the waterline. Considerable leaks appeared where rusting rivets began to

After much thought, it was decided in the spring of 2016 that *Roar Ege's* sailing days were over. The ship was 32 years old at this point and the first of our Skuldelev ship reconstructions to be retired from service (See Figure 11).

FIG 11. ROAR EGE WAS RETIRED PERMANENTLY ON LAND IN THE SPRING OF 2016. (PHOTO: WERNER KARRASCH. COPYRIGHT: VIKING SHIP MUSEUM IN ROSKILDE).
