Yeaving Reconsidered

EXARC Journal Issue 2015/2 | Publication Date: 2015-05-15

Author(s): J. T. Smith ¹ ✉

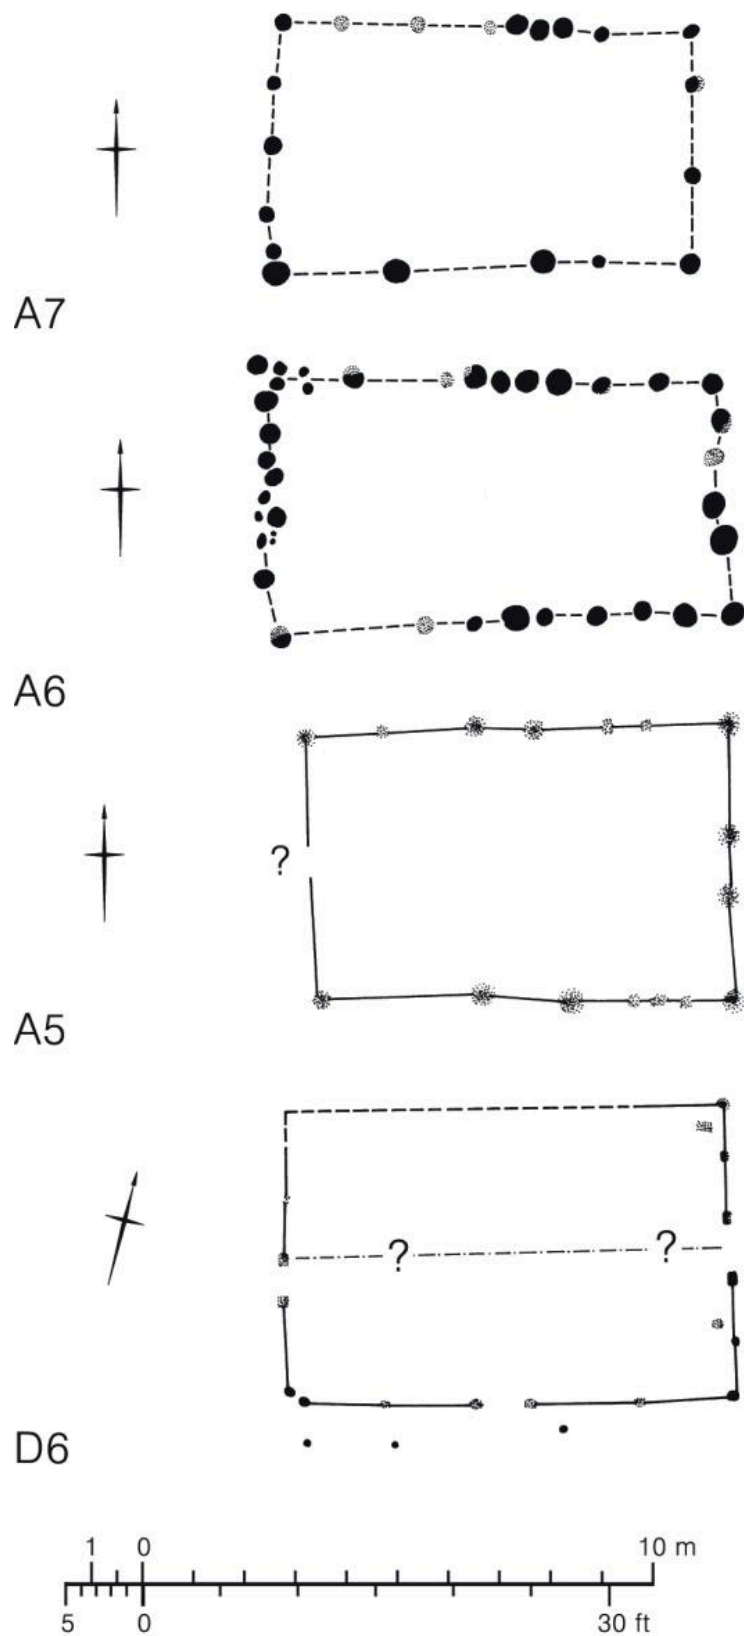
Fig 1 Buildings A5, A6, A7 and D6

FIG 1. BUILDINGS A5, A6, A7 AND D6

In the first post-Roman Phase I the two earliest buildings, **A7** replaced by **A6**, had walls built of large imperfectly aligned posts which are described as "post & panel (wattle & daub)" (Hope-Taylor 1977, SC; 63). That is impossible; the posts only make sense if they supported a thick clay wall upon which the roof structure stood or, more likely, into which it was embedded. This is a long-lived technique observable in masonry buildings well into the eighteenth century. The first advance in building construction came when **A6** was replaced by **A5** in which posts were set at varying intervals in a thin wall-line of wattle-and-daub (Hope-Taylor 1977, SC; 63). This created quite different problems of roof carpentry. Since the two buildings were of the same size the advantages sought from the change may have been economy of timber and the greater speed or durability of construction. Of the same type and little larger was D6: both it and A5 display a notable characteristic which was to persist at Yeavinger in many buildings, the presence of two opposite pairs of doorways, two in the middle of the long walls and two in the end walls; a contrast with the wall construction, which found few successors.

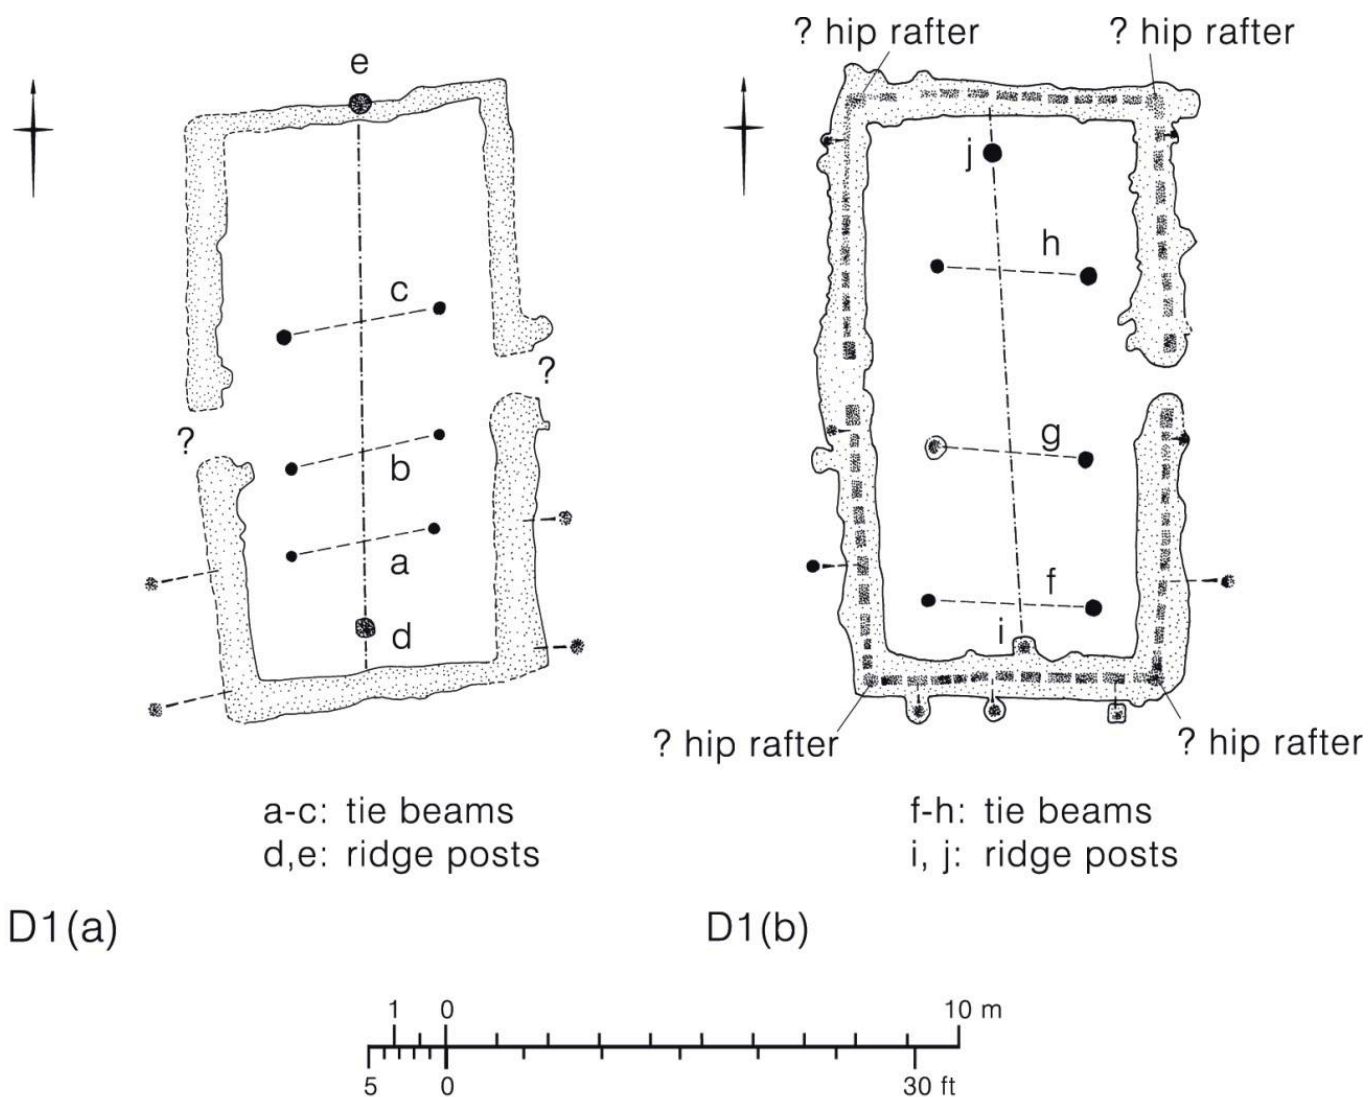
Fig 2 Buildings D1(a) and D1(b)

FIG 2. BUILDINGS D1(A) AND D1(B)

The first of the three, **D1(a)**, is dismissed as incompetently built because, "though clearly intended to be rectangular in plan, [it] was rhomboidal" (Hope-Taylor 1977, 95-96)—a large assumption. Its long walls are very slightly bowed and the roof was supported by a quasi-aisled structure of paired posts carrying ridge-posts to provide longitudinal rigidity. The three pairs are set out with sufficient care to be more or less parallel with the gable-end walls and each was joined by a tie-beam upon which, it can be inferred, stood a king-post supporting the ridge-beam. Sufficient care was taken in setting out the posts so that the king-post, set in the middle of the tie-beam, could carry a perfectly straight ridge-piece—something rarer at Yeavinger than might be expected. How the king-post was joined to the tie-beam is hard to guess—perhaps by a simple saddle-like joint, slotted over the beam, especially if a root stock were available. All the lateral support the king-post needed was provided by long rafters which reached from the apex and either rested on the tie-beam or were cut into the end of it; they terminated on the timber walls and were buttressed externally. It may be noted that the two rows of posts are not parallel, they are slightly wider apart at the north end where an approximately square space is free of posts. This is a feature of some other buildings but in this small one the unsupported length of the ridge beam is only 4m and presented no problem. To finish the roof support the rafters bore laths carrying the cladding. But what form did the cladding take? It is plausible to assume the cladding was heavier than that used in earlier buildings because the trenches dug for the long walls were deeper than those of Phase I, but were the more solid walls needed to resist outward thrust or do they merely represent improved durability and better living conditions? In the absence of direct evidence an answer can perhaps be extrapolated after looking at subsequent development.

D1(b) is generally similar. The well defined individual wall timbers, "merely packed together in palisade fashion" (Hope-Taylor 1977, 96), are not set out in straight lines and have, as the plan shows, small gaps between them which were presumably plugged with clay. Despite the claim that "the most obvious imperfections of its predecessor were rectified" (Hope-Taylor 1977, 96), the spacing of its post-pairs still appears erratic, presumably because it did not matter. They divide the length of the building into a very short south bay, a medium bay, a long bay and a medium bay, the last being a shortening compared with D1(a), produced by bringing

the terminal ridge-post inside. Its new position suggests the possibility of a hipped roof. At the south end the closeness of the ridge-post to the wall may preclude a hipped gable unless it were steeper than anything in surviving buildings, but the alternatives are also problematic. A palisade wall could be carried up to meet the roofline but would demand prefabrication to ensure that succeeding planks were cut precisely enough to make the exercise worthwhile. A third possibility is that the gable end was of different construction from the wall, perhaps of clay on a wattle base rising to a pair of rafters above the wall, themselves stabilised by extended roofing laths. As for the paired posts, since they are not equidistant from the long walls it follows that they did not carry a specific proportion of the roof load, unlike those in Romano-British and medieval aisled buildings in which the precisely set-out internal structure supports half or somewhat more of the total; and the external posts (Hope-Taylor 1977, SC) do not relate closely to them. Continuing the assumption in D1(a) that the tie-beams carried king-posts at the logical point, in the middle, the ridge-beam cannot have been straight; a slight skewing appears at the north pair, perhaps to avoid putting the beam over the fire—and however odd this may look in orthodox structural terms this characteristic can be construed to occur in other buildings. The alternative, that some or all of the king-posts were placed away from the middle of the tie-beam, implies irrationality on the part of the carpenters. Lengthwise rigidity evidently required some improvement but, curiously, three buttress posts at the south end bear no relation to the roof timbers and were perhaps intended to check any southward leaning in the end wall.

D1(b) was innovative in three respects. Palisade walls with quite closely fitting timbers became the norm for a long time: so did the closeness of a post-pair, a ridge-post and an end wall, probably to avoid any longitudinal roof thrust on the end wall. The third, setting the ridge-posts off the long axis of the building, is an emphatic demonstration of the skewed ridge-piece observed in D1(a).

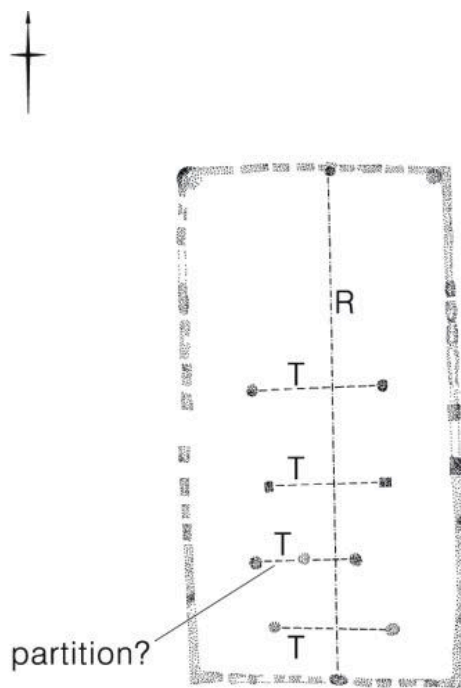
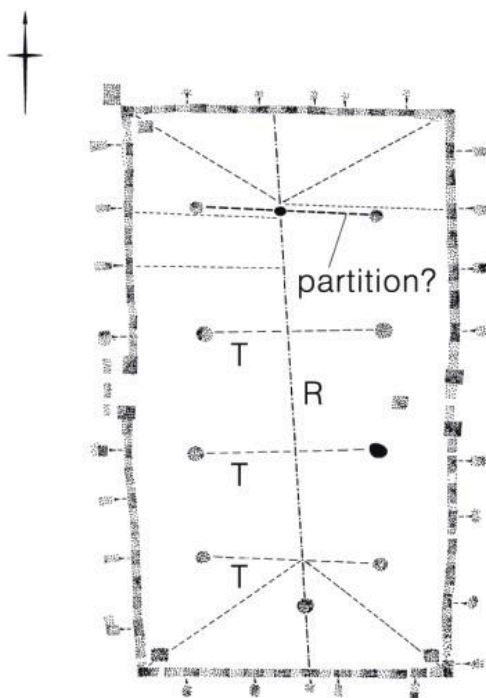
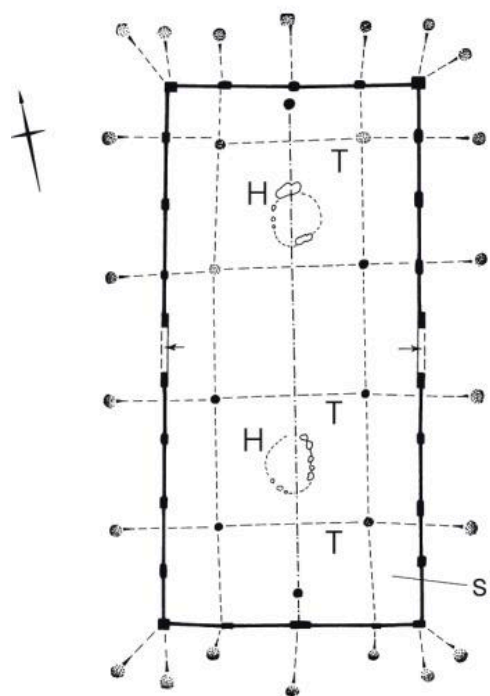
Fig 3 Buildings D2(a), D2(b) and D3

R: ridge beam
T: tie beam
H: hearth

FIG 3. BUILDINGS D2(A), D2(B) AND D3

D2 must surely provide the only instance of a building whose second phase is alleged to encapsulate the still-standing first. D2(b) "was built as a massive shell around D2(a)" (Hope-Taylor 1977, 158); "there was striking evidence that it had been demolished after devastation by a fire...and the timbers of ...D2(a) were certainly removed at the same time as those of its 'successor' " (Hope-Taylor 1977, 97), yet "there was no evidence whatsoever to suggest that D2(a) had ever been damaged by fire" (ibid); in other words, D2(a) remained undamaged by a fire that devastated its shell. This contradiction will be set aside for the moment to consider how the stability of D2(a) could be maintained while digging trenches for D2(b) very close to its walls and then erecting new walls which necessitated removal of the existing buttresses. Hope-Taylor's Plate 81, adduced as showing this process, suggests the contrary. Was the roof of D2(a) dismantled prior to their removal? It can hardly have remained because an enclosing structure would necessarily have been quite unusually tall, so were just the old walls left standing? Given that some at least of the post-pairs were replaced, the old roof must surely have been renewed completely—so what possible reason can there have been to leave

D2(a), which was "the exact counterpart of...D1(b) in size, form and orientation", (Hope-Taylor 1977, 97) had walls of heavy squared timbers and, "just inside the middle point of each end-wall" but not precisely indicated, was a ridge-post (*loc cit*); which post is meant at the north end is not obvious. Four post-pairs, two with spans of 8 ft (2.4 m; south) and two of 9 ft (2.7 m; north), and one or two ridge-posts do not differ significantly from those in D1(b). In **D2(b)** the post-pairs provide for a slightly skewed ridge-piece in the northern half of a roof that seems to have prompted concern for its lengthwise stability to the extent of needing four heavy inclined buttress posts at each end. It is not obvious why these and a 'regular series of smaller buttress-posts' lining the long walls should have been necessary unless they were required to resist the thrust of a much heavier roof cladding than was used hitherto. The number and position of the external posts can be judged fairly accurately, although if the post-pairs are correctly identified, corresponding buttress-posts or rafter ends are hard to find. Two groups each of four pairs spaced a little under 5 ft apart flank the 10 ft space between the opposite doorways, one pair standing close to each gable end, the others corresponding fairly closely to the pairs of internal posts and all buttressing the walls at the points where the rafters rested, as in D1(b). The gable end buttresses, more pronounced at the north end, are not so carefully positioned and may have provided general support. But the most important difference between the alleged two buildings is that D1(a) has shallow wall trenches and D1(b) deep ones (Hope-Taylor 1977, SC).

For most of Yeavinger's history palisade walls were the dominant and almost exclusive technique, with one strikingly well-built exception. **D3**, approximately coeval with D2(a), is one of the best-preserved buildings and the only to have a sunken floor apart from the gruebenhaus (sunk-featured building) C1 (which offers no meaningful comparison) and it is unfortunate that the probable depth of the floor from the contemporary ground-level is nowhere stated; the long section (Hope-Taylor 1977, Fig. 56) suggests about 3 ft. It was unique among the larger buildings in having heavy posts with panels probably of wattle-work (*ibid*, SC) and resembles D1 and D2 in its combination of paired posts, buttress-posts and ridge-posts, even to the spacing of the latter. It differs from them in the superior precision of its setting-out, so that the three bays formed by the paired posts are equal and the west wall has a regular rhythm from north to south. Because D3 has a quite wide middle span relative to the overall width (1:1.7) and external post-holes matching the well-aligned paired posts it can be inferred that this innovation was intended to relieve the walls of some of the roof weight. For the first time the post-pairs are so well aligned as to make the use of lengthwise plates conceivable, carried at the ends of the tie-beams, not on the posts; a structural procedure the more probable because the gable-end walls have suitably placed posts reinforced by

buttresses on which the plates could terminate. Any skewing of the ridge-beam is hardly perceptible and a ridge-post close to each gable-end implies a king-post on each post-pair.

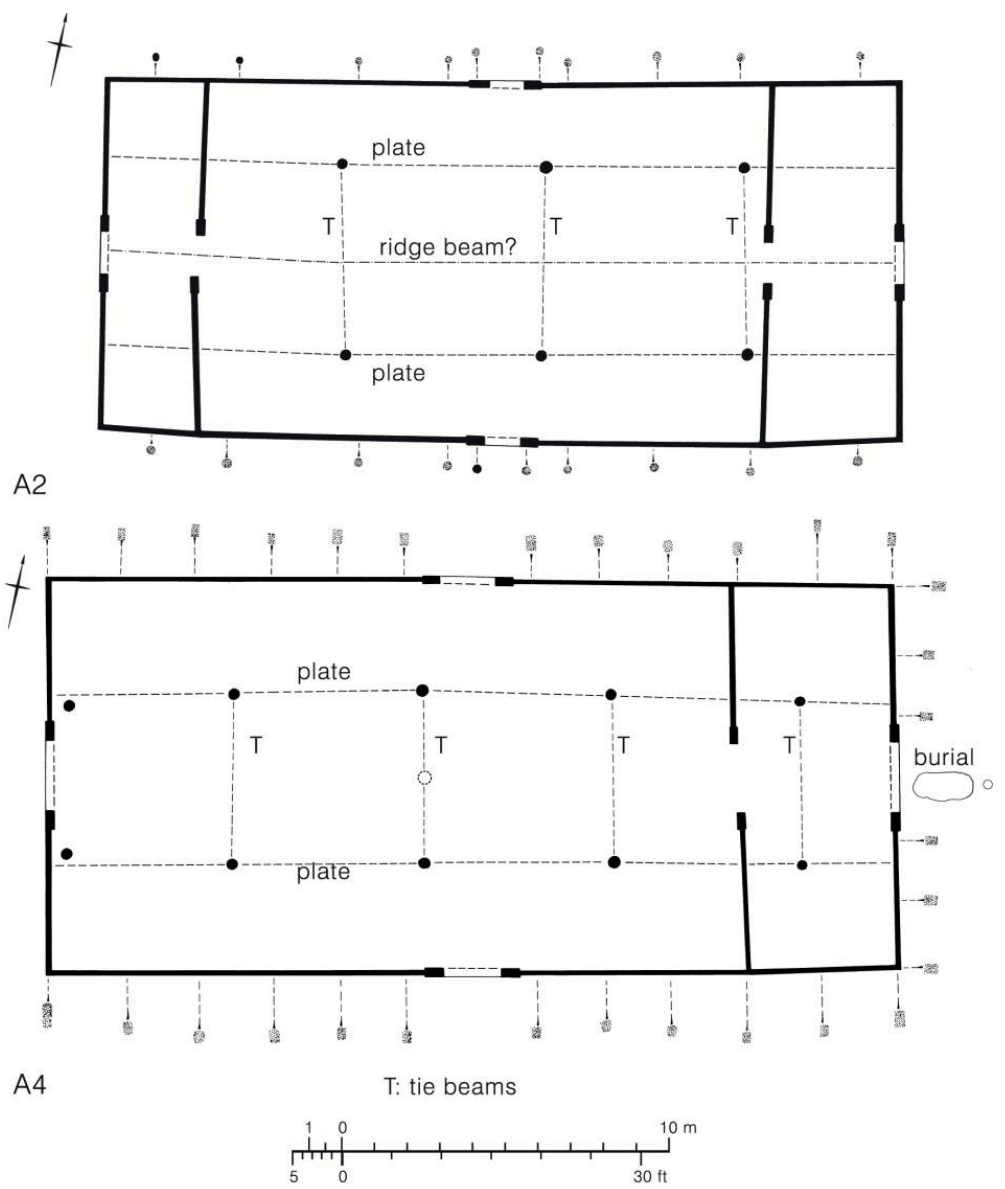
Fig 4 Buildings A2 and A4

FIG 4. BUILDINGS A2 AND A4

A2 was "of massive construction", exemplified principally by the long walls set in trenches "on average 3 feet deep" and the end-wall which were as much as 6 inches deeper (Hope-Taylor 1977, 51); evidently a great roof weight was expected to thrust both laterally and longitudinally. That condition governed the design of the great medieval barns too but, given the prefabrication of such structures by the twelfth century, it was possible to put half the roof weight on to the internal posts of the aisled structure. Without prefabrication and its complex joints the roof structure above the nave (Mittelschiff) could not be built separately and consequently that part of the roof weight had to be transmitted to the outer walls as well as the rest: the whole of what was clearly a great load rested on deeply founded walls. Even

All the more surprising, then, that it was supported internally by only six posts apparently some 2ft in diameter (Hope-Taylor 1977, 58) and that the two middle bays are 19-20 ft (5.7-6 m) long—an impossible unsupported length for a plate or purlin under heavy loading even supposing it were of large scantling and playing-card section like the wall-plates at Maulbronn, Germany (Binding 1991, 31). Another unexpected feature is the lack of a post-pair near the west gable end. This is the more surprising as there are no buttress-posts at the end of a west bay no less than 23 ft (6.9 m) long. The initial solution to these problems seems to be that each post-pair carried a king-post and the ridge-beam, from which long rafters extended to the wall, ending, probably in a birds-mouth joint on the arris of a wall-post; some such joint was a more feasible way of preventing outward thrust than one involving attachment to the wall top. Setting aside for the moment the precise form of the quasi-aisled structure, a roof structure of uniform pitch capable of delivering the entire weight of the cladding to the walls has to be envisaged. Before going into detail on these points the limitations imposed by the handling of long, heavy timbers need to be assessed. Hope-Taylor does not discuss how, for example a tie-beam would have been placed on the tall posts of A4 (Hope-Taylor 1977, Fig. 59). It would seem to need some kind of crane and elsewhere the use of block-and-tackle is suggested for dealing with wall timbers (Hope-Taylor 1977, Fig.11 and 40), but bearing in mind the difficulty of putting in place whatever enormously heavy roof cladding A2 had, a reconstruction should envisage a roof of rather low pitch supported by posts far shorter than those conveniently shrouded in smoke in Hope-Taylor's drawing. But what kind of cladding was so weighty as to produce such a solution to the problem of thrust? Wooden shingles are heavy but demand a system of rafters supported mid-length by a purlin or plate and supporting the many cladding laths that are the accompaniment of the aisled construction already ruled out. An equally heavy roof might result from using bay-length boards, each of which, by abutting others end-to-end, would function as a purlin if secured to a rafter of flat plank-like section, thus achieving lengthwise stability. At the foot of the rafters the last board may have covered the wall top if that were thought necessary.

Improved solutions to some of the structural problems presented by A2 are found in the marginally wider **A4**. It is reasonable to infer that the span of the paired posts was reduced because of bending in the tie-beams; to remedy the same weakness arising lengthwise, an unequal bay system was replaced by four equal and shorter bays extending nearly the full length of the building; there was a reversion to the practice in D3 in placing one post-pair near the east wall. What was gained by this is not obvious; given the apparent wish to have a long impressive space, a short end bay coupled with the end buttresses may have compensated for stability lost by the absence of buttresses at the west end. The smaller axial post in the middle of the hall was not structural; its purpose is not considered (Hope-Taylor 1977, 62). This solution explains why the gable-end walls lack larger posts corresponding to the free-standing post-pairs—there was no plate to support and the lengthwise cladding boards were secured in some way to the wall-top. There remains the question of how watertight such a boarded roof might be. A tongue-and-groove joint is the obvious way of preventing water seepage but is doubtful in the absence of such jointing in the wall timbers; that leaves either some kind of seal where the boards abutted or an outer cladding—a living roof of sods of turf if the pitch were suitable—clearly weight was no object, or perhaps simply moss. But what was the pitch? Bearing in mind the difficulty of handling long heavy timbers, with or without the use of block-and-tackle, a relatively low pitch would seem desirable, and the weather-resistant properties of a boarded roof would make it possible.

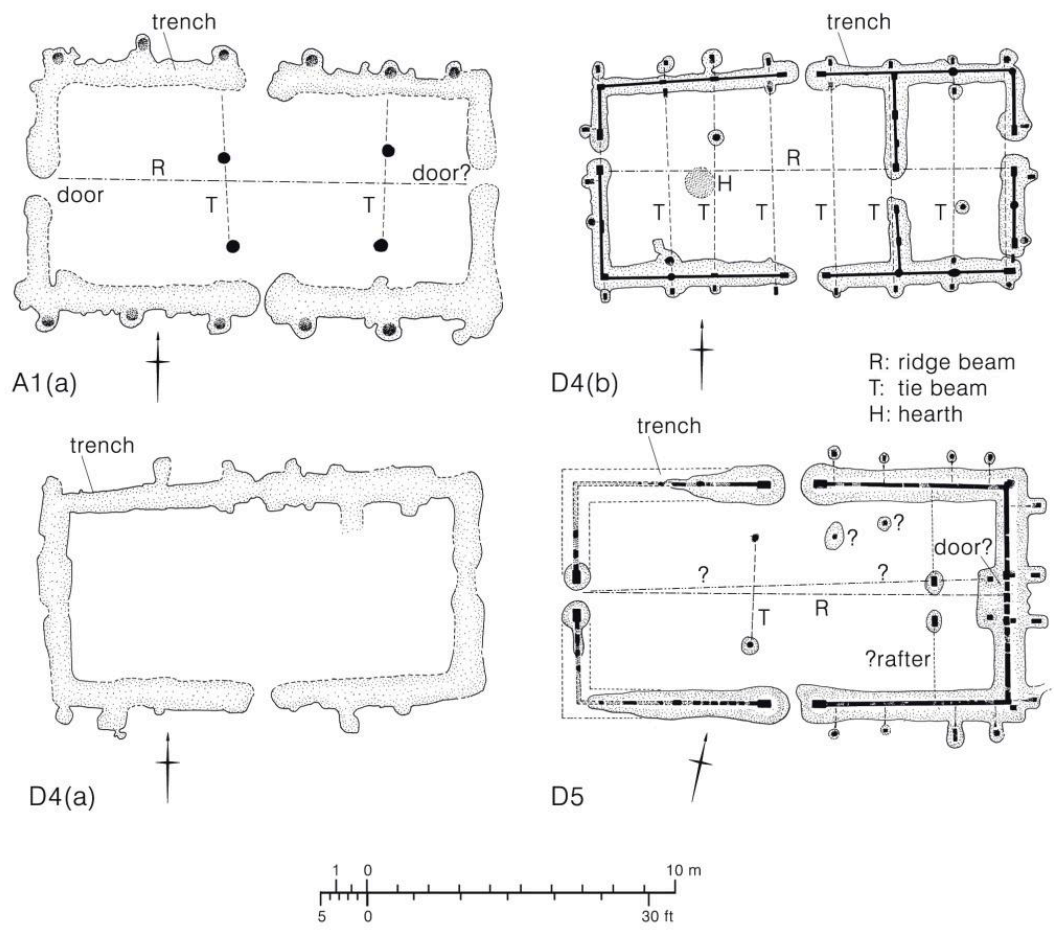
Fig 5 Buildings A1(a), D4(a), D4(b) and D5

FIG 5. BUILDINGS A1(A), D4(B) AND D5

D4(a), which "was in nearly all respects similar to...A1(a)" (Hope-Taylor 1977, 117), has something in common with it if indeed it did have paired roof posts (Hope-Taylor 1977, SC), although there is no sign of them on the plan, and since its successor D4(b) is not said to have had them, both are more likely to represent a reversion to monospan construction not seen since Phase I. D4(a), also with palisaded walls in deep trenches, was apparently an undivided open hall with doorways in the middle of the end walls.

D4(b), of the same size as its predecessor, displays interesting innovations in both plan and construction. About one third of the hall is partitioned off at the west end; at the end opposite doorways are moved off the long axis and the partition doorway is staggered. Hope-Taylor pointed out that the asymmetrical position of the west doorway accords well with the site of the hearth; presumably the east doorway was moved similarly to avoid alignment with that in the partition. The walls are of medium, plank-like timbers in "deep trenches" (Hope-Taylor 1977, SC) of unstated depth, and the roof construction, about which nothing is said, is problematic: its principal traces are three clear post settings, two at the west end, one at the east, and each of three posts - one somewhat larger than its fellows in the deep wall trench, one inside and one outside of it. Adding to them three virtually certain intermediate settings that lack signs of a south inside post and another one at the partition, together they provide for six close-spaced roof frames in a roof of seven bays; a clear solution but for the unsettling presence of one major post-hole towards the north side of the hall. It looks like a ridge-post so placed to carry the ridge-piece away from the hearth - just what was achieved in D2(a) by different means, but hard to incorporate in a succession of roof frames.

Not all buildings of this phase were monospan. **D5** presents a contrast in having a pair of posts west of the middle doorways and one post east of them to hint at another pair, forming a bay about 10 ft (3 m) long and a somewhat longer one (14 ft; 4.2 m) at the east end. Some kind of support must have been required in the remaining length of the building, where ploughing had destroyed the evidence. What remains points to a king-post and ridge-beam roof.

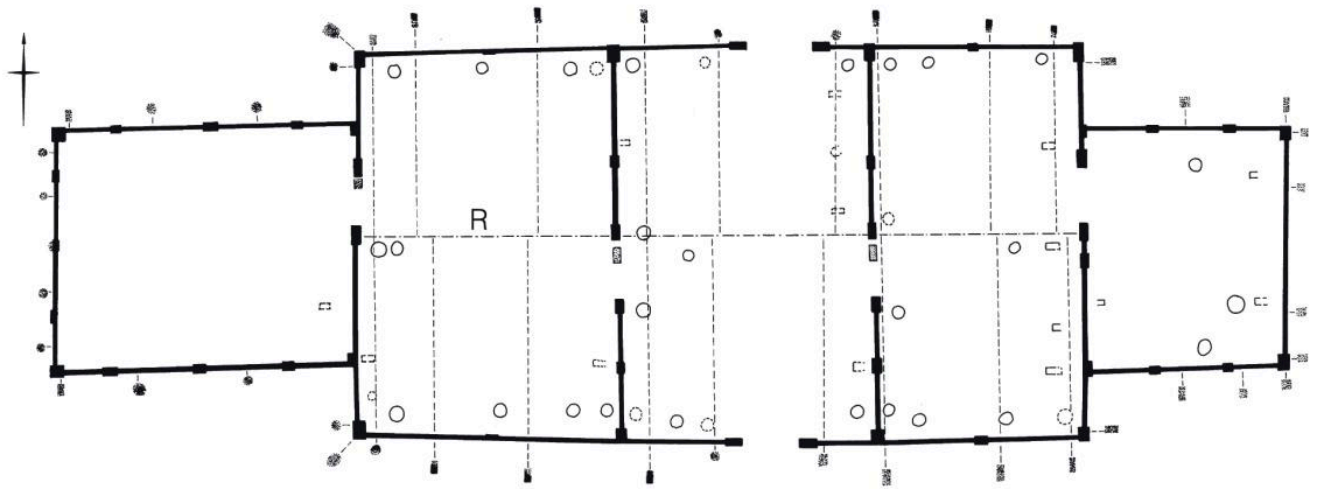
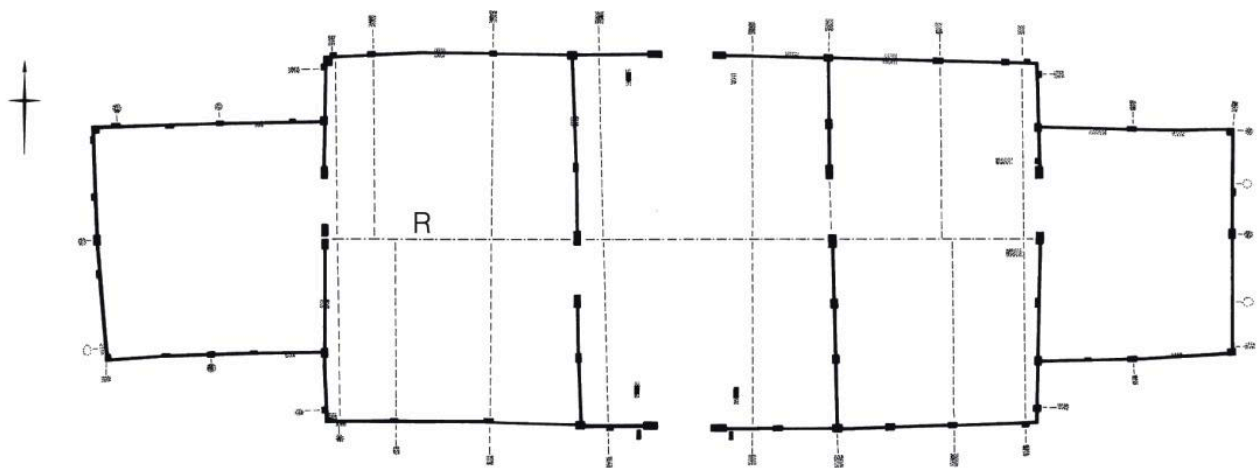
Fig 6 Buildings A3(a)and A3(b)

R: ridge beam

FIG 6. BUILDINGS A3(A) AND A3(B)

In the two latest phases when the administrative function of Yeavinger was diminished a great hall was replaced by what is misleadingly called that but is really the Great House, **A3(a)**

Annexes are the most striking new departure in A3(a) but they are important as a social phenomenon rather than structurally. Straight walls were acceptable, acting as buttresses to the main block to which, as the posts at the points of junction suggest, they may have been linked by a timber jointed to them in some rudimentary form. The larger annexe to the west, some 20 ft (6 m) wide, is at or close to the maximum possible span without internal posts.

A3(a) was succeeded in Phase V by **A3(b)** which differed only in detail though it was dismissed in slighting terms: "Viewed as a simple plank construction, A3(b) appears to have been remarkably flimsy...a half-hearted expedient: a wooden shell actually and visibly solidified by a plastering of daub..."(Hope-Taylor 1977, p 55). That is to judge the building by its least important element; structurally, it was probably as sound as A4. The walls were of medium-sized upright planks at intervals showing signs of the "addition or partial substitution" of horizontal clinch-built planks (Hope-Taylor 1977, 149); a row of three door-jambs are aligned on the long axis as if extended upwards to act as ridge-posts; improbable though the required length of timber may be, it is hard to see any other purpose in their siting.

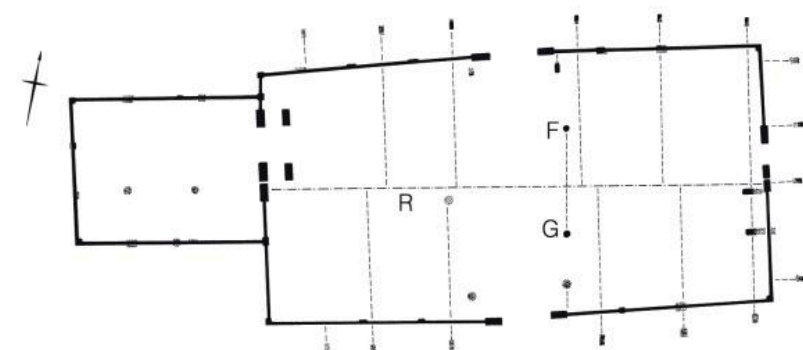
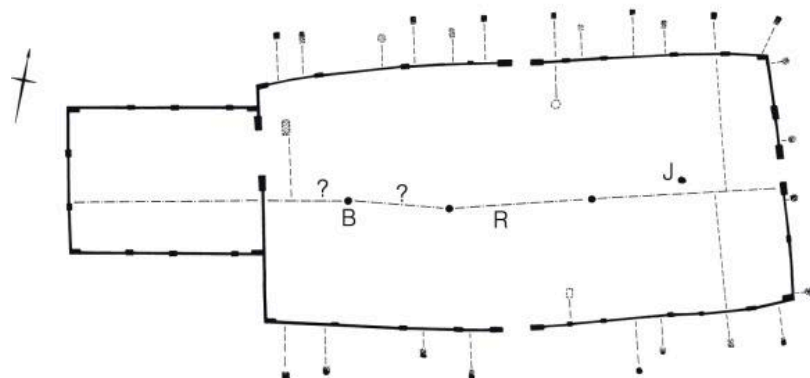
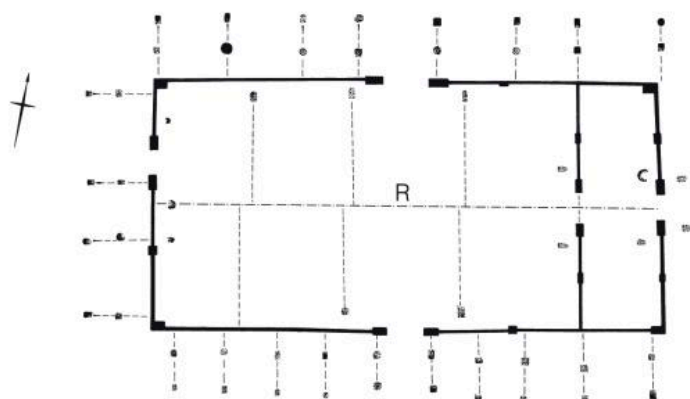
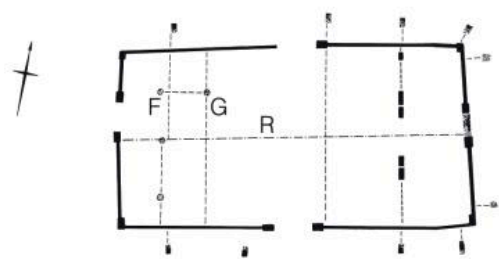
Fig 7 Buildings C4(a), C4(b), C3 and C2

C4(a) R: ridge beam F, G: post pair

C4(b) R: ridge beam B, J: posts

C3 R: ridge beam

C2 R: ridge beam F, G: posts

FIG 7. BUILDINGS C4(A), C4(B), C3 AND C2

A4 was the apogee of building construction at Yeavinger; only one other building, **C3**, was governed in its design by the aim of transmitting the roof load to the long walls or outside, and it must be admitted at the outset that no really satisfactory reconstruction can be devised. The essential facts are that it has no internal posts; the wall timbers were about 11 inches wide and 4 inches thick, set in trenches at most 5ft deep (Hope-Taylor 1977, Fig. 40, 6,7); and two rows of close-spaced external posts were, strangely, uniformly vertical (Hope-Taylor 1977, 91). Only near the partition do bigger posts that might support a roof frame interrupt the long walls; they are not aligned with any external posts. Yet more posts, 'traces of later repairs...had been inserted alternately against the inner and outer face of the walls' (Hope-Taylor 1977, 92). All very confusing, yet the inescapable conclusion is that this was a monospan building entirely dependent for its roof stability—and in this it follows A4—on its walls and external posts. That leaves the purpose of the inserted posts—whether sloping or vertical is not stated—uncertain, but their spacing is interesting. In the west half of the building two posts are clear by the north wall and one is uncertainly shown by the south; in the east half, one uncertainly by the north, one clearly by the south wall. All appear to be at a regular distance from the wall. Assuming a roof-frame for each pair of posts, their spacing within the hall bears a marked resemblance to that of A4, with another frame at the partition instead of an extra freestanding frame. That still leaves the external posts, not one of which is aligned with a roof frame, to be explained. If the general similarity between C3 and A4 is well founded it is likely that the roof will have been of quite low pitch and the walls of—no great height—would need buttressing at or near the top, hence a short outer post and an inner one of intermediate height provided notched housings in a beam notched to fit the housings and rising to the wall top. Such supports would not require prefabrication; each was cut on the spot as construction progressed and regular spacing from the wall did not matter provided the buttresses functioned as intended.

In these phases the evidence of building construction is unclear: "...there is suspicion that enough of **C4(a)**'s eastern half remained standing, after the fire, to allow of piecemeal demolition and reconstruction..."(Hope-Taylor 1977, 94). But the walls of C4(a) and (b) do not correspond except in the annexe and adjoining west wall and to make matters worse no serious attempt is made to assign post-holes to one phase or the other (Hope-Taylor 1977, pp.93-95). The putative ridge-posts of C4(a) abutting the jambs of the end doorways (**A, K, Figure 00**) imply a slightly oblique ridge-beam with one post-pair (**F,G**) carrying a king-post as its only other support, which is impossible. A little to the west of the lateral doorways is what might be an axial ridge-post matching two buttress-posts, which would reduce the unsupported length of the ridge-beam to a credible 18 ft (5.4 m), comparable with the 20 ft (6 m) from the east wall to the paired posts. So far, just feasible, but what is said about the roof of C4(b) confuses the issue further: there was "a row of deeply founded ridge-posts along the long axis" (Hope-Taylor 1977, 94, SC), four in all, giving a doubly skewed ridge-beam. It may be that piecemeal reconstruction applies to the walls and not the ground-based roof structure, which was rebuilt bowed, presumably to resist racking.

The C4 annexes, which are all but identical except for an extra pair of wall-posts in (b), are remarkable for the two unique freestanding off-axis posts aligned at both ends with wall-posts and rather too big for a partition. The only other obvious purpose for internal posts is to support the roof - here, the ridge-beam, and no external posts were needed in C4(a) at least. Bizarre though the idea of a roof with a steep pitch to north and a gentler one to south unquestionably is, it is advanced here for want of anything better. Other internal posts recurring in odd positions may be noticed in the hope that others will find explanations for them: thus D2(b) has a large square post just inside the east doorway, rather like one close to the north doorway of C4(a), and D4(b) has a freestanding post north of the hearth in a comparable position to one in C2.

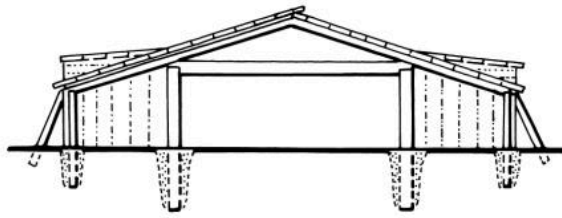
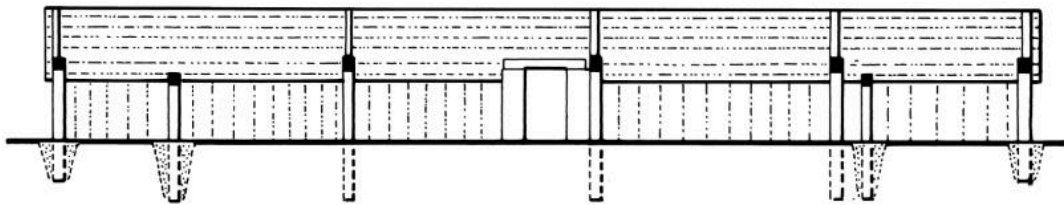
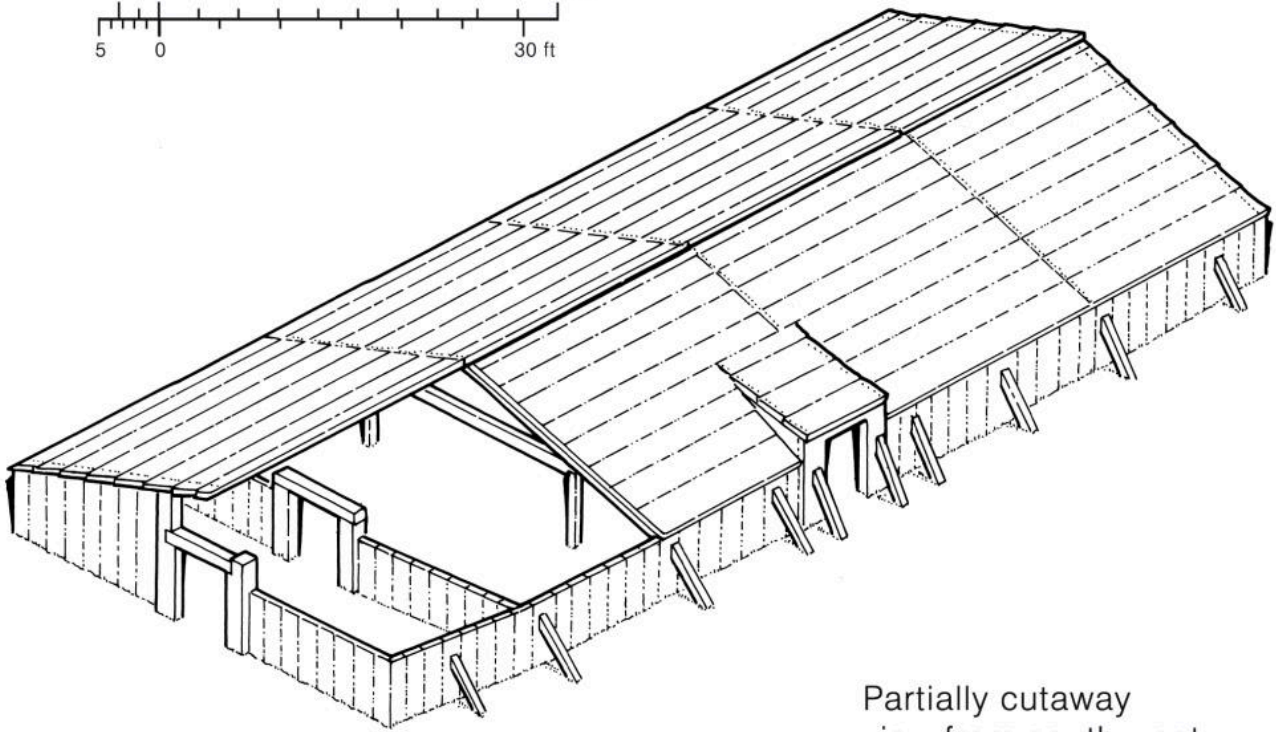
Fig 11 Building A2

Building A2

Cross section

Long section

Partially cutaway
view from south west

A2 was the first building to present the problems defined in A4 and their solutions; its wall timbers were larger than in A4 and not set in such deep trenches, and the post-pairs were fewer and formed longer bays. Although no evidence of impending failure was observed in A2, the changes made in A4 in these respects show where improvement was thought necessary; principally, it seems, resistance to outward thrust and also lengthwise racking was inadequate. The latter consideration may have led to an increase in the number of post-pairs.

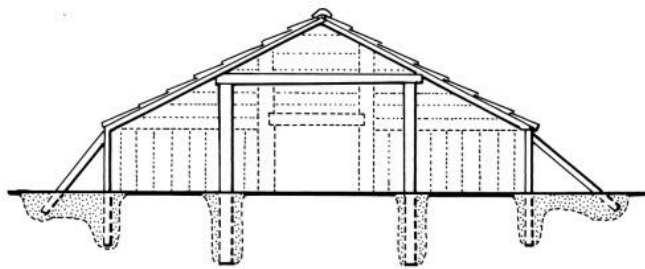
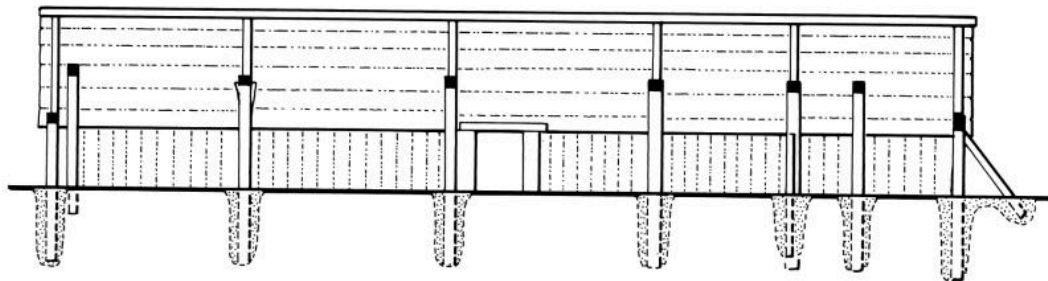
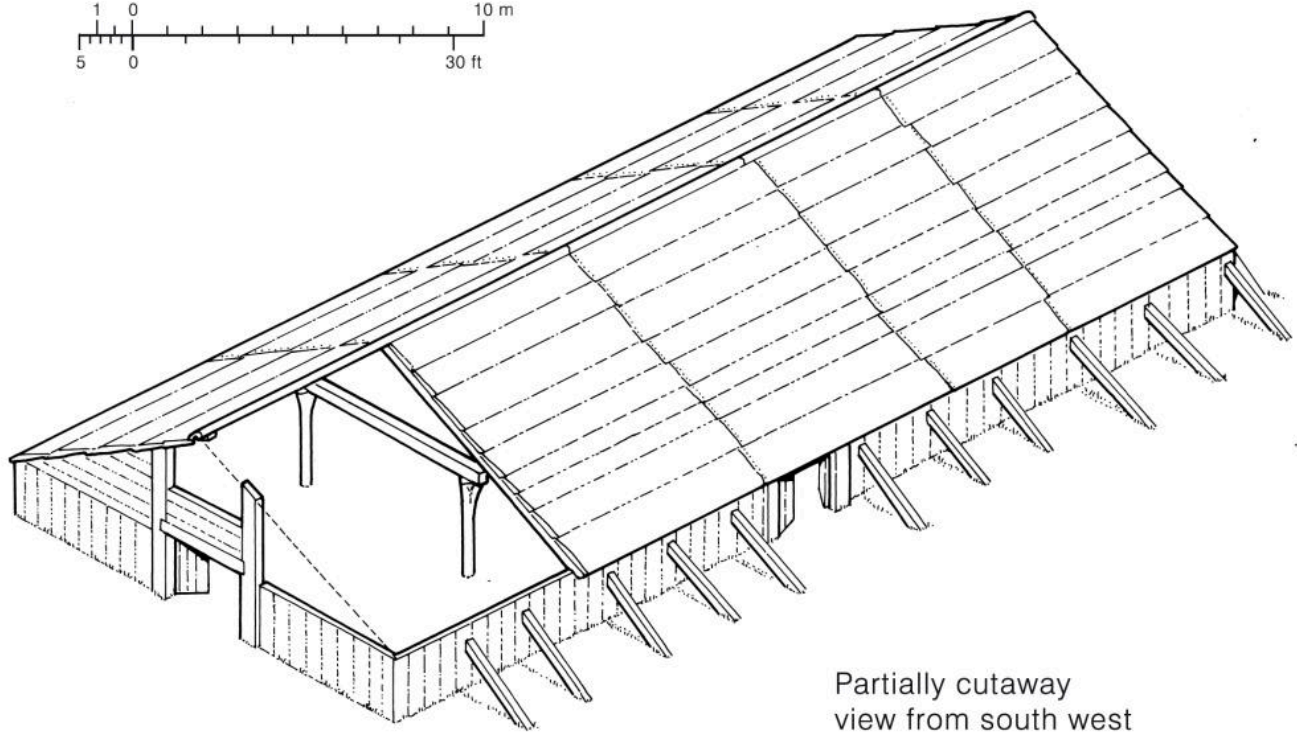
Fig 12 Building A4

Cross section

Long section

Partially cutaway
view from south west

The structures that can be inferred from the archaeological evidence began with A4, where the builders' design brief and their primary assessment of the problems are clear. A large hall was required and it had to have as wide a span as possible—width was an expression of status throughout the middle ages—and that condition exacerbated the problems familiar to carpenters of achieving lengthwise and lateral stability. Height can reasonably be assumed to have been desired by the patron but the means of achieving it were limited by the difficulty of working much above man height with long or heavy timbers which, not having been prefabricated, required fitting together as easily as possible.

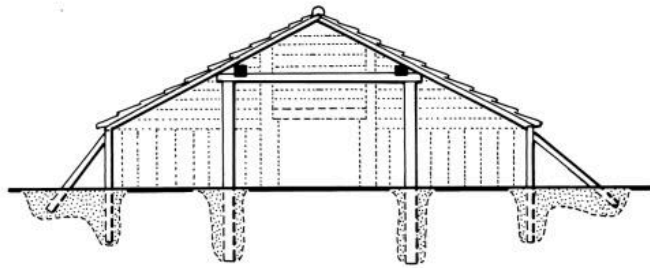
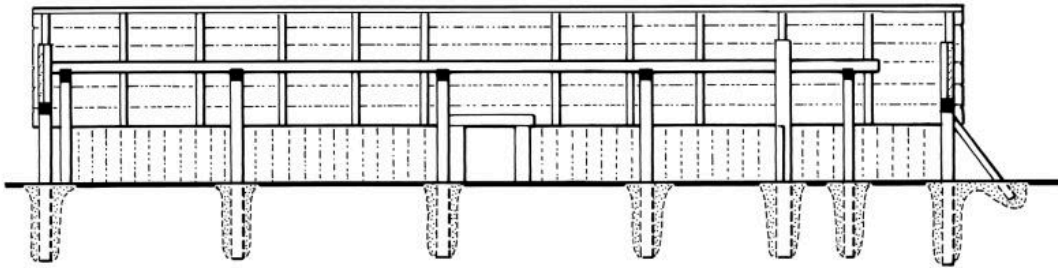
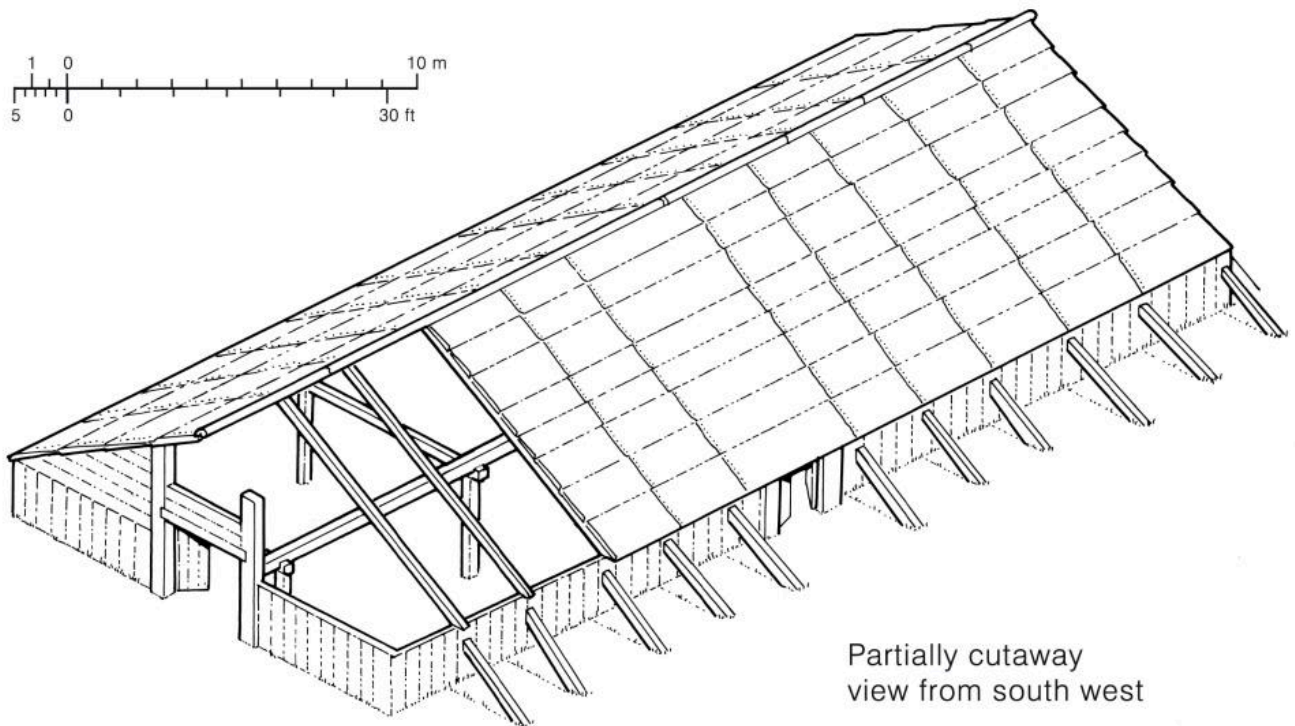
Fig 13 Building A4, alternative interpretation with arcade plates

Cross section

Long section

Partially cutaway
view from south west

FIG 13. BUILDING A4, ALTERNATIVE INTERPRETATION WITH ARCADE PLATES

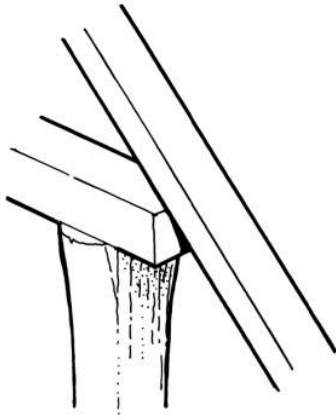
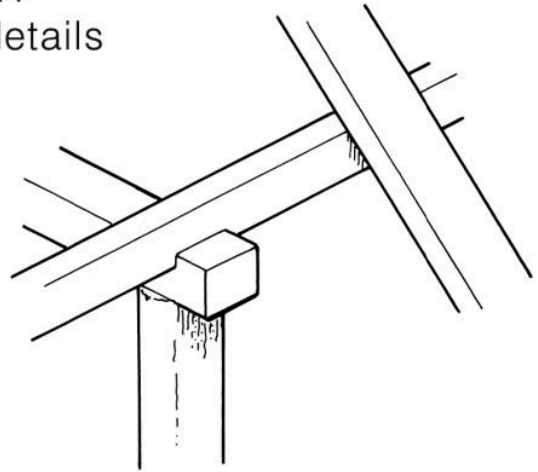
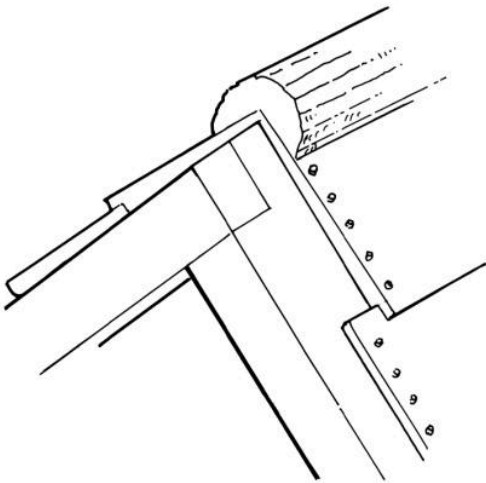
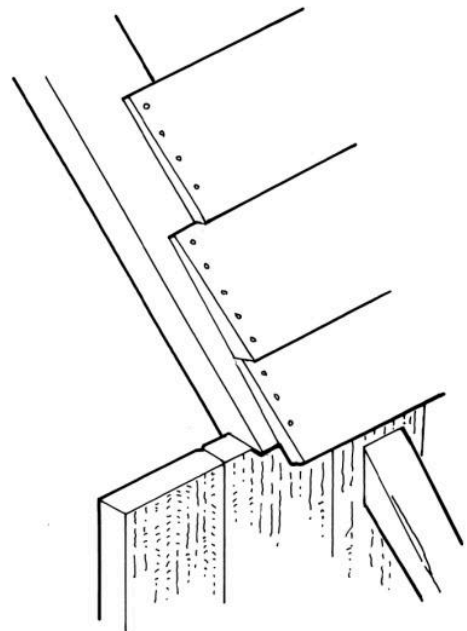
Fig 14 Building A4 construction details

Rafter supported by tie beam

Rafter supported by arcade plate

External ridge piece

Rafter with bird's mouth joint
and large boards butted at rafter

The boards must have been fixed to the rafters by nails, presumably, although no trace of them was found; or wooden pegs might have been employed if augers - first mentioned in English c.700 (OED; Innocent 1917), 99) - were in use then - and since rafters were not used for support at the gable ends that leaves the boards terminating on top of the wall timbers. It follows that the timbers aligned with the post-pairs were of the same height and those adjoining the door lintels somewhat higher, but whatever the difficulties of handling, the depth to which they were buried- rather more than the long walls- shows they were intended to resist any lengthwise movement. The possibility of a hipped roof was considered, particularly at the east end, but the lack of any reinforcement at the corners, coupled with the depth of the wall trench (apparently uniform with the west wall) argues against it. Yet one more problem arises with the end walls: how were the roof boards supported above the lintels of the end doorways? Horizontal timbers with tapered ends slotted into grooves - a modest instance of prefabrication - seem to be the most practical solution, although if so, it is surprising that all Hope-Taylor's meticulous excavation did not produce evidence of the technique. Upright logs, the only alternative, also require some kind of prefabrication in the joint with the lintel, so the same point applies. In short, no really convincing solution can be offered for this detail.

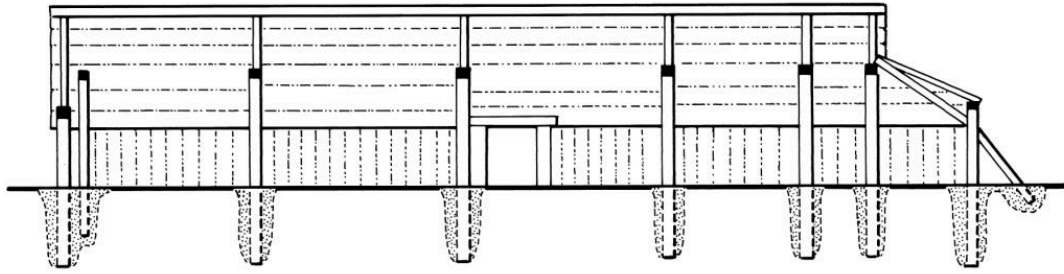
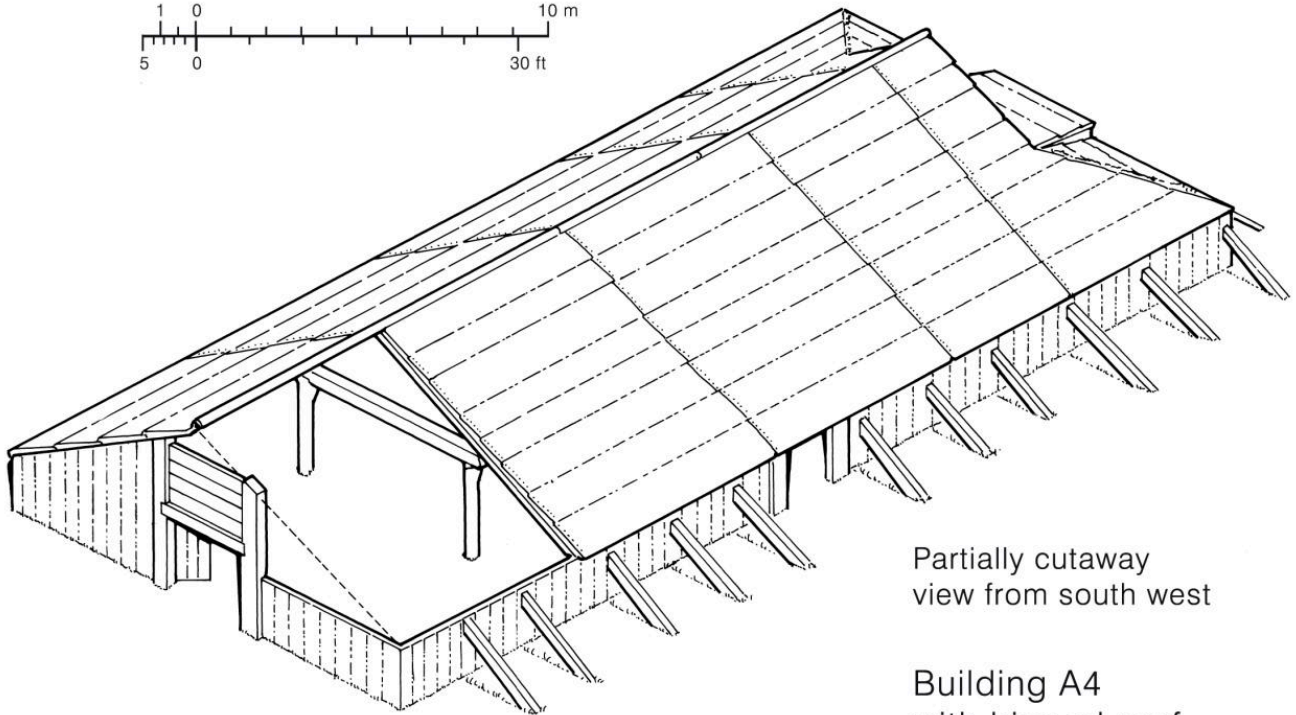
Building A4
with hipped roof

Long section

Partially cutaway
view from south west
