Yeaving Reconsidered

EXARC Journal Issue 2015/2 | Publication Date: 2015-05-15

Author(s): J. T. Smith ¹ ✉

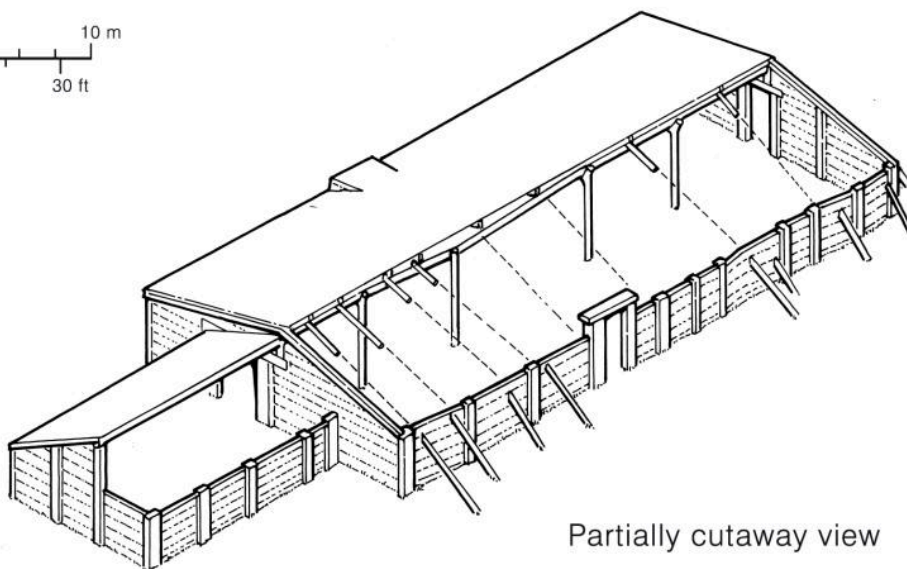
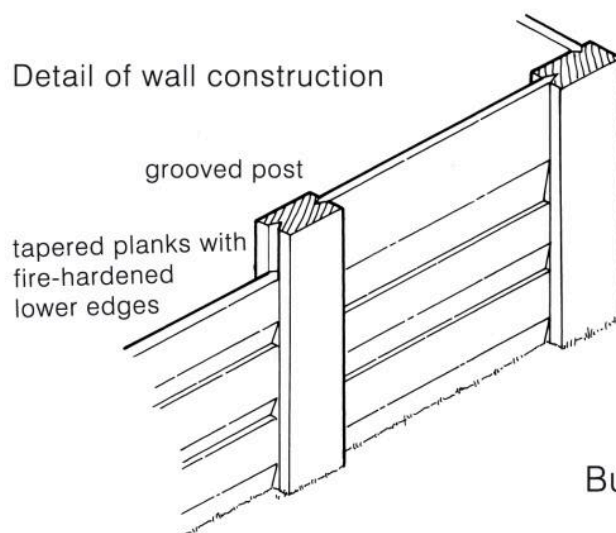
fig 16 Building C4(b)

Partially cutaway view

Detail of wall construction

Building C4(b)

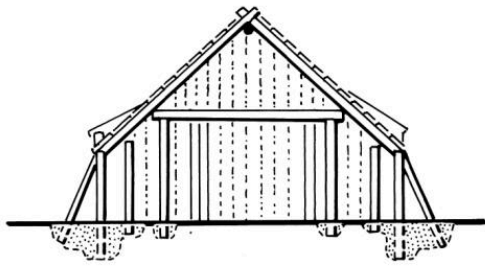
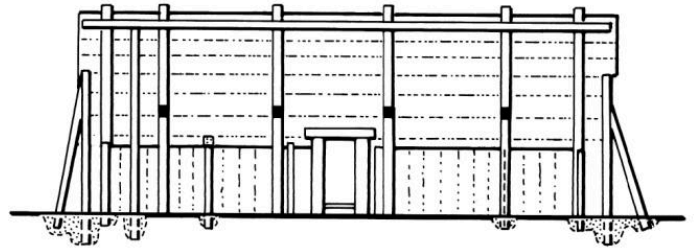
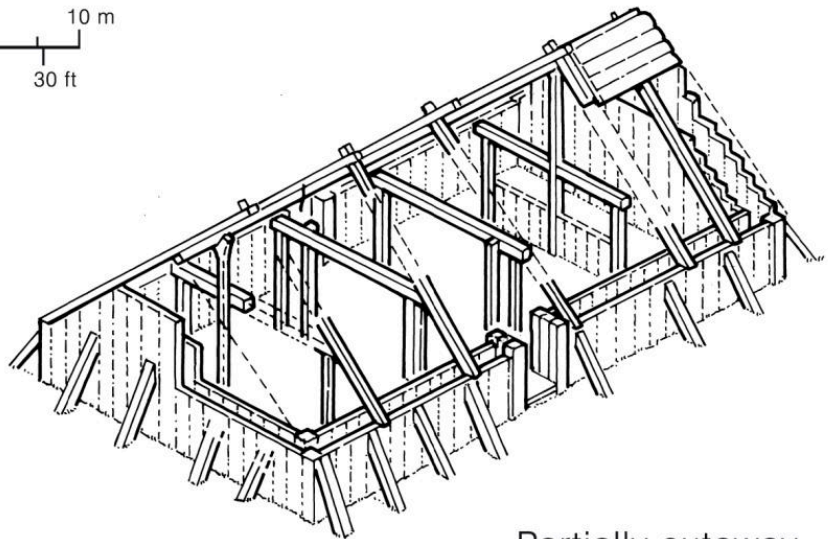
Fig 17 Building D2 with double walls

Cross section

Long section

Partially cutaway
view from south west

FIG 17. BUILDING D2 WITH DOUBLE WALLS

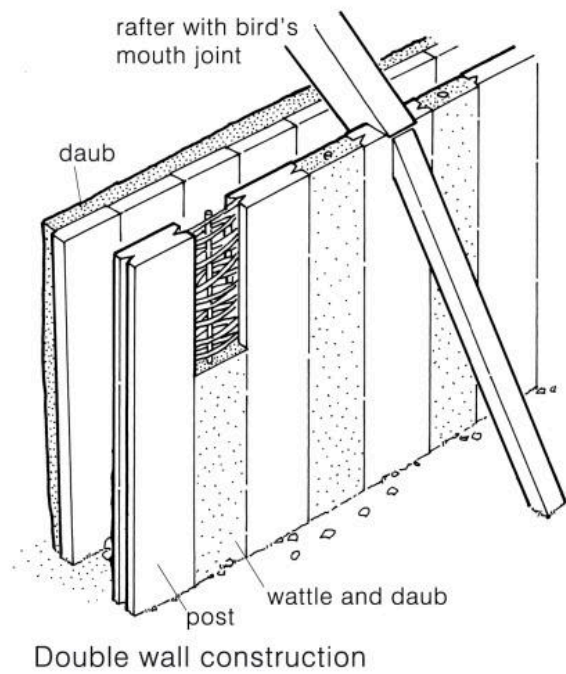
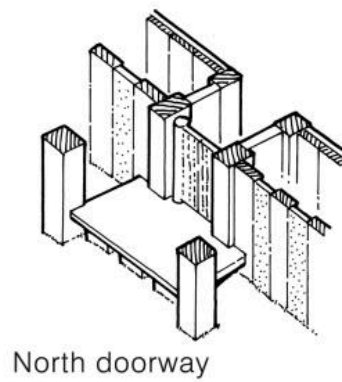
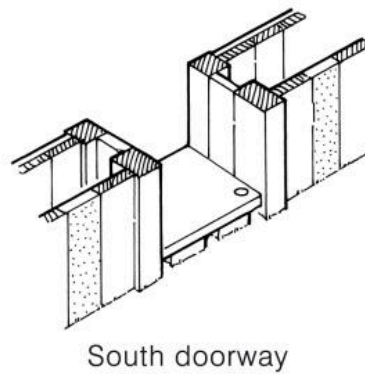
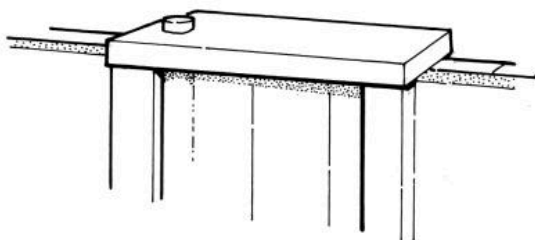
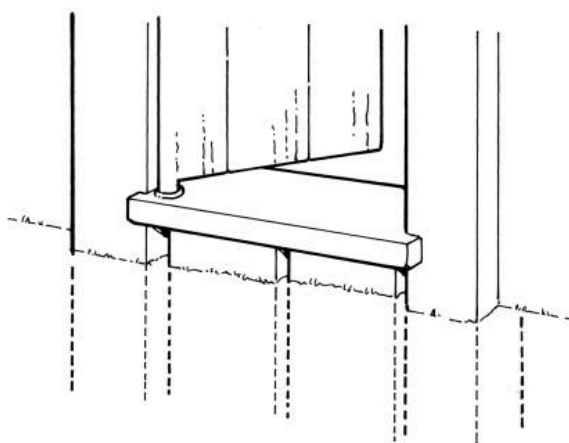
Fig 18 Building D2 construction details
FIG 18. BUILDING D2, CONSTRUCTIONS DETAILS

Foot of harr-hung door

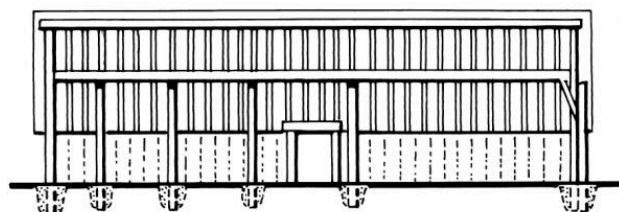
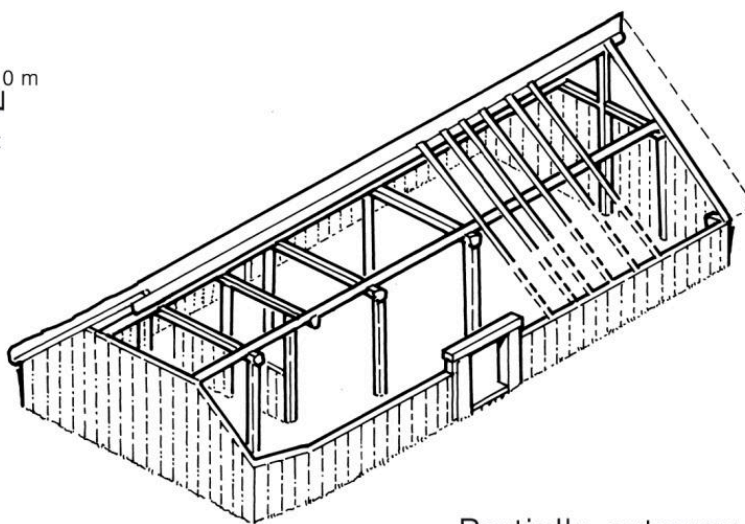
Fig 19 Building D2(a) as a single-walled structure

Long section

Partially cutaway
view from south west

FIG 19. BUILDING D2(A) AS A SINGLE-WALLED STRUCTURE

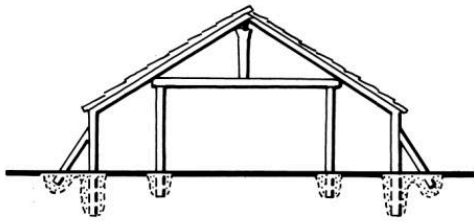
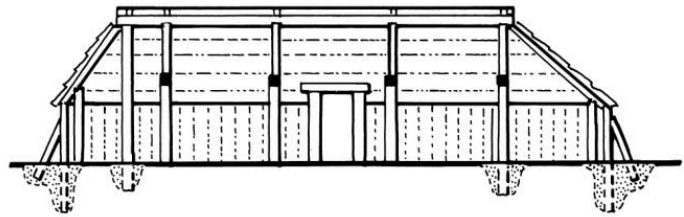
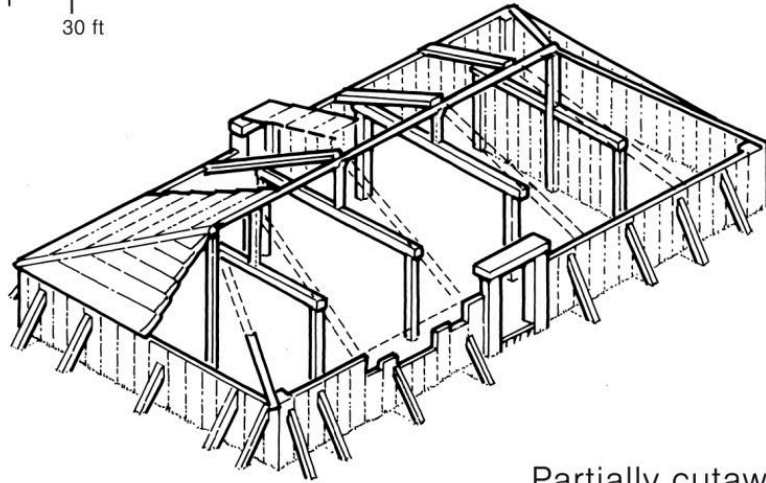
Fig 20 Building D2(b) as a single-walled structure

Cross section

Long section

Partially cutaway
view from south west

FIG 20. BUILDING D2(B) AS A SINGLE-WALLED STRUCTURE

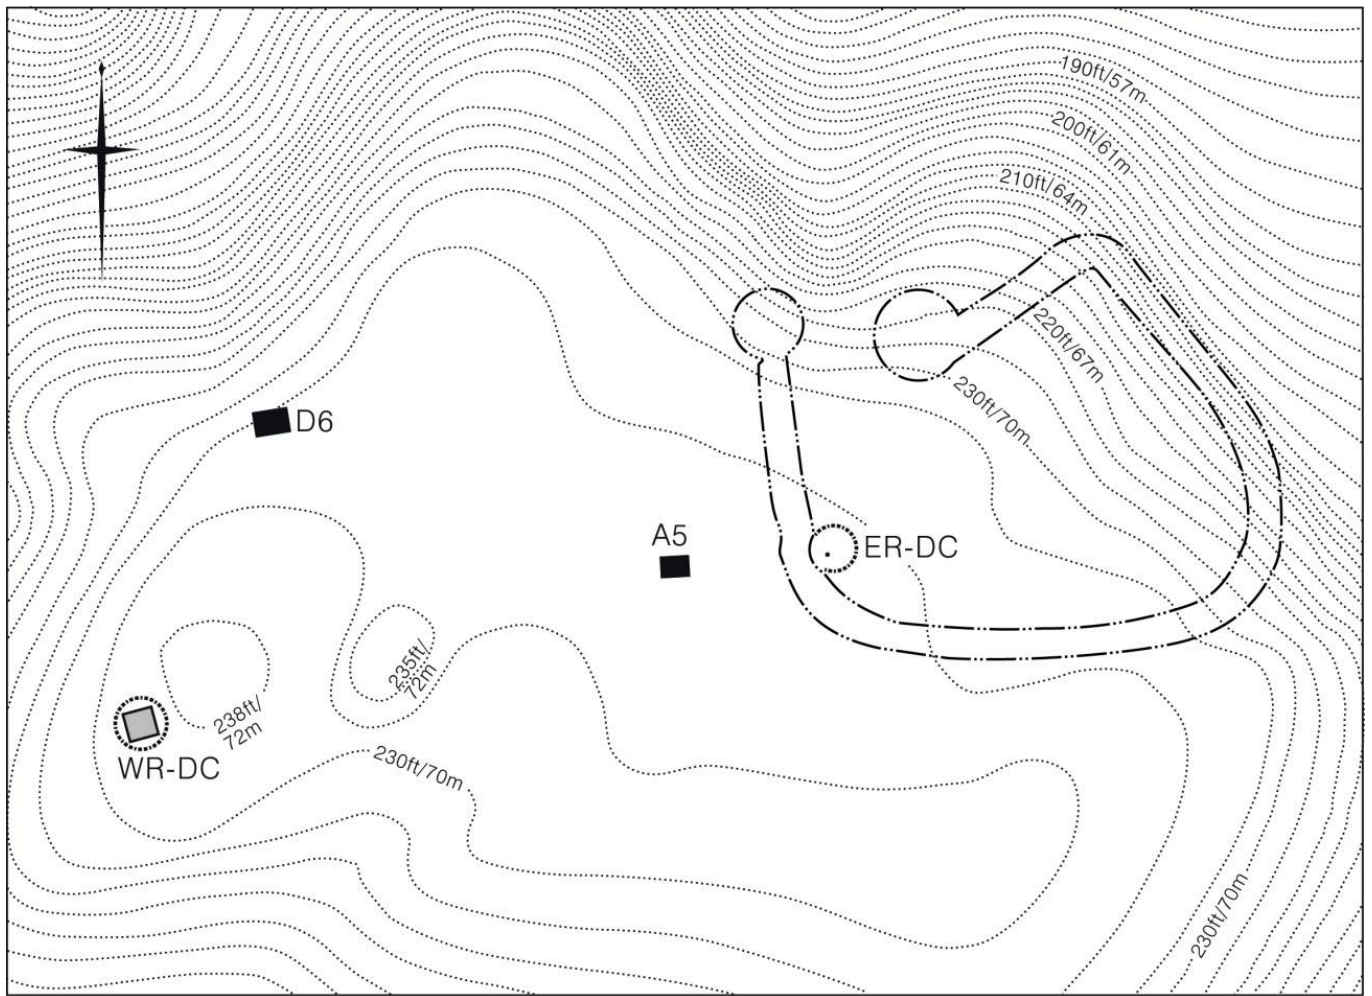
MAP 1. YEAVINGER, POST-ROMAN PHASE 1

Yeavinger, post-Roman Phase I

- Buildings with symmetrical end-doors
- ◻ Other buildings

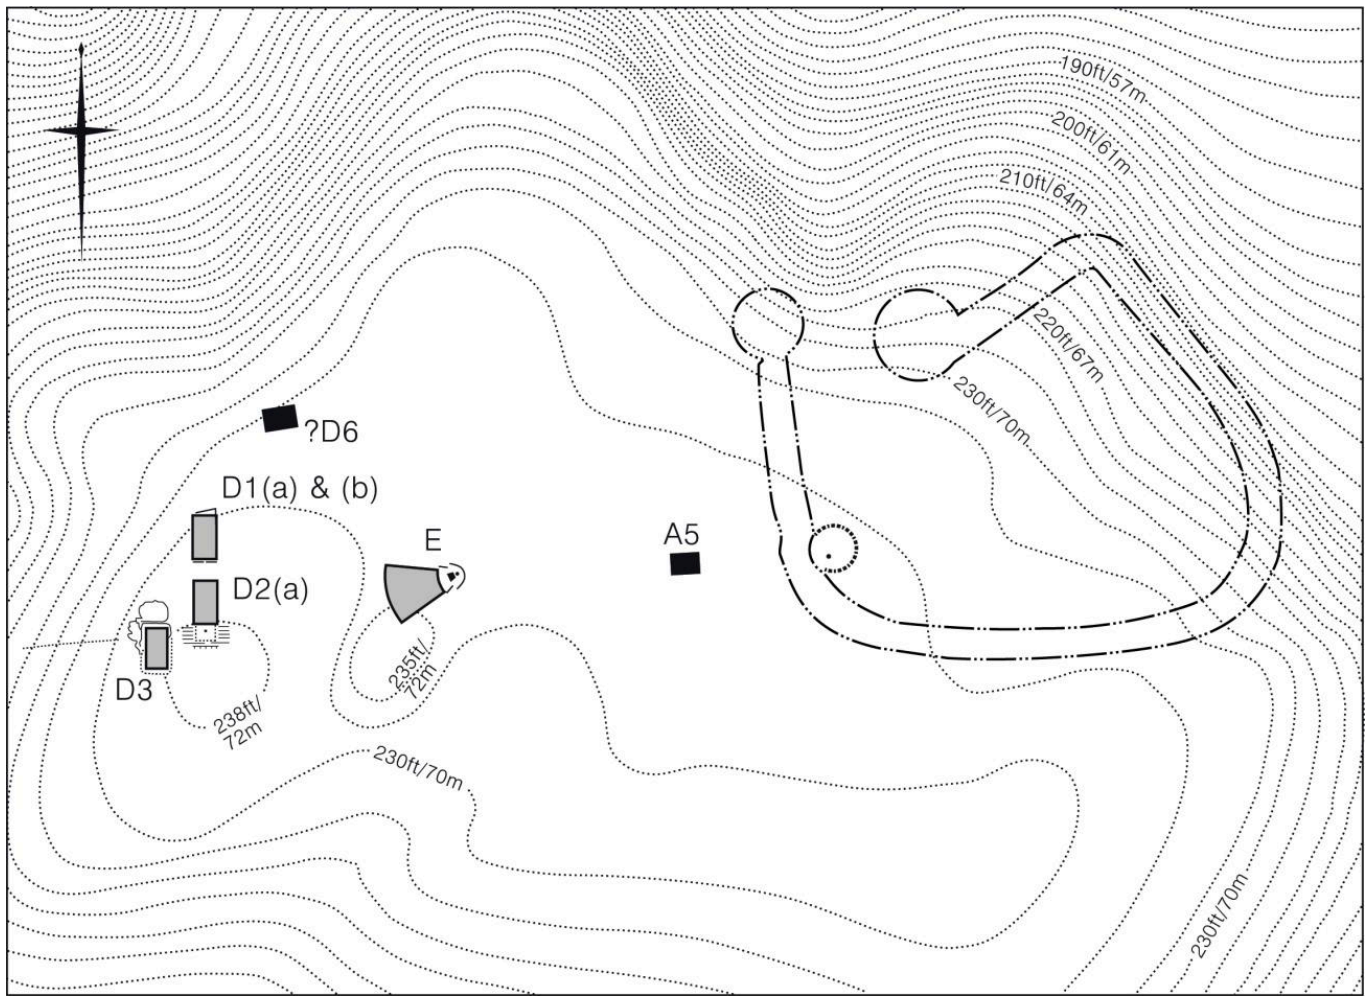
MAP 2. YEAVINGER, POST-ROMAN PHASE 2

Yeavinger, post-Roman Phase II

- Buildings with symmetrical end-doors
- Other buildings

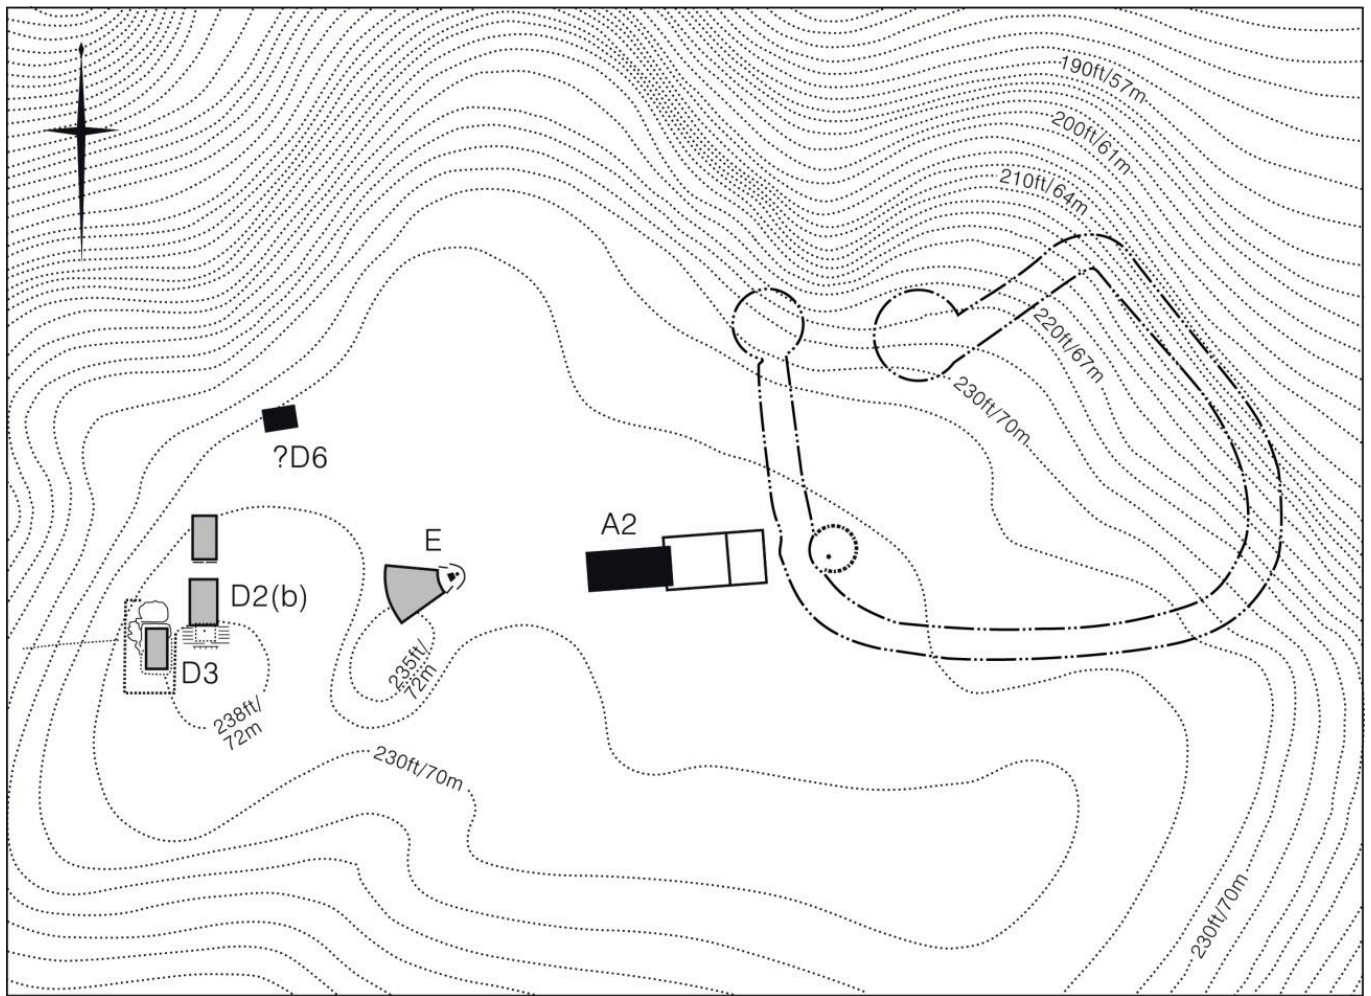
MAP 3. YEAVINGER, POST-ROMAN PHASE IIIAB

Yeavinger, post-Roman Phase IIIAB

- Buildings with symmetrical end-doors
- Other buildings

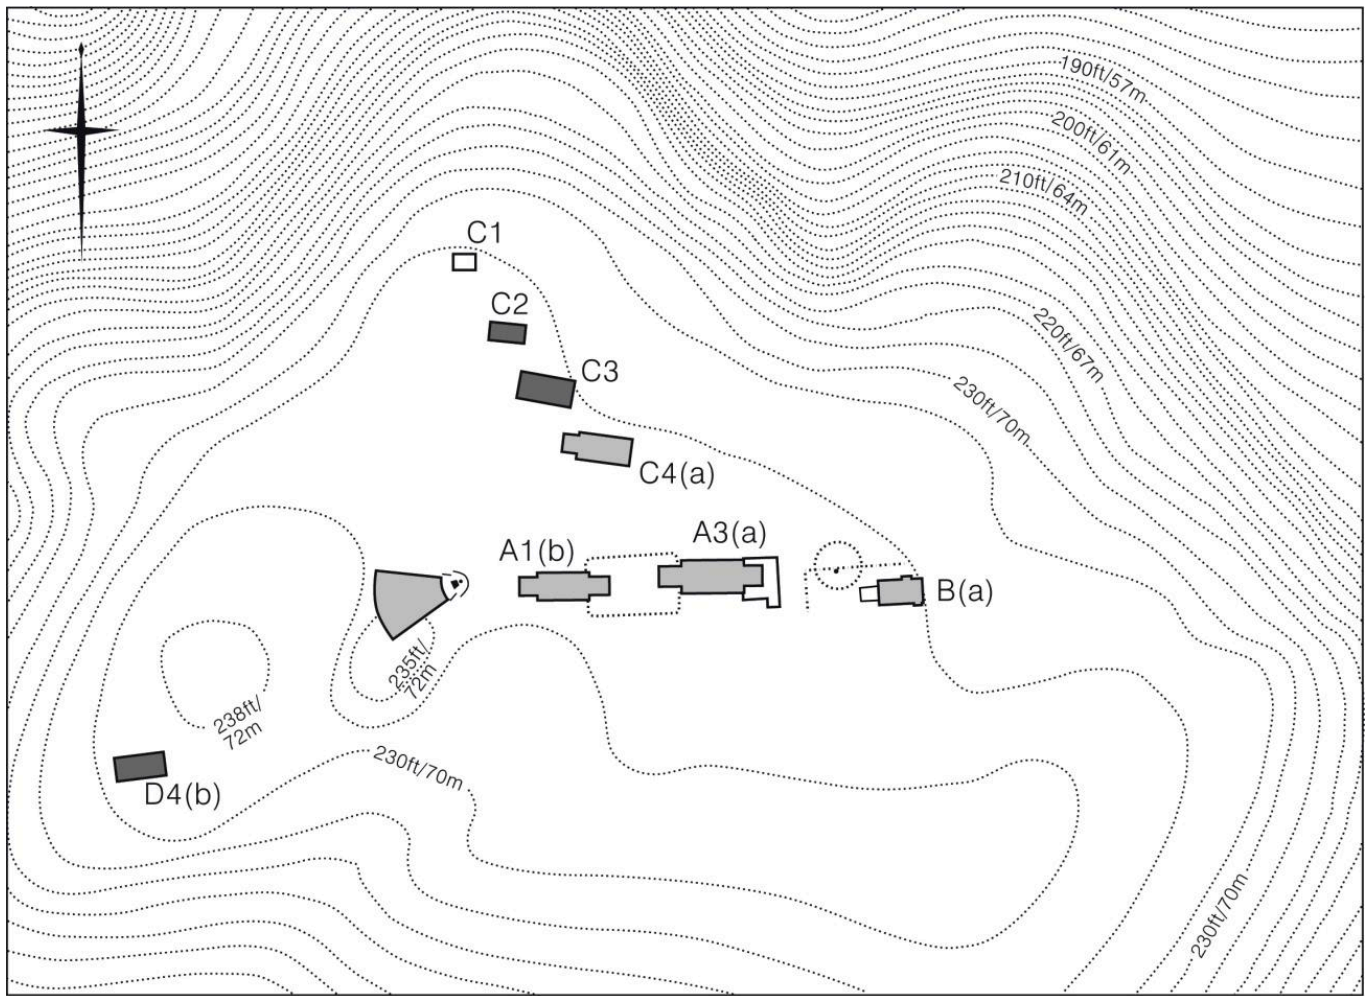
MAP 5. YEAVINGER, POST-ROMAN PHASE IV

Yeavinger, post-Roman Phase IV

■ Buildings with asymmetric end-doors
