Problems and Suggested Solutions in the Replication and Operation of a Glass Furnace based on Roman Remains: an Experiment in Glass Production

EXARC Journal Issue 2016/1 | Publication Date: 2016-02-15

Author(s): Ernst Lauermann¹

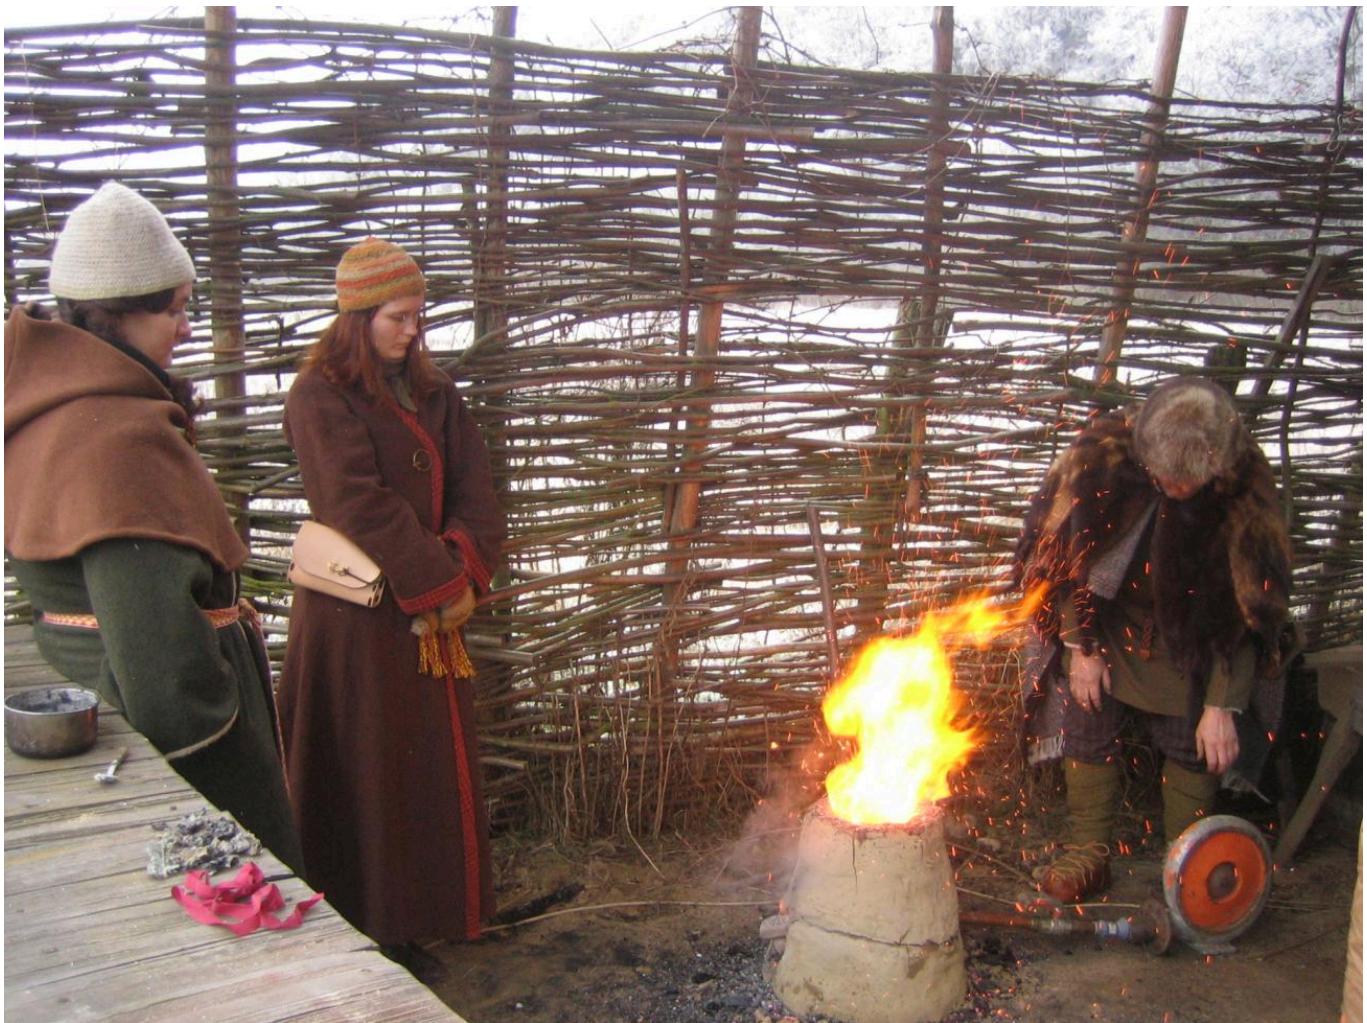
FIG 1. OPERATING A SIMPLE CHARCOAL FORGE

A preliminary experiment was carried out on 21 December 2007 by a team led by Putzgruber to explore possible ways of manufacturing glass. A mixture of quartz sand, potash and lime was melted directly in the fire of a simple charcoal forge and with the help of an electric fan. The mixture was made by instinct. 5% lime, 20% potash and 75% quartz sand. Our aim was to find out if this primitive mixture would melt directly in the fire without using a crucible. The attempt showed that this mixture melts in the heat and produces a semifluid glassy mass, which, it was noticed, was significantly contaminated by charcoal and ash (See Figure 1). For this reason, a charcoal furnace was erected again at Whitsun 2008 and a second attempt carried out, in which the glass batch was introduced in a fireclay crucible and the potash-quartz-lime mixture melted with the help of a pair of bellows. The result was a green mass, similar to glass, which improved continuously after the experiment had been going on for several hours. Another part of the experiment was to find out how long it would take to melt the glass by using bellows instead of the fan. During the experiment it turned out that working with bellows was not economic- because too many workers would be needed. Possible solutions were sought by using an excavated third-century Roman glass furnace (Wedepohl 2003, 62, Fig. 21) from Aix-en-Provence as a model (See Figure 2). It appears to have been a working furnace (Wedepohl 2003, 61). First, a sketch was made of the possible appearance of the future furnace. The measurements of the firing channel, combustion chamber and chimney were

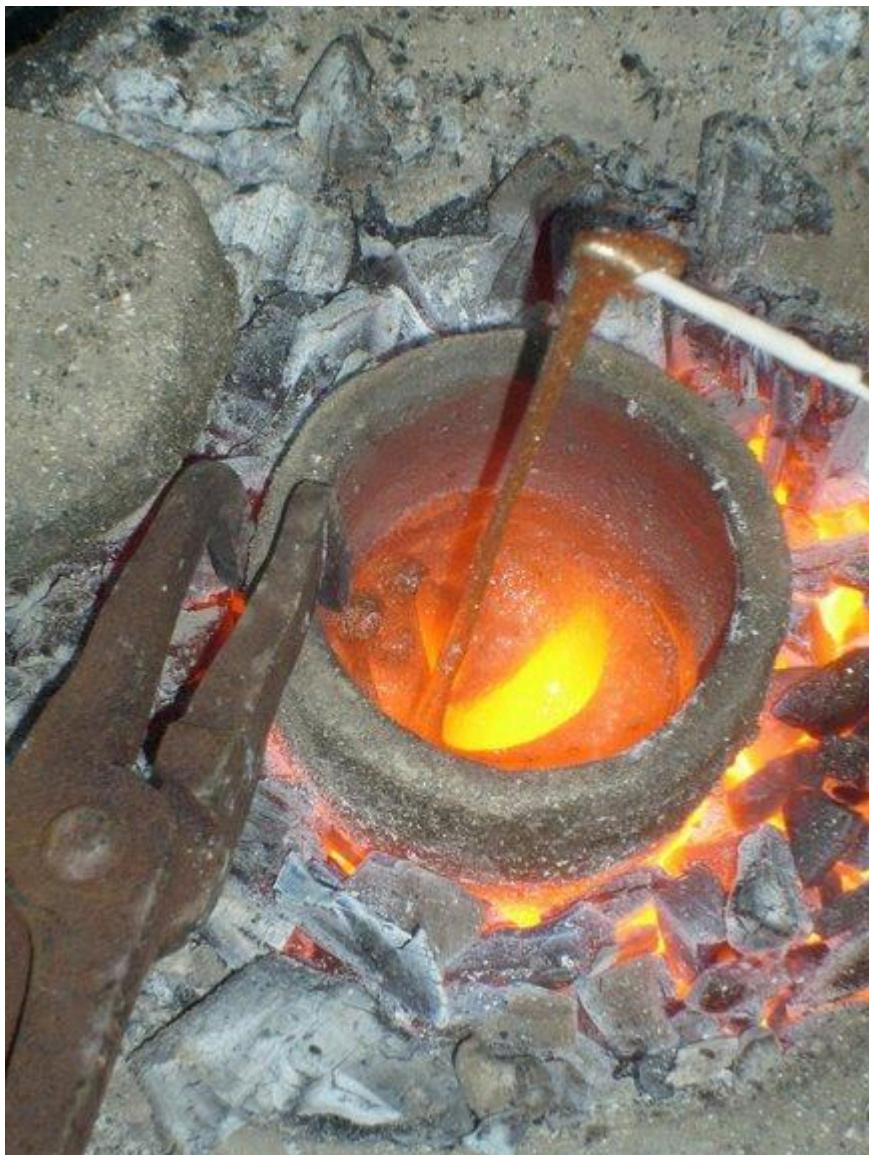
FIG 2. FIRST RESULTS OF A GLASS PRODUCTION EXPERIMENT WITH A CRUCIBLE

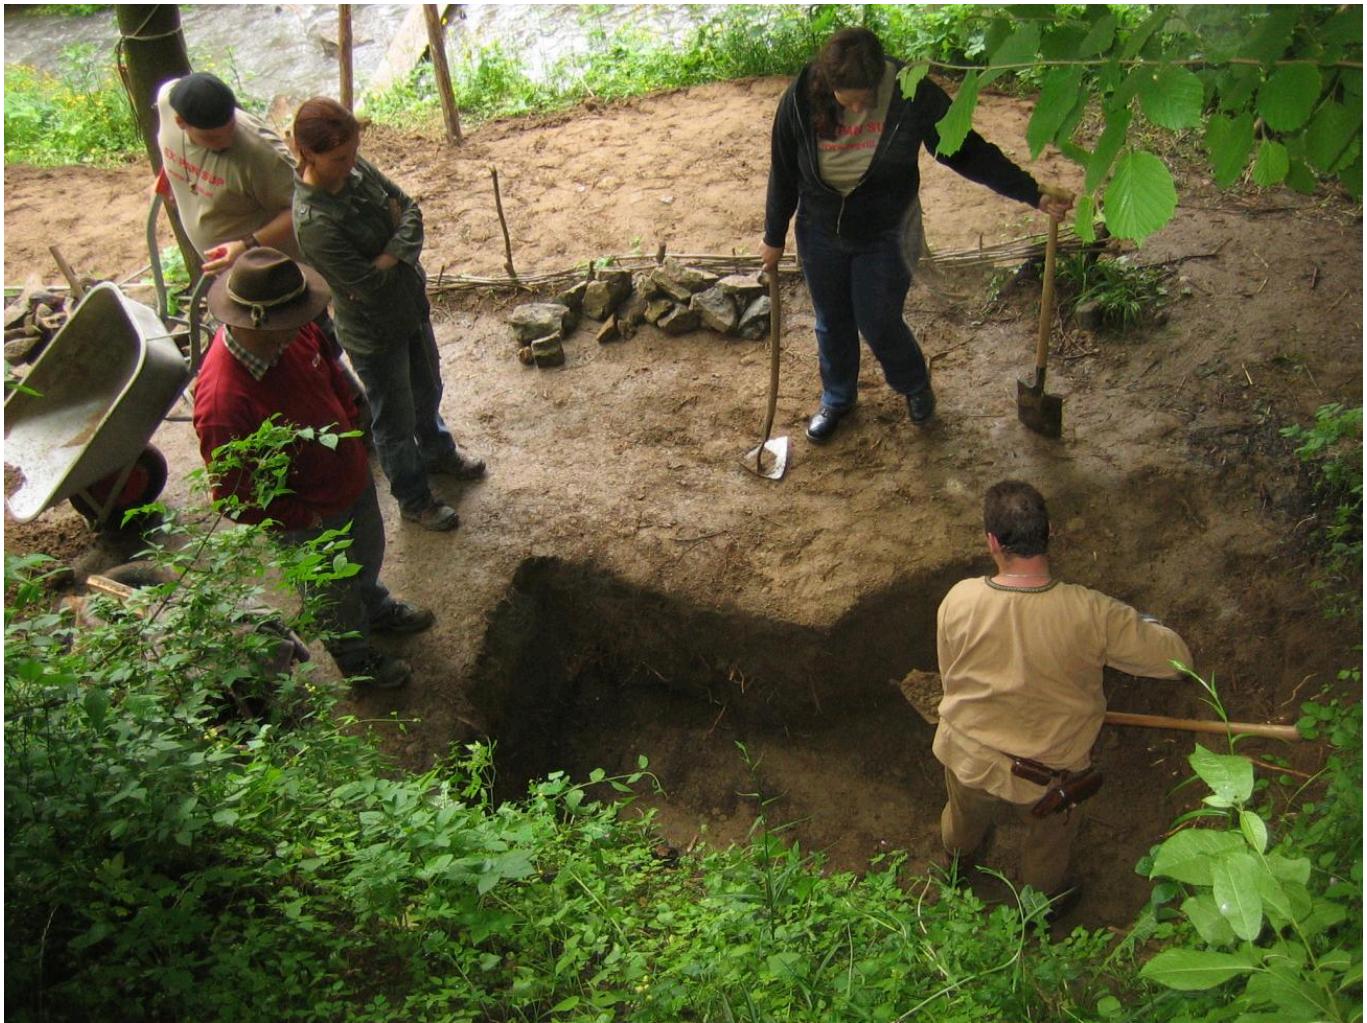
FIG 3. EXCAVATION OF A KEYHOLE-SHAPED FOUNDATION

calculated. Construction began in June 2008. The team thought that a drawn-out firing channel would make it possible to achieve and maintain high temperatures over a longer time period. Thus it would be possible not only to process glass in the furnace, but also to produce it (See Figure 3). The furnace was built of mud bricks and clay and stabilised by hay. To protect the inner surface of the furnace from the great heat expected, a layer of naturally-occurring fire resistant clay several centimetres thick was applied.

Based on previous experience with building smelting furnaces it was thought impossible that a furnace fuelled by wood would generate enough heat to melt glass unaided, so a very tall chimney with a solid foundation was necessary in order to create enough suction. First a keyhole-shaped foundation trench with a depth of 80 cm was excavated, filled out with rough stone and finished off with clay and earth. Next, the combustion chamber and the firing channel were built of bricks and clay. On top of this fresh air ducts were built in the walls of the firing channel with the help of reed, in order to be able to ignite gases in the chamber and thus increase the temperature.

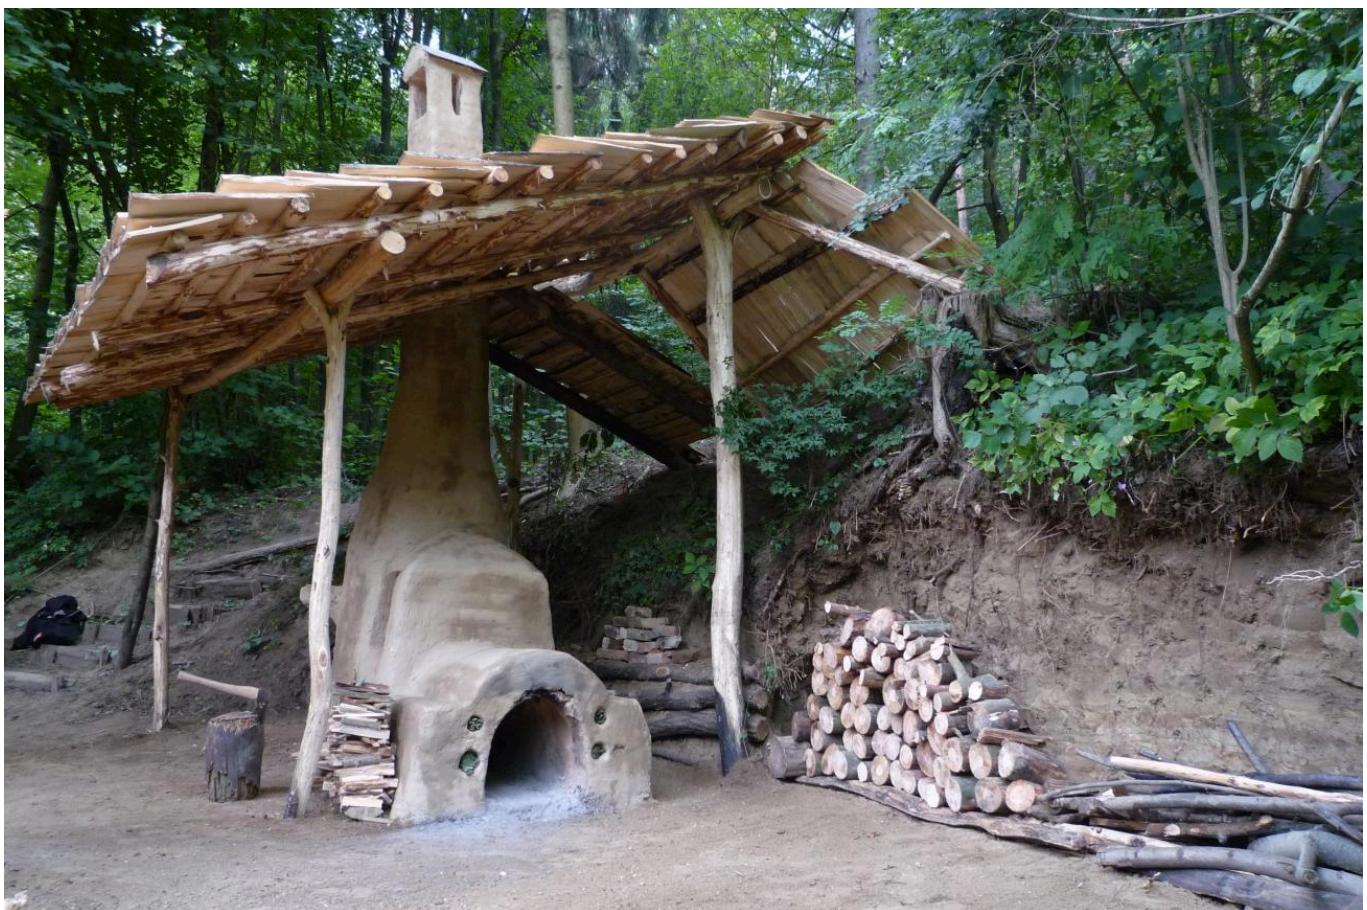
FIG 4. THE COMPLETED GLASS FURNACE WITH A TOTAL HEIGHT OF 4 M

A warming cupboard was added above the firing channel, which was intended to be heated by the surplus heat from the furnace. This is necessary in order to relax the glass products. Three fireclay supports were inserted into the combustion chamber, and the crucible was to rest on them and thus be surrounded by flames on all sides. Finally, a chimney was built above the furnace, resulting in a total height for the entire structure of 4 m (See Figure 4).

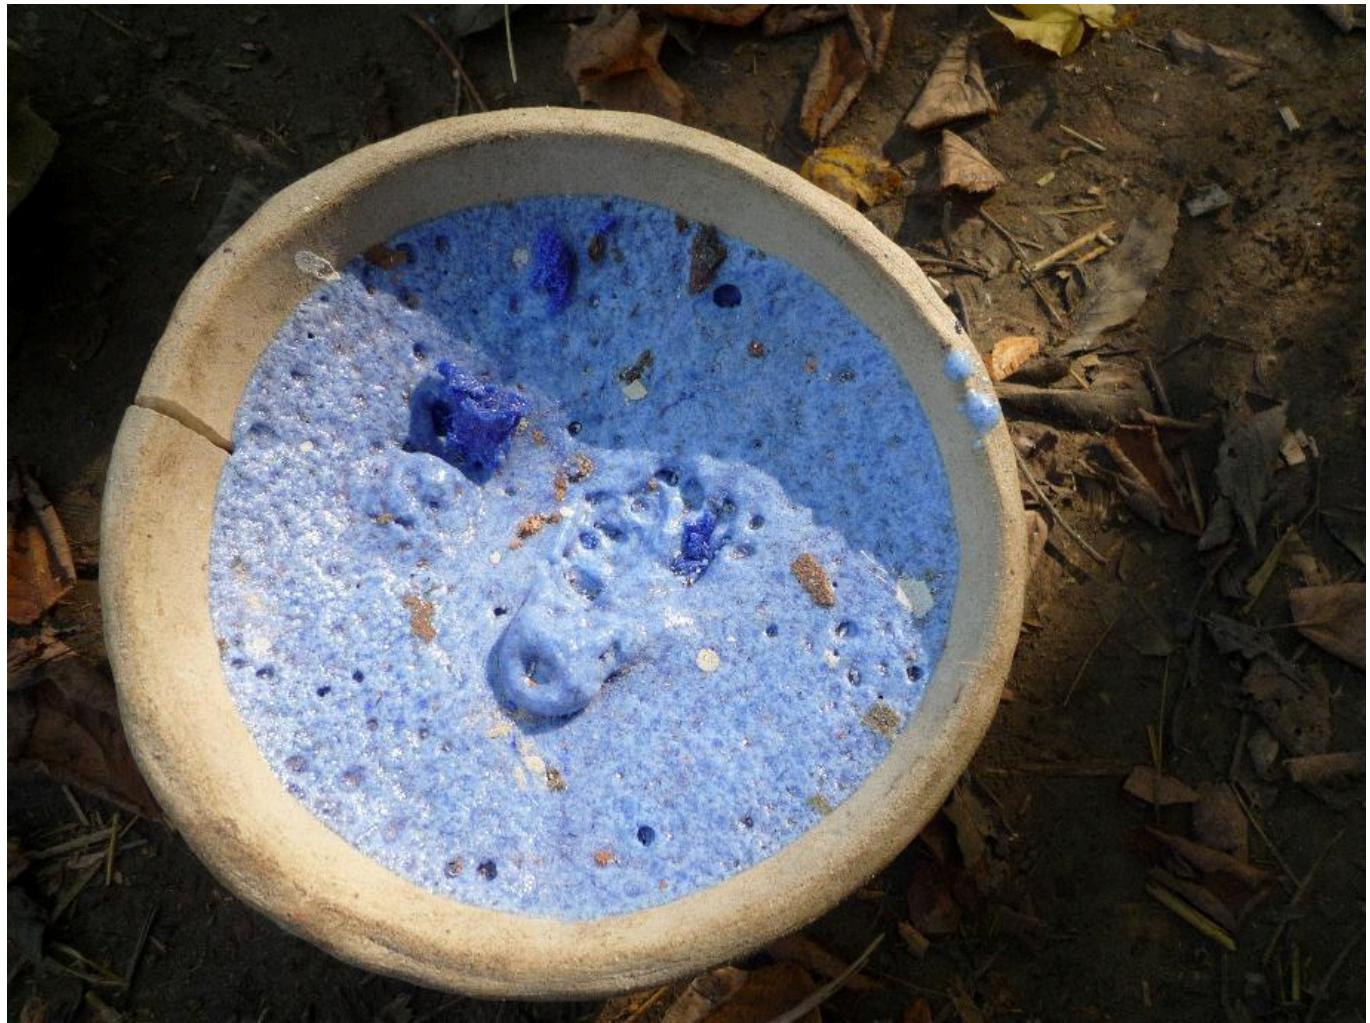
FIG 5. CRUCIBLE WITH A FAILED GLASS BATCH; BAKING SODA HAD BEEN USED BY MISTAKE

Ultimately we reached temperatures of around 1200°C. However, the mass had not really become liquid by 15:00, when the experiment was concluded (See Figure 5). Afterwards, having been advised by a friendly chemist, we used the more appropriate washing soda ($\text{Na}_2\text{CO}_3 \cdot 10\text{H}_2\text{O}$) instead of baking soda (NaHCO_3) as it is closer to Trona ($\text{Na}_3(\text{HCO}_3)_2 \cdot 2\text{H}_2\text{O}$), the mineral used by Romans.

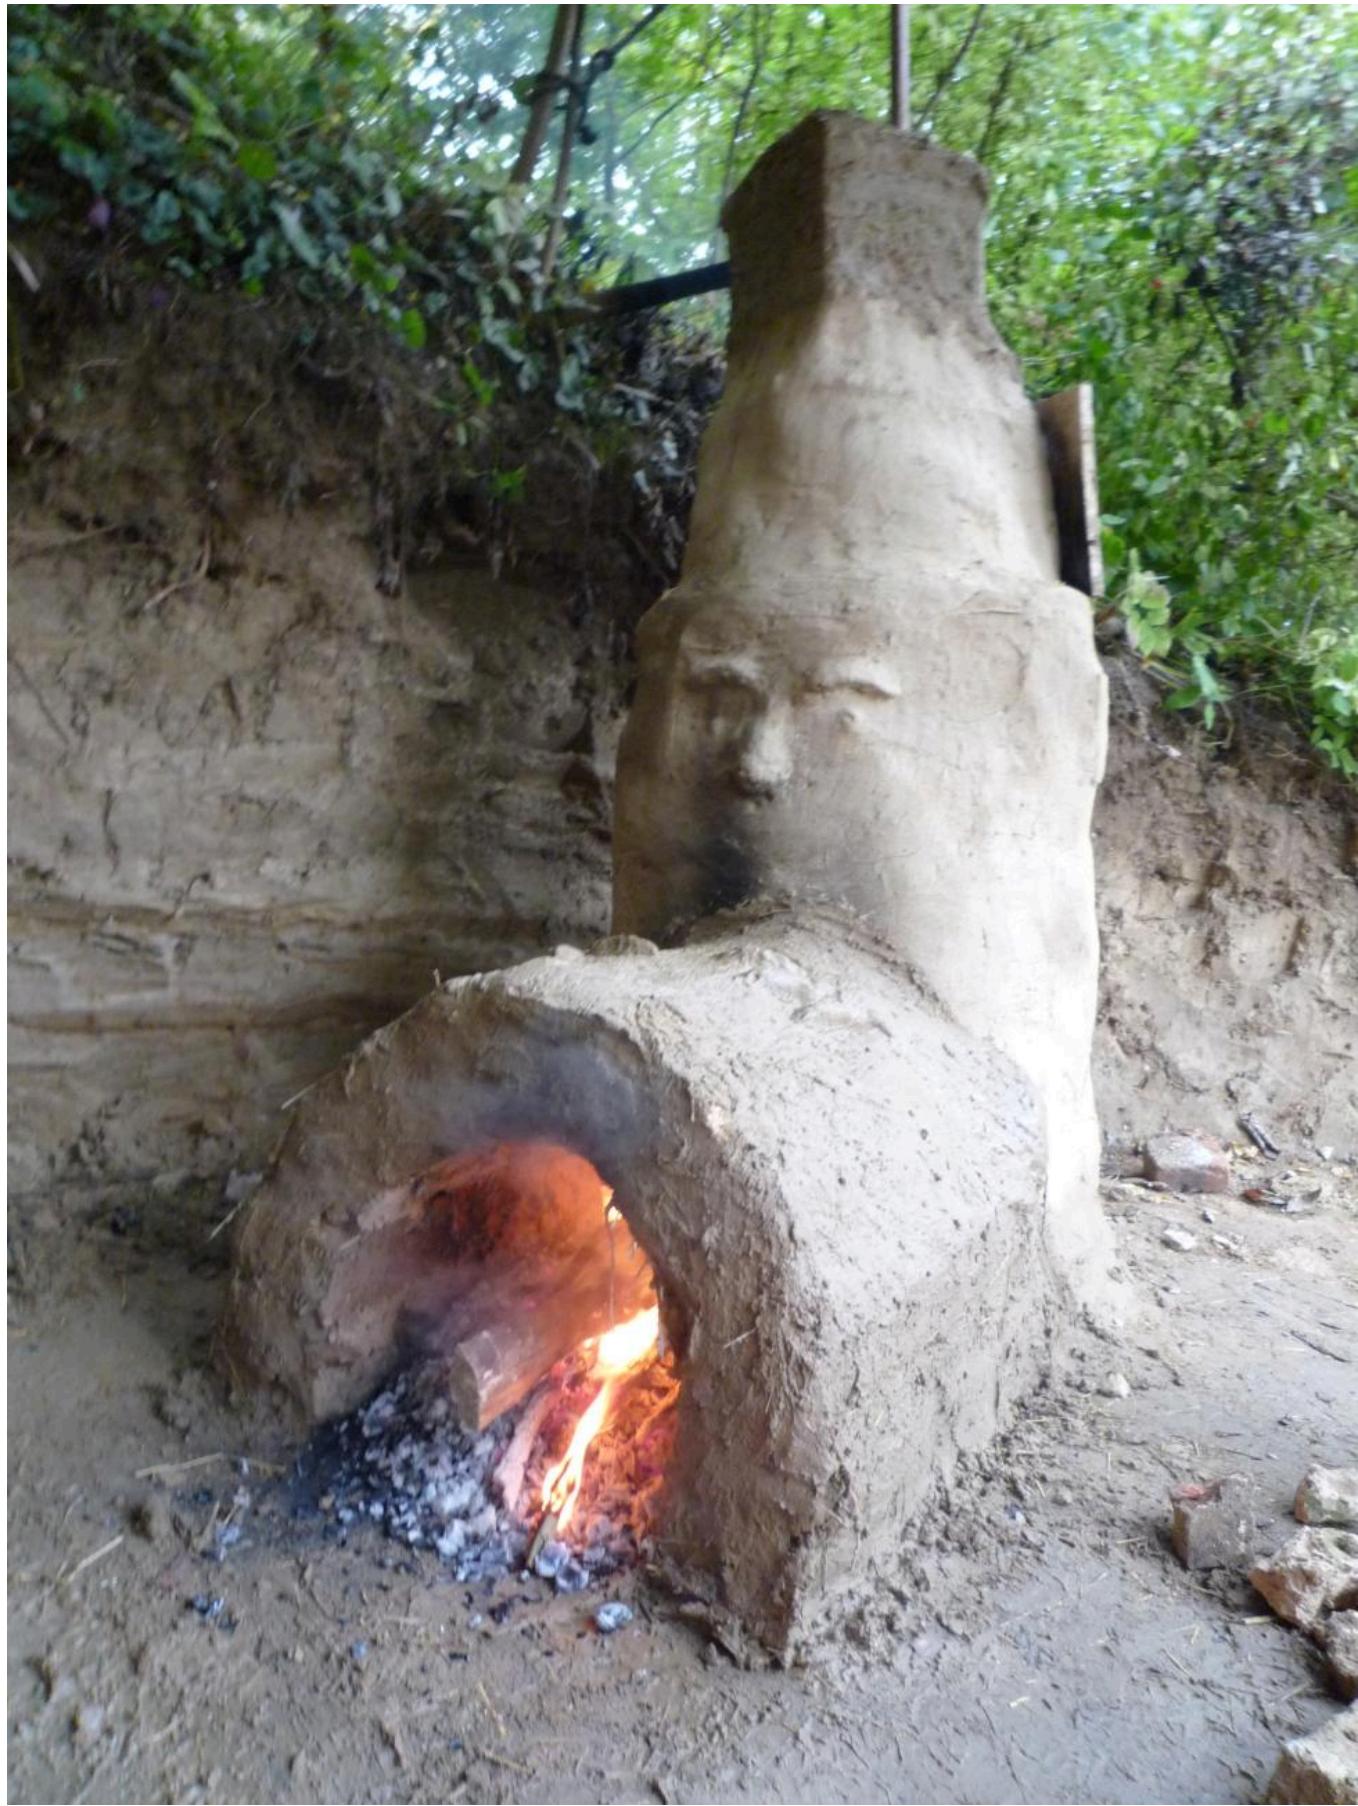
FIG 6. FRITTING OVEN, SIMILAR IN ITS CONSTRUCTION TO THE BIG FURNACE

The new experiment was to be presented to the public on October 26 2008. Three weeks earlier a smaller 'fritting oven' was built alongside the big smelting furnace. We found hints of a two- level melting process in Karl Hans Wedepohls book. (Wedepohl 2003, 45). At this stage of our experiments we thought this would be necessary. Before the glass was further processed or melted, it had first to be fritted for several hours at 900°C. This leads to a reaction between the quartz and the soda, which causes the glass mass to froth up. This temperature is reached in the smaller oven in order to help take pressure off the big glass furnace. This was first used for smelting. The first measurements showed, however, that the small oven could also reach very high temperatures of up to 1200°C. Both ovens could therefore be used for smelting (See Figure 6). This little oven was remarkably similar to the picture of a Roman glass oven on an oil lamp¹.

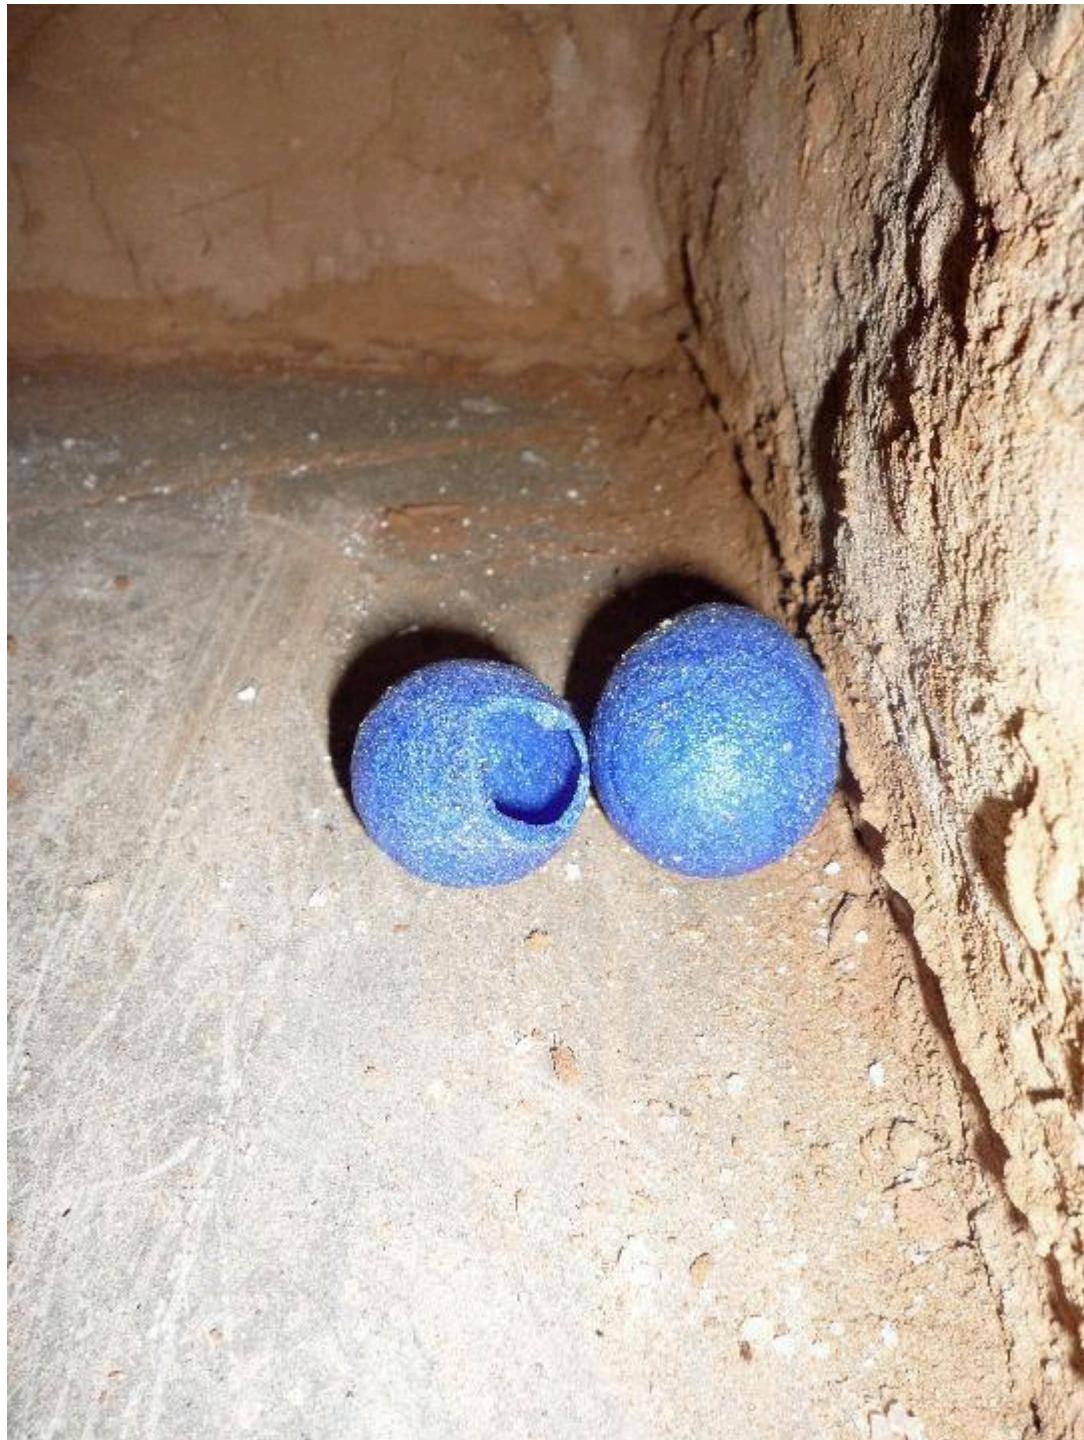
FIG 7. THE FIRST VESSELS OF SELF-MADE GLASS

In the morning, with everyone looking forward to the day, the big furnace put the dampeners on the team again. As previously mentioned, the high temperatures were threatening the stability of the combustion chamber and at 8:00 part of the inner wall of the chimney fell into the crucible containing the glass, which then broke. The glass mixture was also lost. For this reason, the furnace was shut down for the duration of the event. Everyone was very disappointed as almost twenty-four hours of work had been wasted. Nevertheless, we succeeded in producing simple vessels without a handle or a complicated rim (See Figure 7).

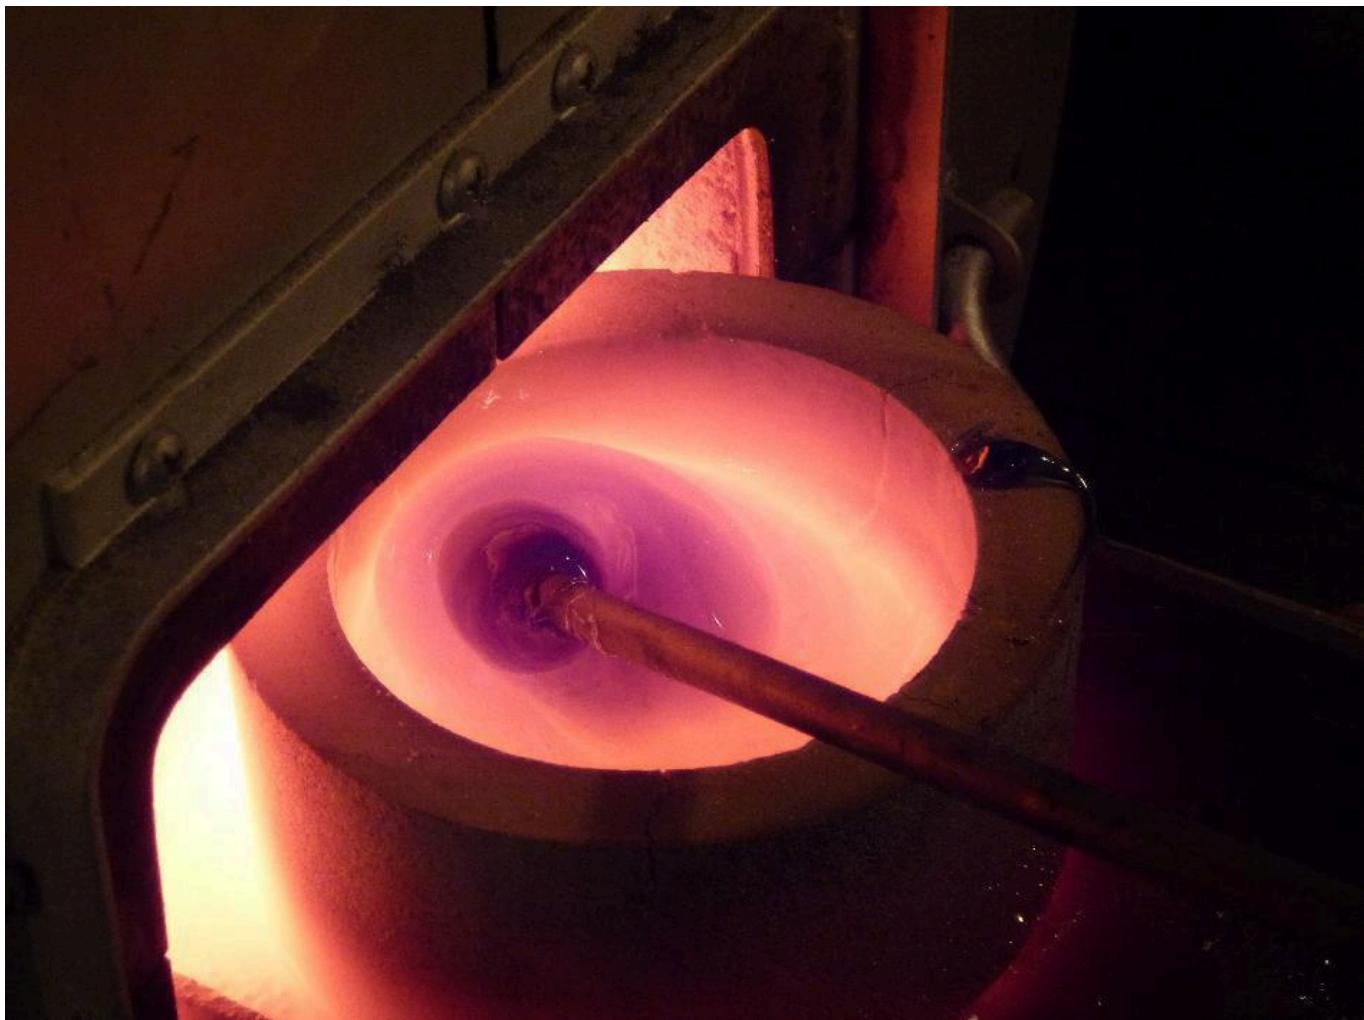
FIG 8. SMALL-SCALE EXPERIMENTS WITH AN ELECTRIC ANNEALING OVEN

Following this, small-scale experiments with 100 g glass batches were tried out in an electric annealing oven (See Figure 8). After several attempts, during which the crucible repeatedly broke as it heated up, it became apparent that the soda used was responsible for the lack of success². The liquid soda was absorbed by the crucibles and when it continued to boil they were destroyed.

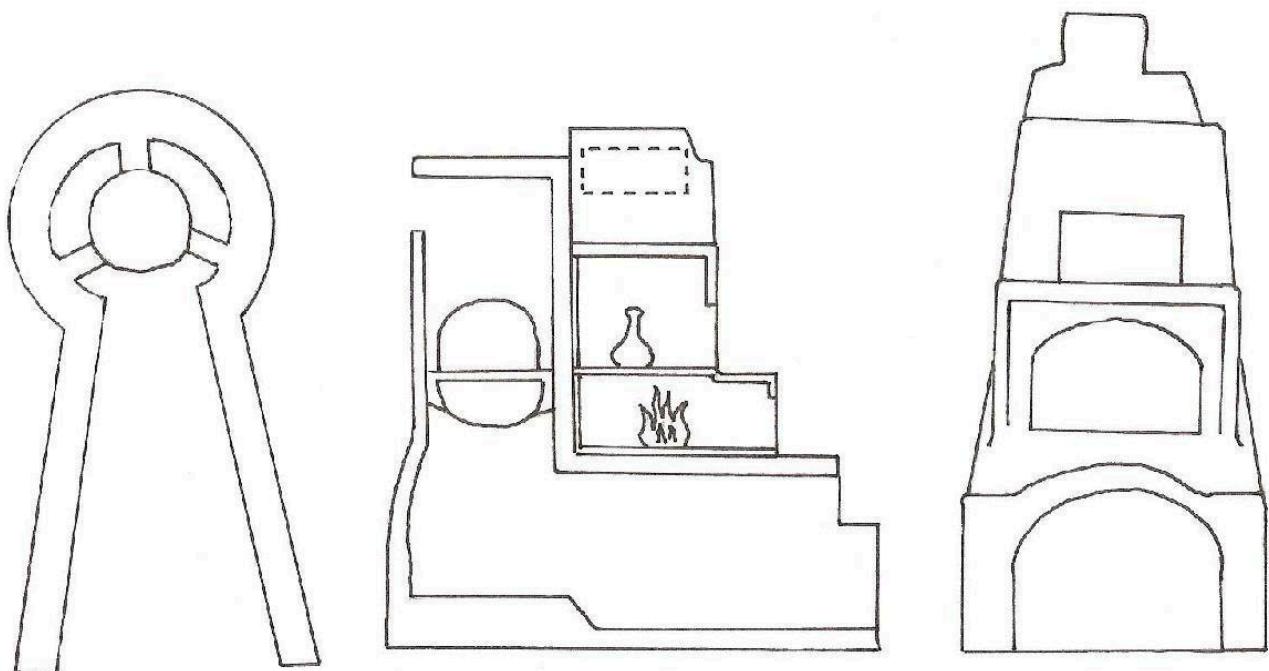
FIG 9. OUTLINE OF A NEW GLASS OVEN

In spring 2009 we decided to demolish the large furnace due to space and because of the large amounts of wood it needed, and to rebuild it. It was now rebuilt along the same lines as the small oven, but now included thicker outer walls for stability, and an integrated cooling oven to relax the glass. In this model the warming cupboard had to be separately heated, so that the beads which might later be produced could relax there (See Figure 9). The new furnace was built on the foundations of the older version, that means again we followed the groundplan of the furnace from Aix-en-Provence (Wedepohl 2003, 62, Fig. 21). The above ground part was modelled on a drawing from an oil lamp from Asseria (Archaeological Museum Split). The furnace was carefully fired after two weeks drying time. It was then operated for two days at Whitsun 2009.

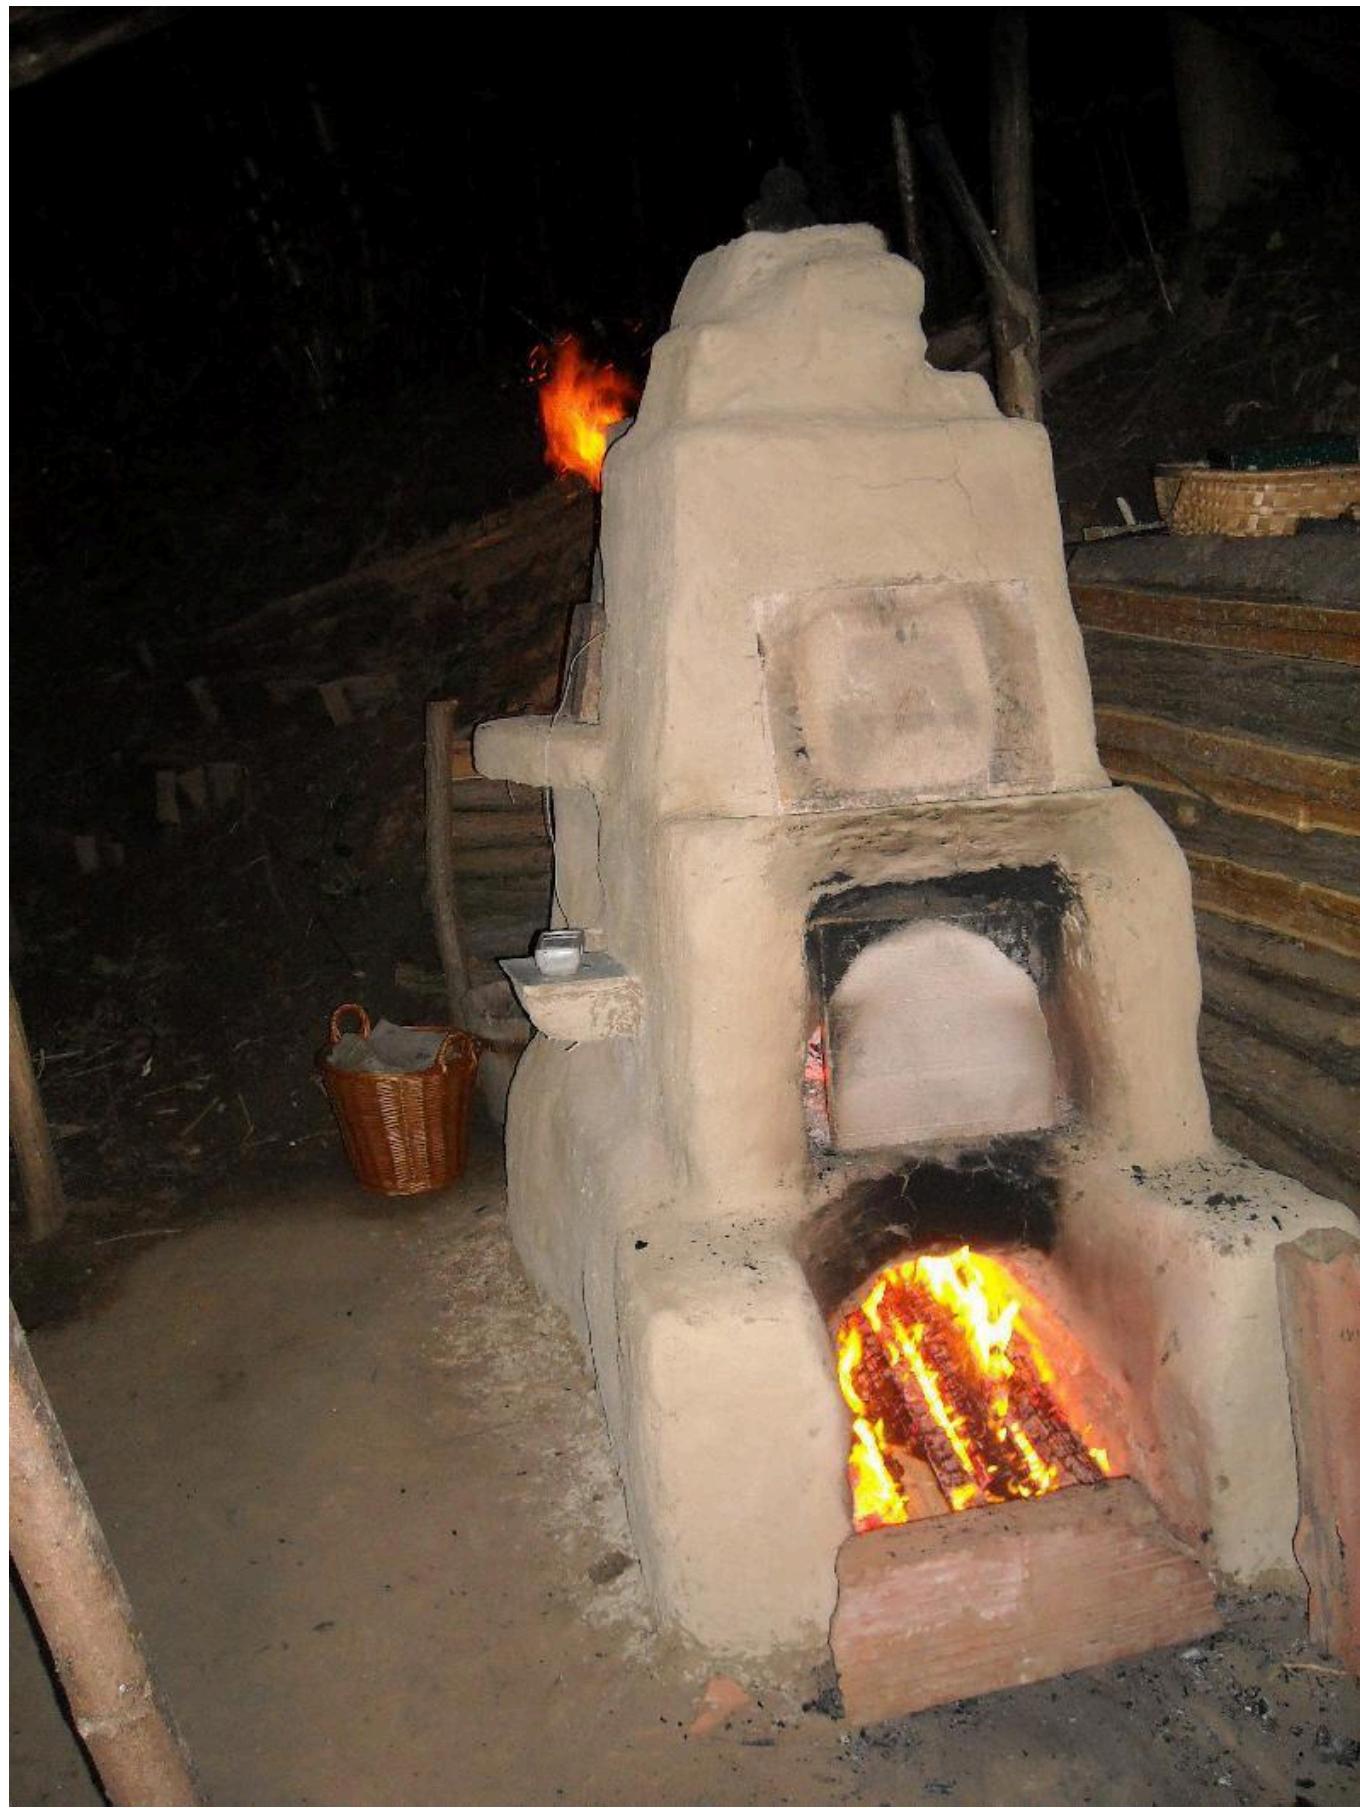
FIG 10. THE NEW GLASS OVEN WITH A SEPARATE COOLING OVEN

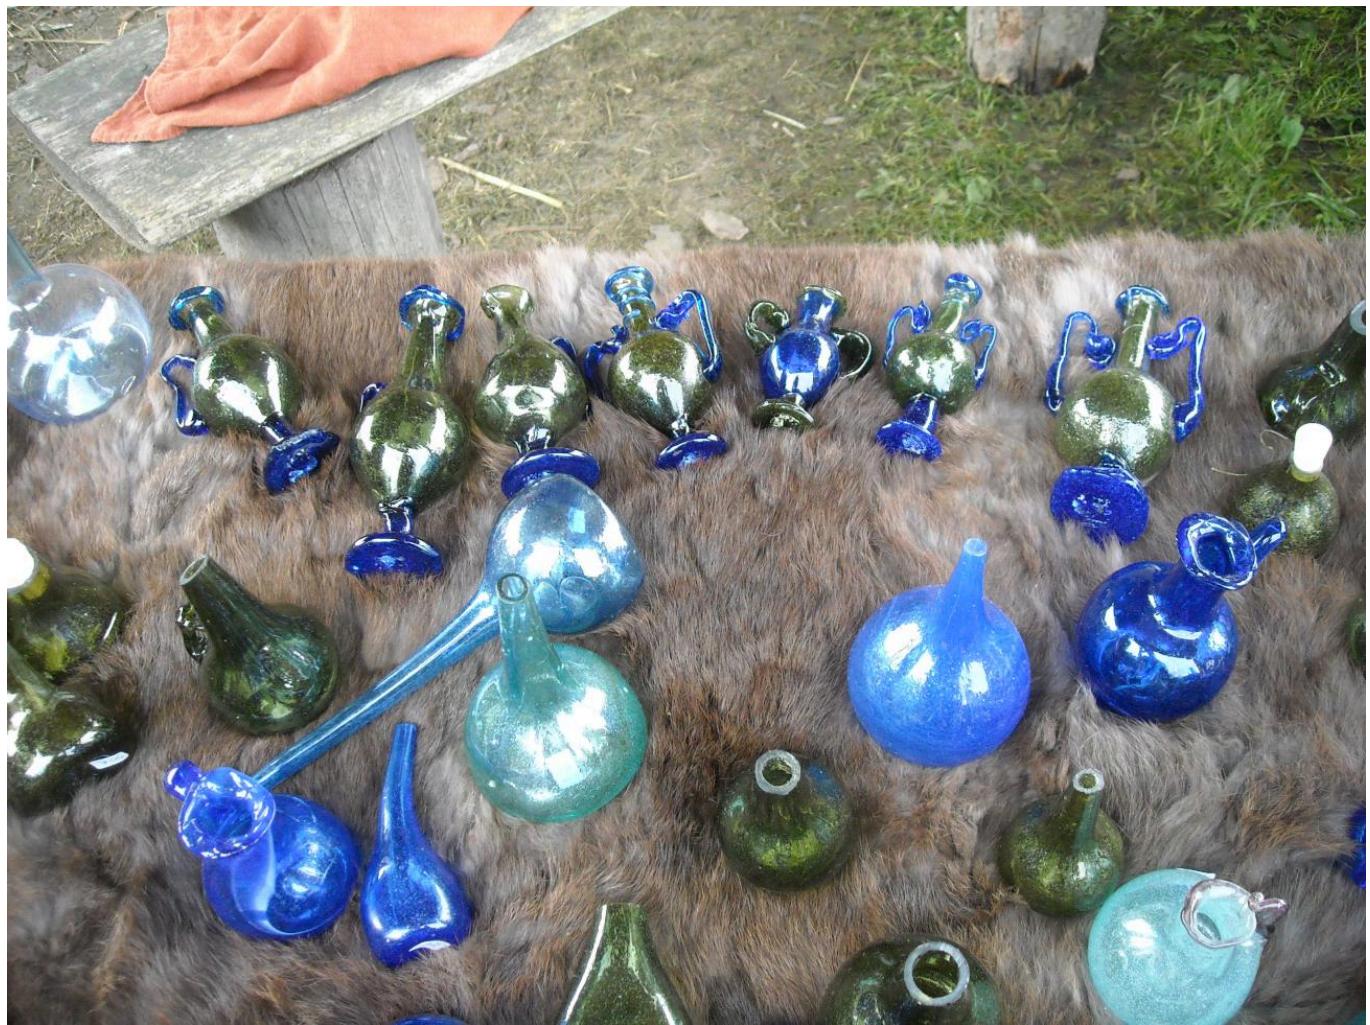
FIG 11. FINISHED GLASSES

During the first experiments, once we were able to produce workable glass, there had been attempts to blow the self-made glass with rudimentary blowpipes. Humble small bottles could be blown with relative ease, but attempts at more complicated models failed repeatedly³. After a while we were able to produce more difficult pieces with an added foot or a complicated rim (See Figure 11).
