Approaches to the Documentation of Houses in Open-Air Museums

EXARC Journal Issue 2021/1 | Publication Date: 2021-02-25

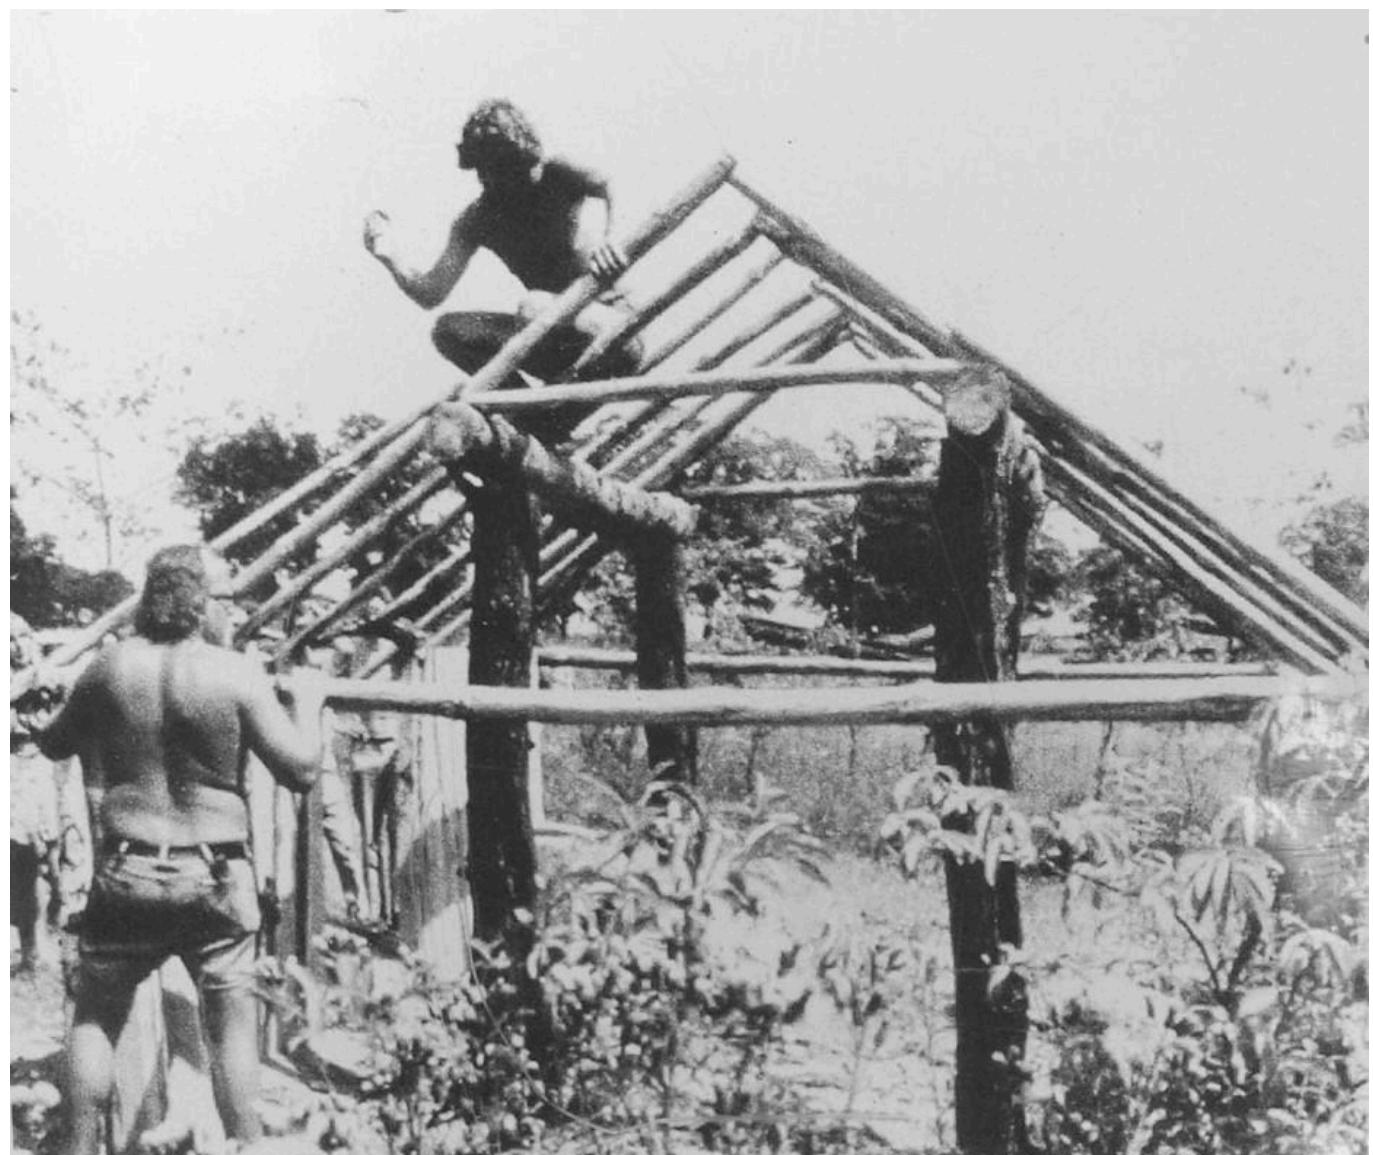
FIG 1. CONSTRUCTION OF THE HOUSE NO. 1 IN SUMMER 1971. PHOTO BY MUSEUMSDORF DÜPPEL E. V.

The decayed house is house no. 1, which was built in 1971 as the first one on the museum grounds, but outside the original medieval settlement area. It does not follow any archaeological features and was only built for the purpose of learning building techniques. The house was erected by a group of Danish scouts (See Figure 1), which is why it is also listed as the 'Viking house' in the Düppel-History by D. Todtenhaupt (2015). The construction method and the building material can be described as follows: Parallel post-construction with posts made of birch trunks, into which purlins are mortised; the rafters rest on the two purlins. The construction is supported in the roof truss and in the lower area by cross battens, at which oak split planks in tongue and groove joint form the walls. The roof was covered with reed (See Figure 2). A floor was not laid.

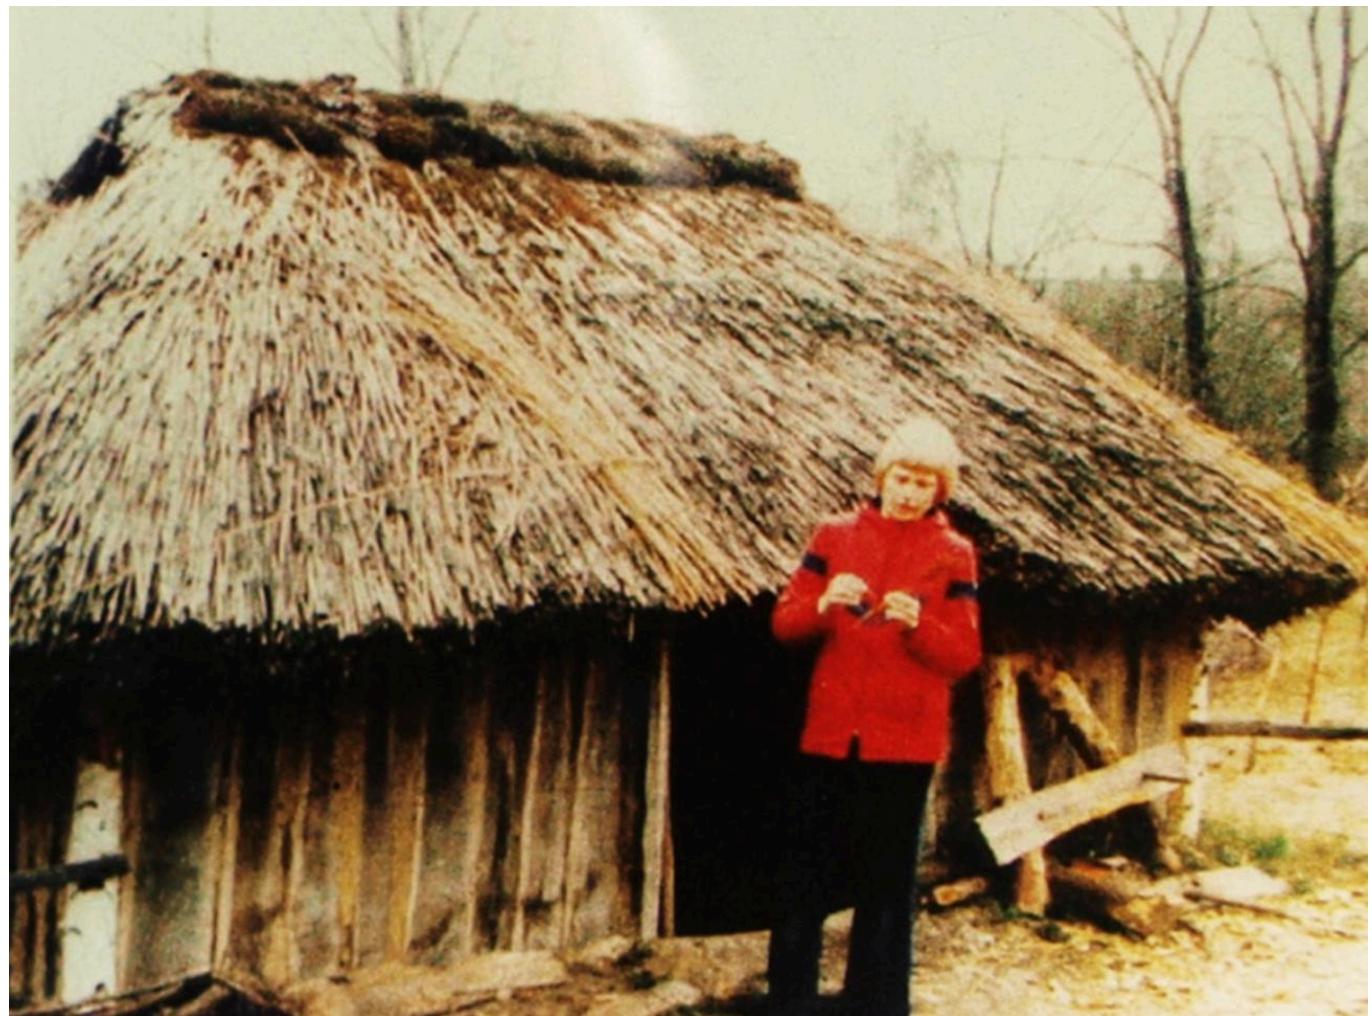
FIG 2. THE HOUSE IN ITS ORIGINAL STATE AND DURING THE PERIOD OF USE. PHOTO BY MUSEUMSDORF DÜPPEL E. V.

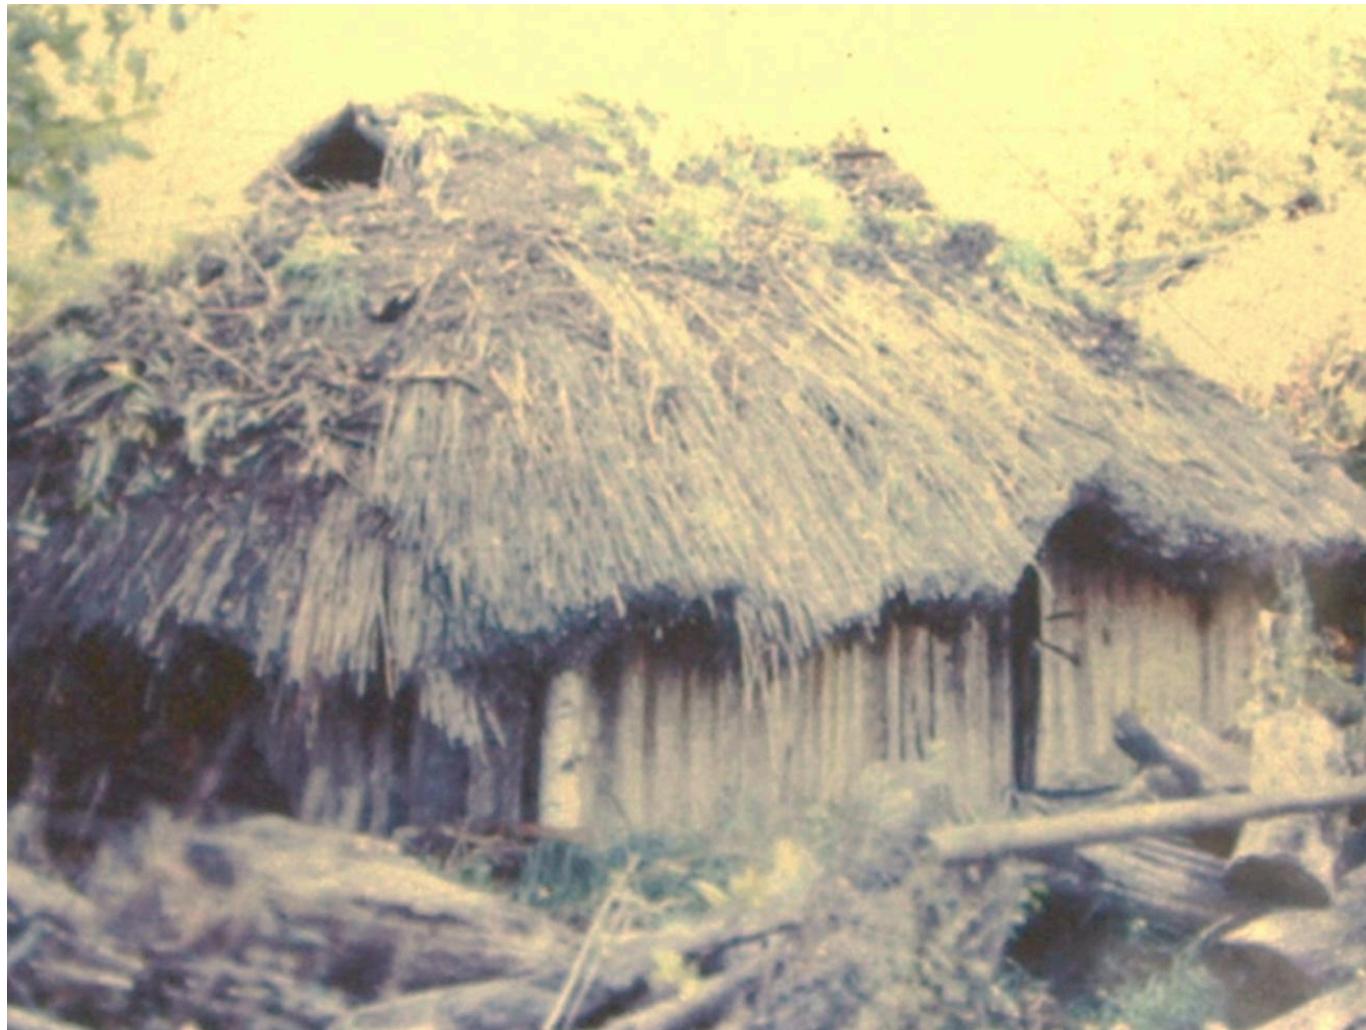
FIG 3. THE PHOTO SHOWS THE BEGINNING OF THE DECAY PROCESS. PHOTO BY MUSEUMSDORF DÜPPEL E. V.

From 1984 onwards the house was no longer used and was therefore exposed to decay (See Figure 3). In 1990, it was decided to let the building, which was dilapidated especially in the roof area, fall into complete disrepair. For this, the rear split-blank wall and the door were removed. The further decay was to be continuously documented and finally, an archaeological excavation was to be carried out. The results and a reconstruction based on them were then to be compared with the original building plan.

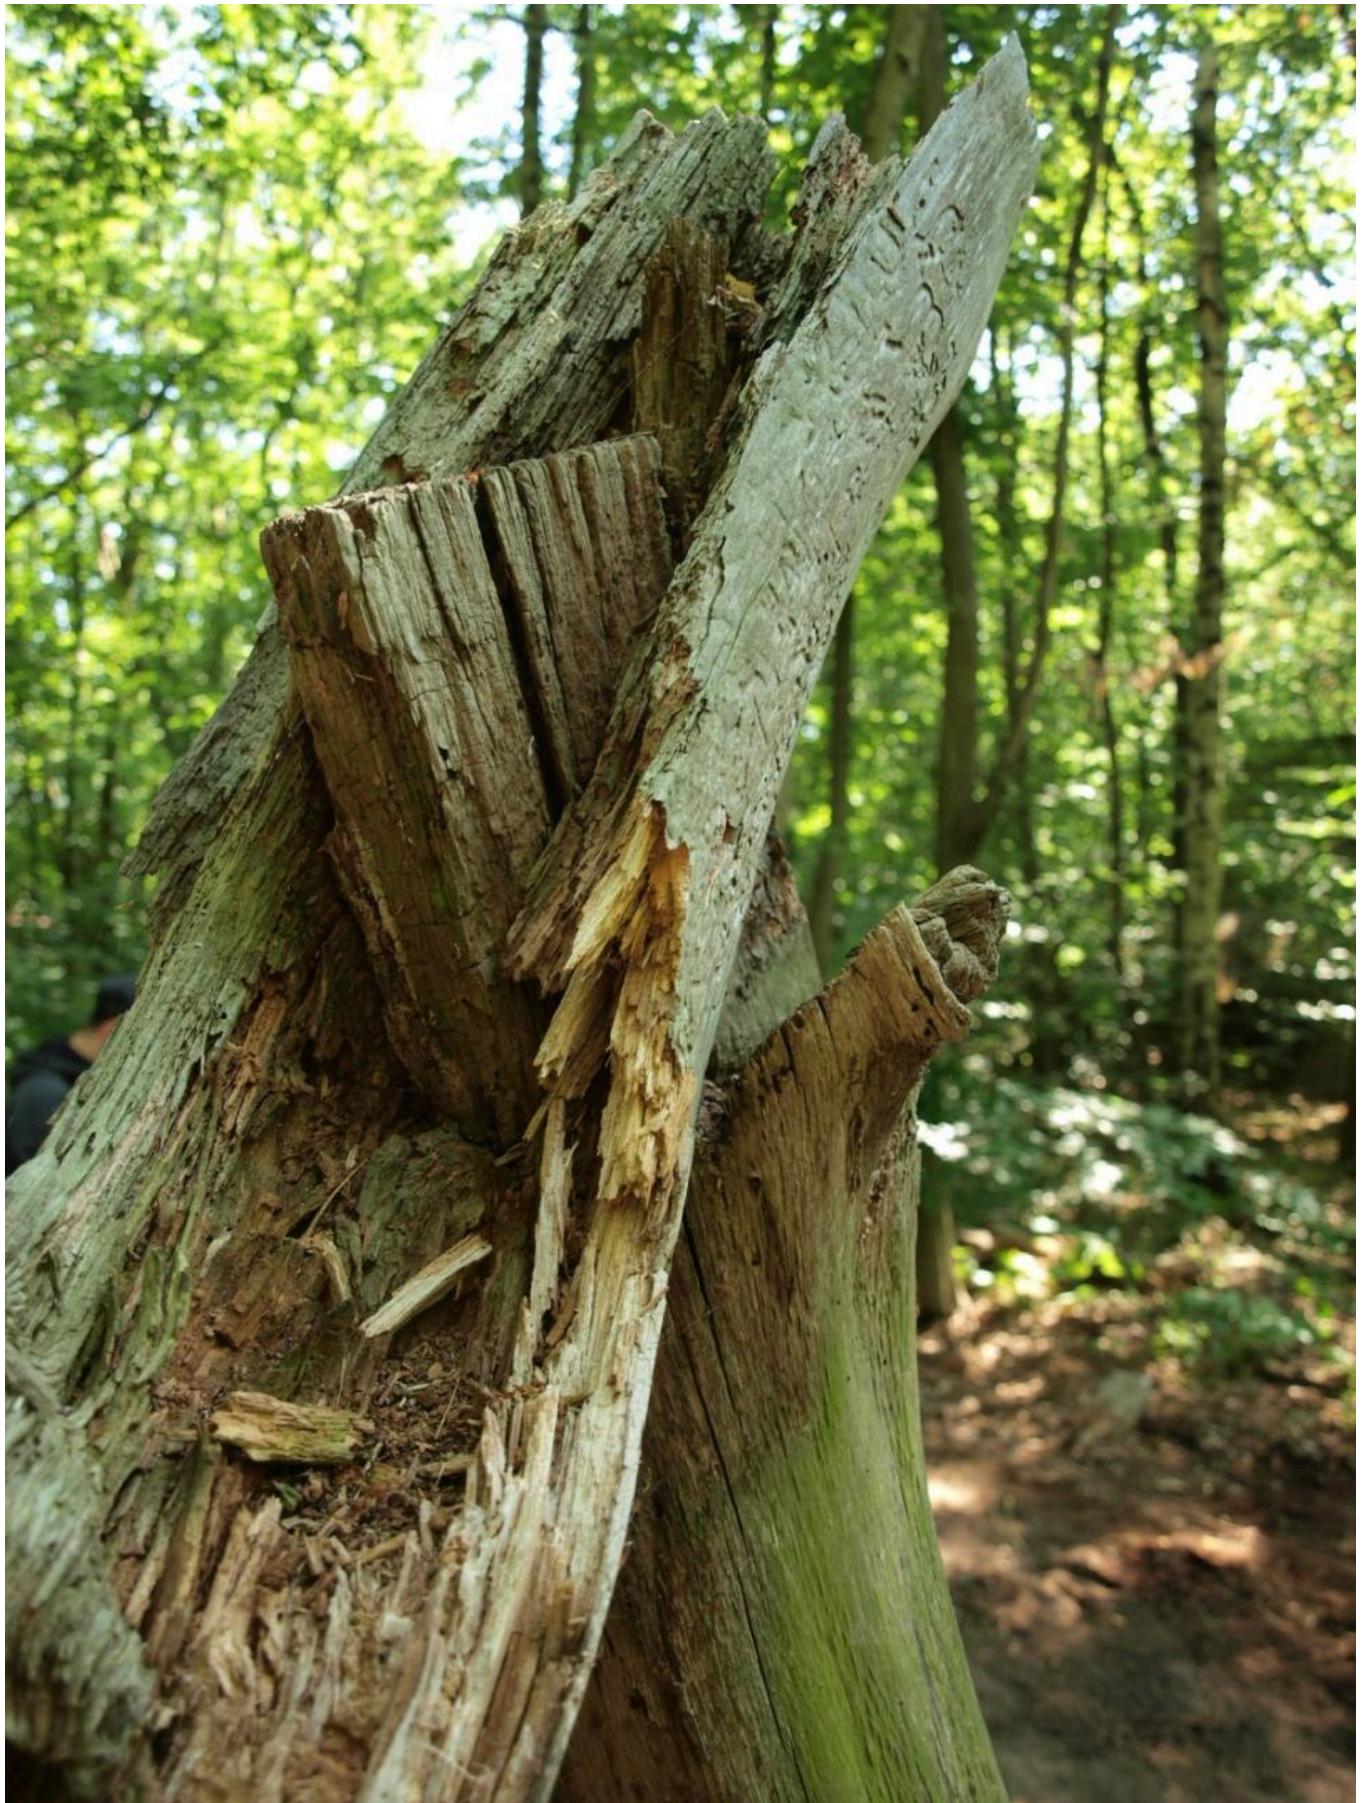
FIG 4. POLE STILL IN TENON CONNECTION WITH HANGING PURLIN. PHOTO BY E. LEHNHARDT

The rafters are no longer detectable respectively cannot be addressed as such properly if the wood is lying on the ground and already heavily decayed, because these could also be fragments of split planks. One of the four posts is still standing (See Figure 6). From this, the purlin, which is still joined in mortise and tenon, hangs down to the ground (See Figures 4 and 5). The posts are much better preserved than the two purlins. The purlin in the rear area of the former house, which is still loosely in the tenon joint, is in parts, already very badly decomposed. The split planks of the former wall in the front area of the house are clearly identifiable. They lie mostly parallel next to each other or partly on top of each other. Some are still quite well-preserved and the holes, which served for the former fastening, are clearly recognizable. As the holes are located at the upper parts of the split planks, it is also possible to reconstruct the different (not regular) directions of the lintel, determined by the respective degree of decay. It can be seen, for example, that some planks lie more or less parallel to the former wall along the edge of the eaves, while others were shifted towards the house area.

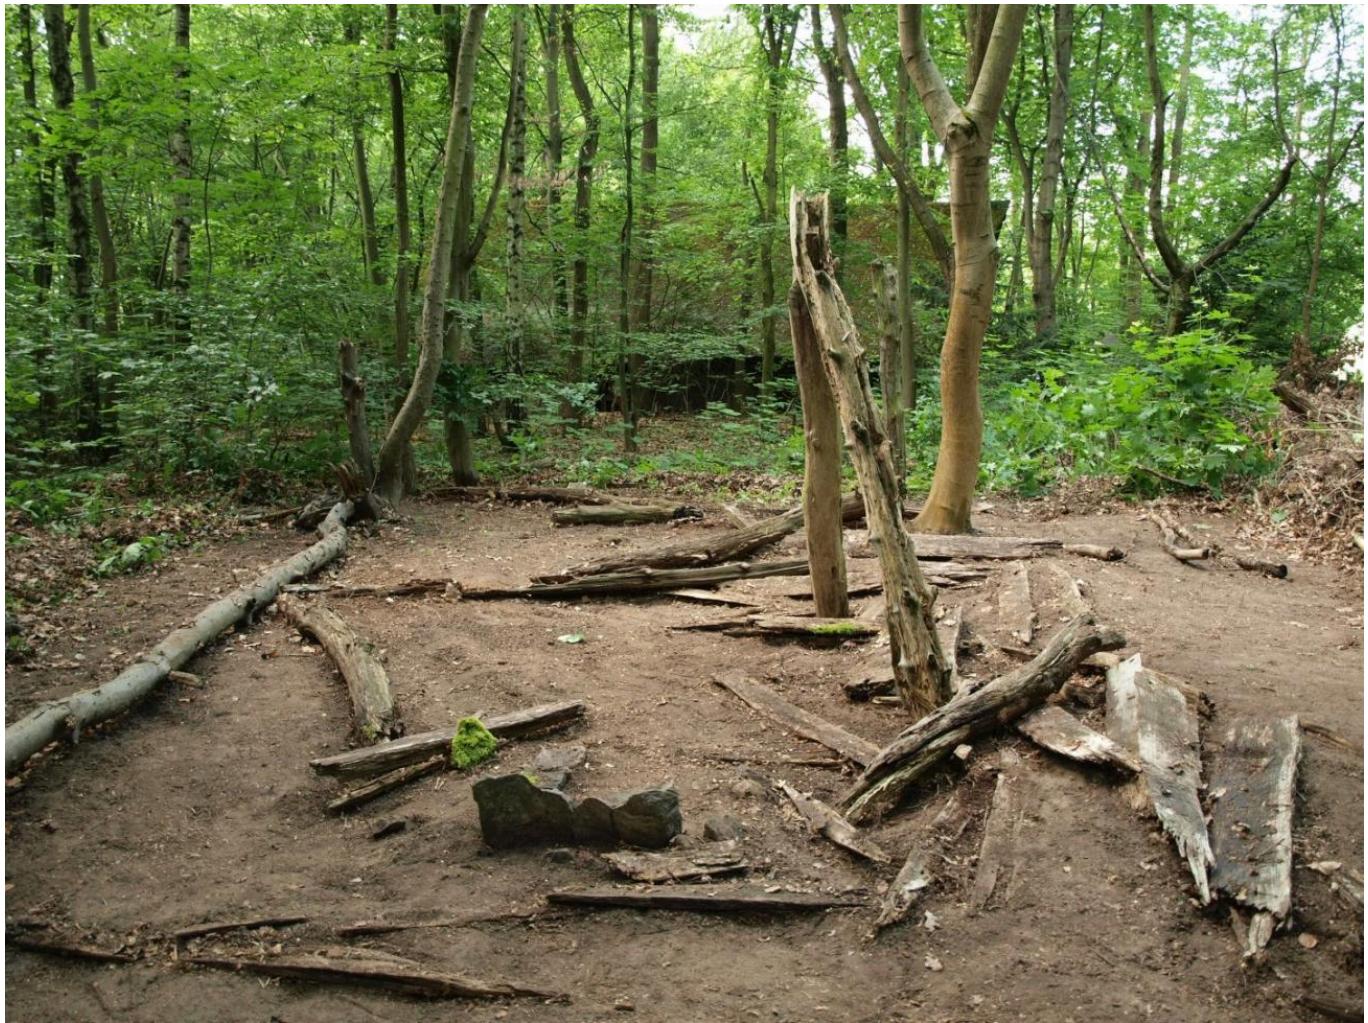
FIG 5. REMAINS OF THE DECAYED HOUSE. PHOTO BY E. LEHNHARDT

The rectangular fireplace is still clearly recognizable as such, although smaller stones have already been shifted and some pieces have splintered off from the larger stones, probably due to frost wedging. There is some moss growth on the stones.

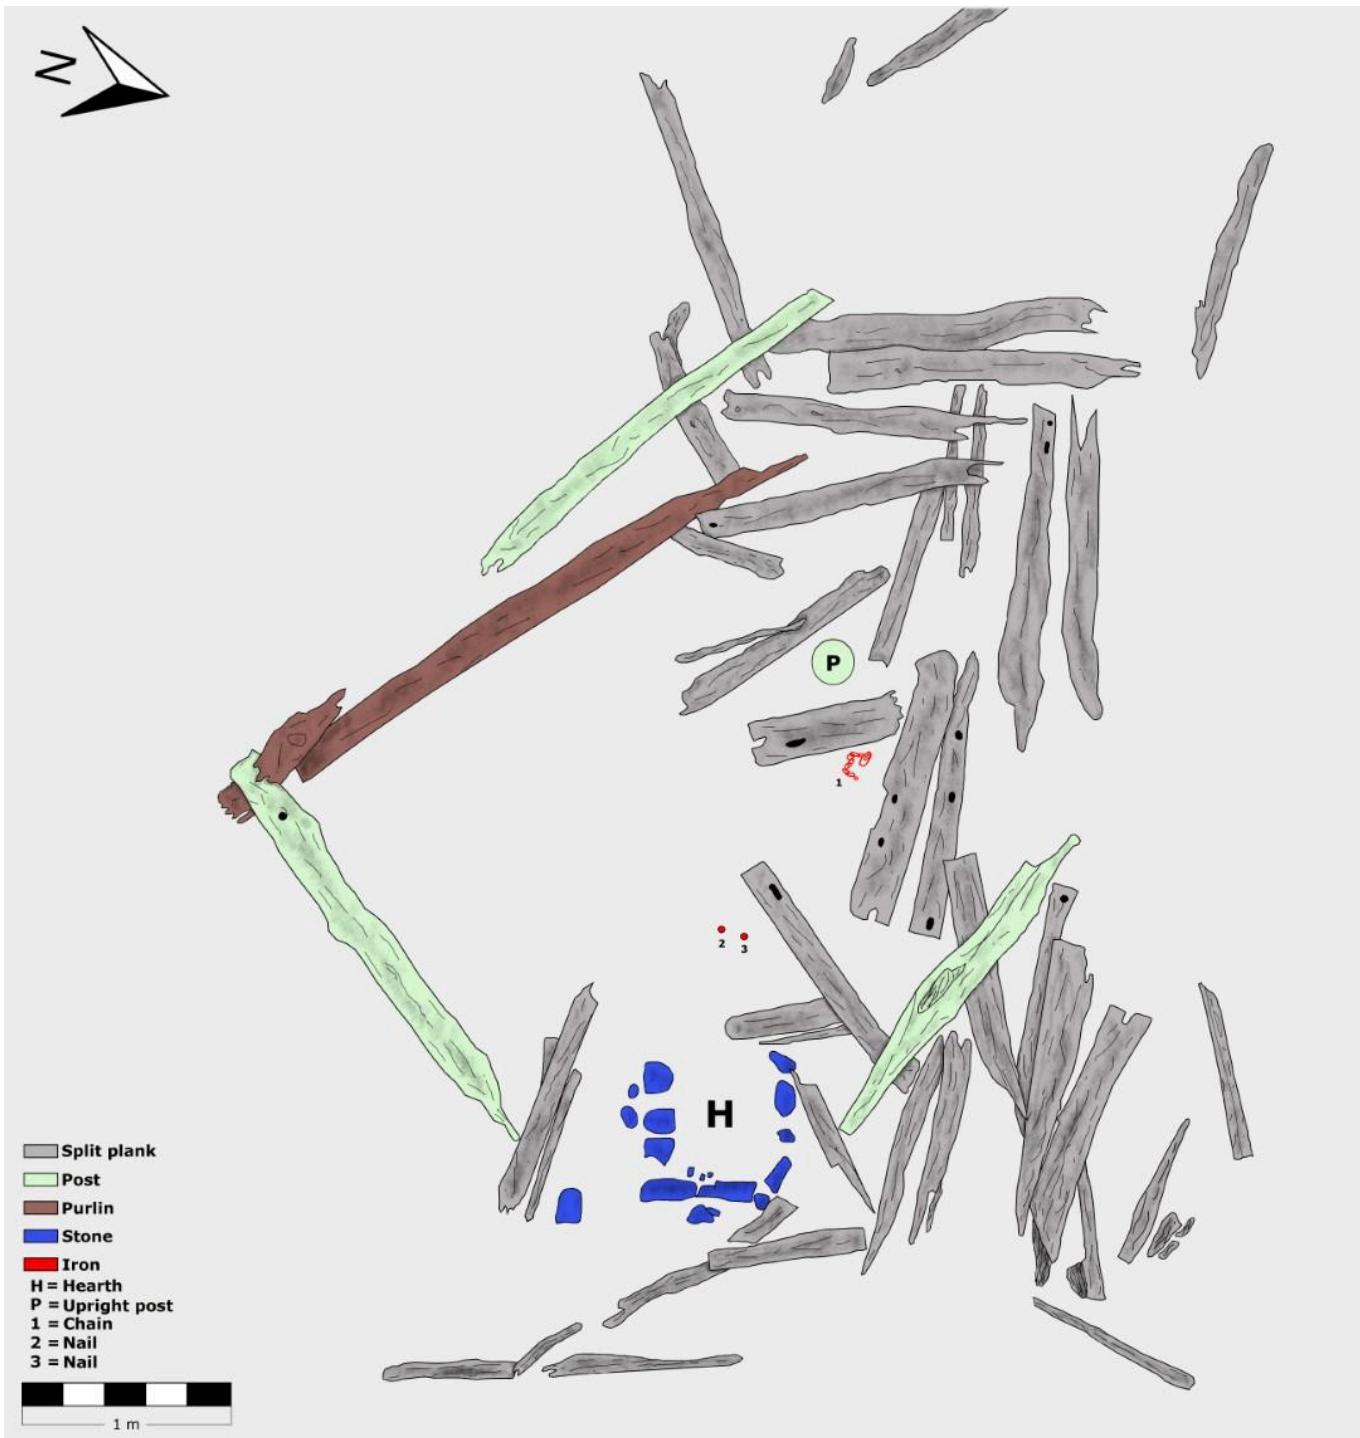
FIG 6. DOCUMENTATION PLAN OF THE DECAYED HOUSE (HOUSE 1) FROM 01.06.2019. DRAWING: J. BEHREND, F. BRÜCKNER, C. JESS, L. MICHAELIS, K. MÜLLER. GRAPHICAL REALISATION: E. LEHNHARDT

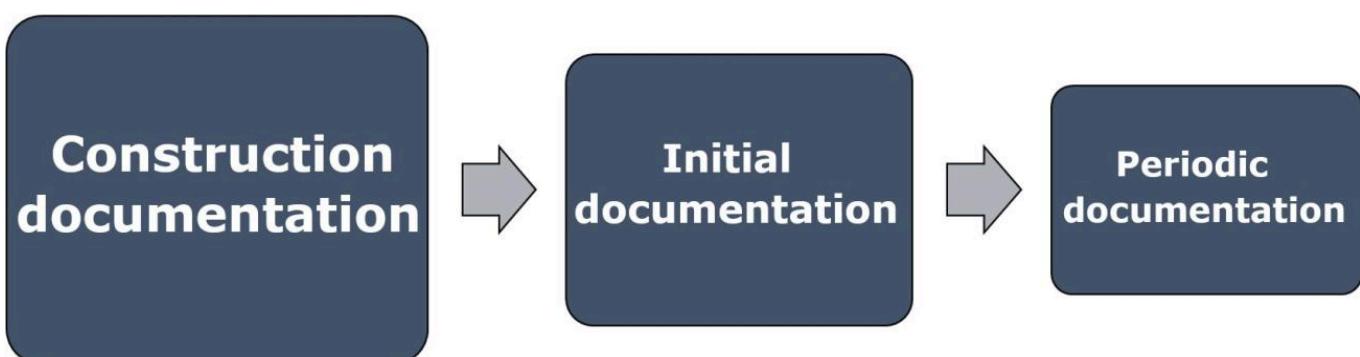
FIG 7. SCHEMATIC REPRESENTATION AND CHRONOLOGICAL SEQUENCE OF THE THREE POSSIBLE DOCUMENTATION PHASES.

Our concept distinguishes between three phases of the documentation of houses in open-air museums (See Figure 7):

1. the documentation of the construction of a house,
2. the initial documentation of a house, and
3. the periodic (annual) documentation of a house.

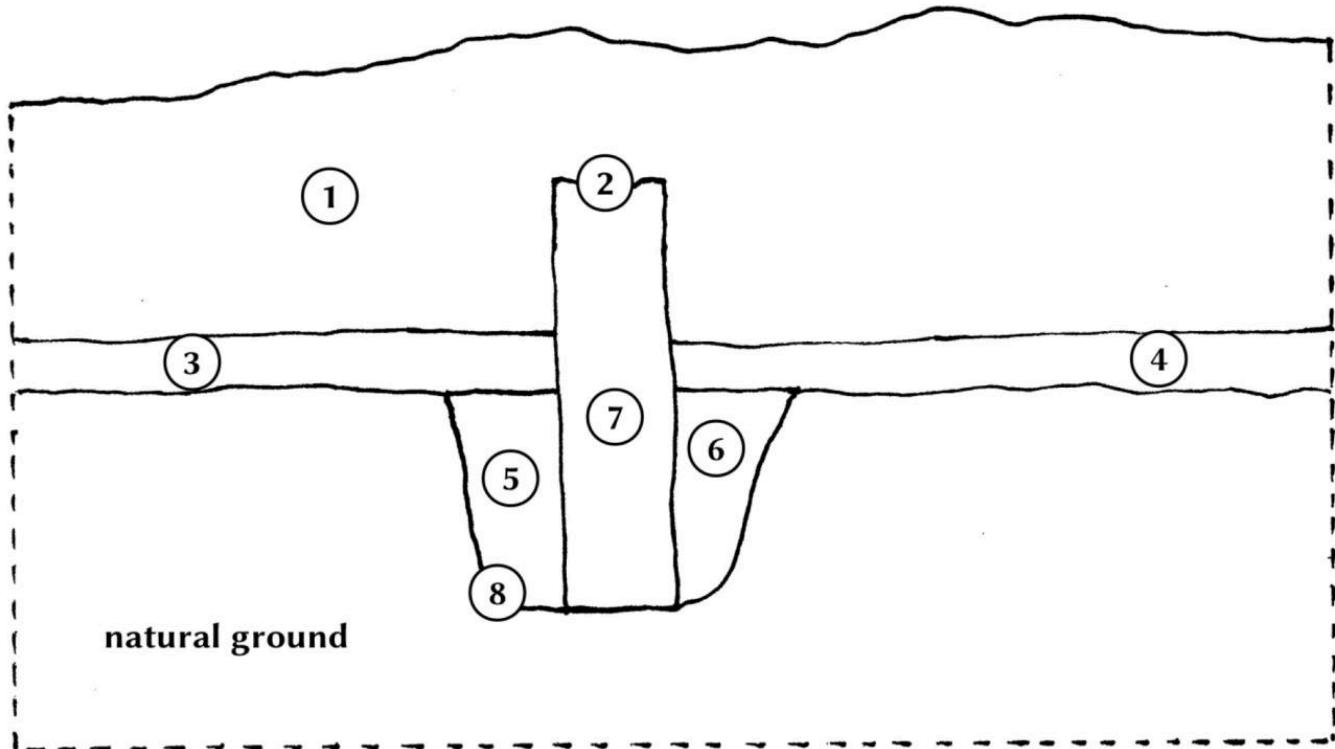
FIG 8A. A SIMPLE STRATIGRAPHY, STRATIGRAPHIC UNITS NUMBERED FROM NEWER TO OLDER (S. SOLLEDER).

Figure 8a shows a simple stratigraphy. The units of stratigraphy are numbered from newer to older and represented in the Harris matrix in Figure 9. Let us assume that we interpret this stratigraphy as the remains of a house: a brick wall (7) with its foundation trench (8) that was filled with material (5/6); the floors of the rooms to the left and right of the wall (3/4). Furthermore, we interpret unit 2 as the trace of the demolition of the wall. And unit 1 is a layer covering the remains.

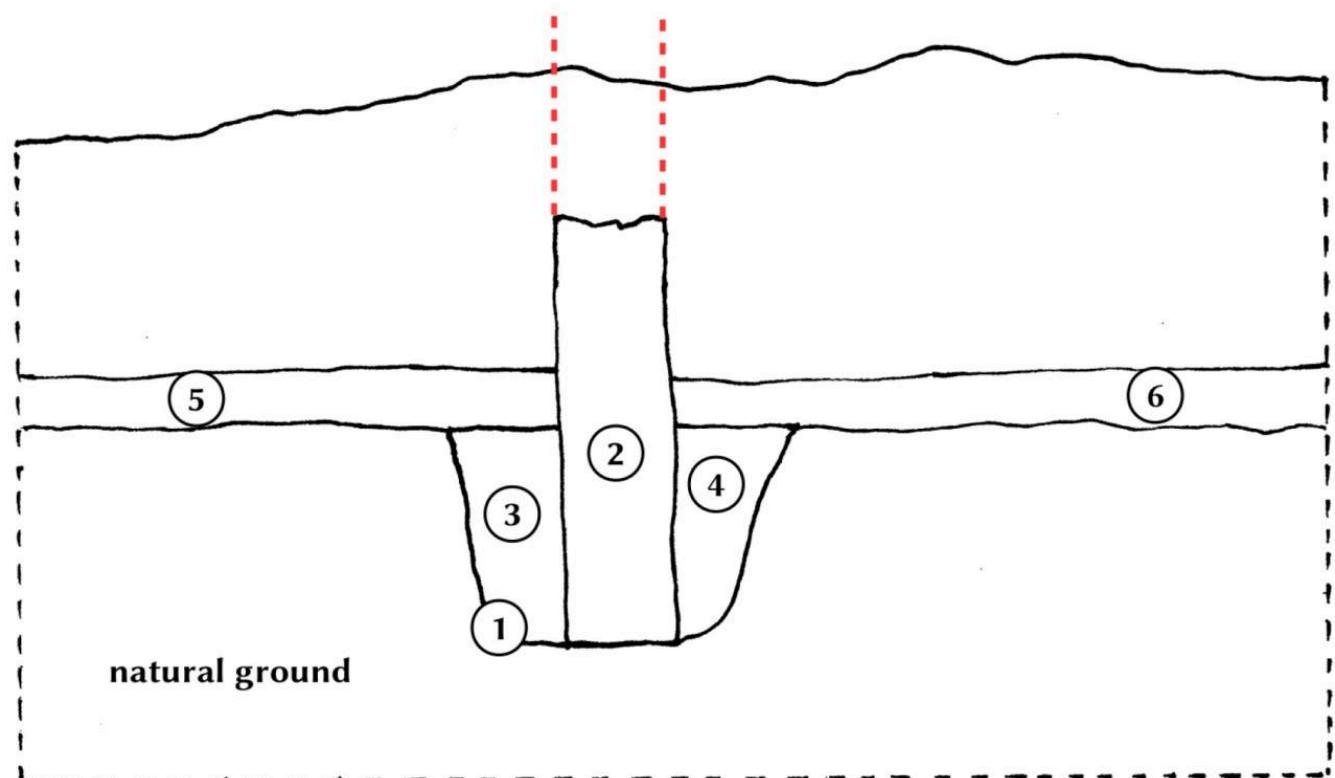
FIG 8B. A SIMPLE STRATIGRAPHY, STRATIGRAPHIC UNITS NUMBERED IN REVERSE ORDER (S. SOLLEDER).

If we reverse this order (and omit stratigraphic units that are traces of later demolition and abandonment), as in Figure 8b, we get information on how the construction of the house proceeded. And this information is already inherent in the Harris matrix in Figure 9. Let us now assume that we want to build a replica of this house. The reverse order tells us how to plan our documentation of the construction, it tells us what to document and when.

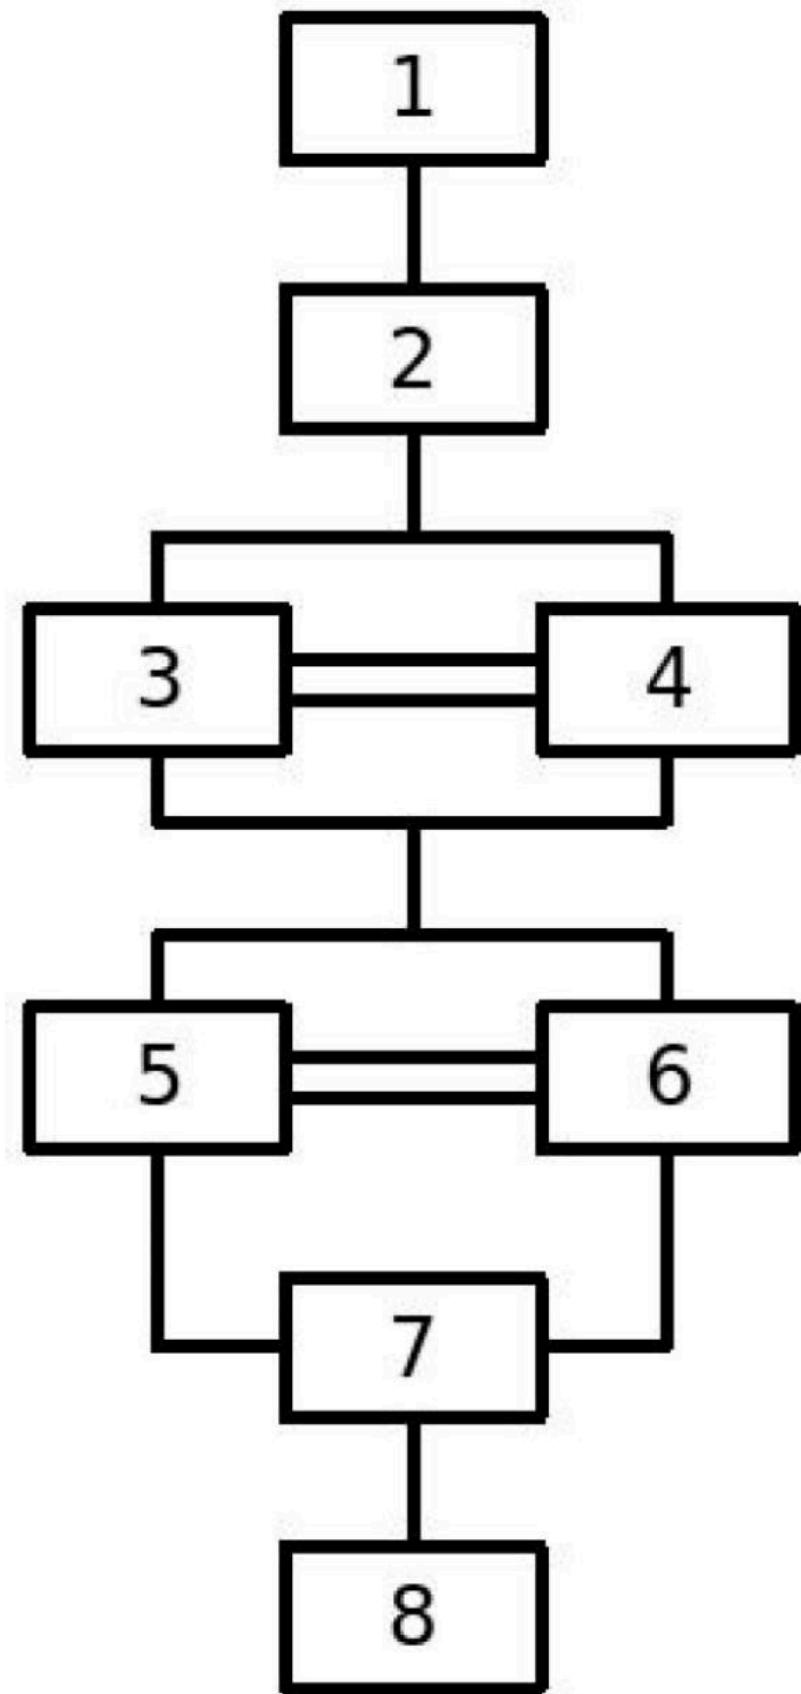
FIG 9. HARRIS-MATRIX REPRESENTING THE STRATIGRAPHIC UNITS IN FIGURE 8A (S. SOLLEDER). FIG.

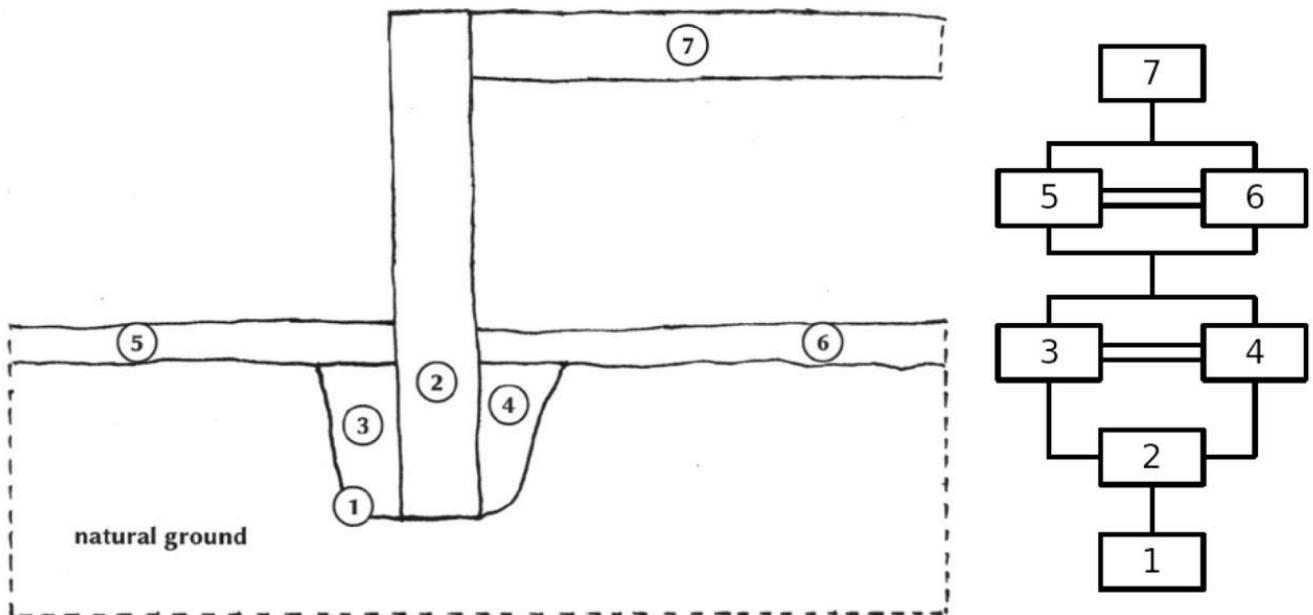
FIG 10. CONSTRUCTION PROCESS REPRESENTED AS STRATIGRAPHY AND HARRIS MATRIX (S. SOLLEDER).

The second stage concerns the preparation of the ground that usually produces negative features, in our example a foundation trench (See Figure 10, unit 1). At this stage it is important to document not only the negative features that are produced for the new building, but as well possible traces of agricultural use, predecessor buildings and any other human activity that are not completely destroyed through the preparation of the building ground.

At stage 3 all the parts of a house that are in the ground or in direct contact to the ground should be documented. In our example, this would be a brick wall, the fills of its foundation trench and the floors (See Figure 10, units 2-6).

Finally, at stage 4, all the parts of a house should be documented that are attached to the parts that were constructed in stage 3 and that have no direct contact to the ground, in our example a wooden beam resting on the brick wall (See Figure 10, unit 7).
